Warm, dry, healthy housing?

Insights from the 2015/16 BRANZ House Condition Survey

5 September 2017

BRANZ House Condition Survey 2015/16

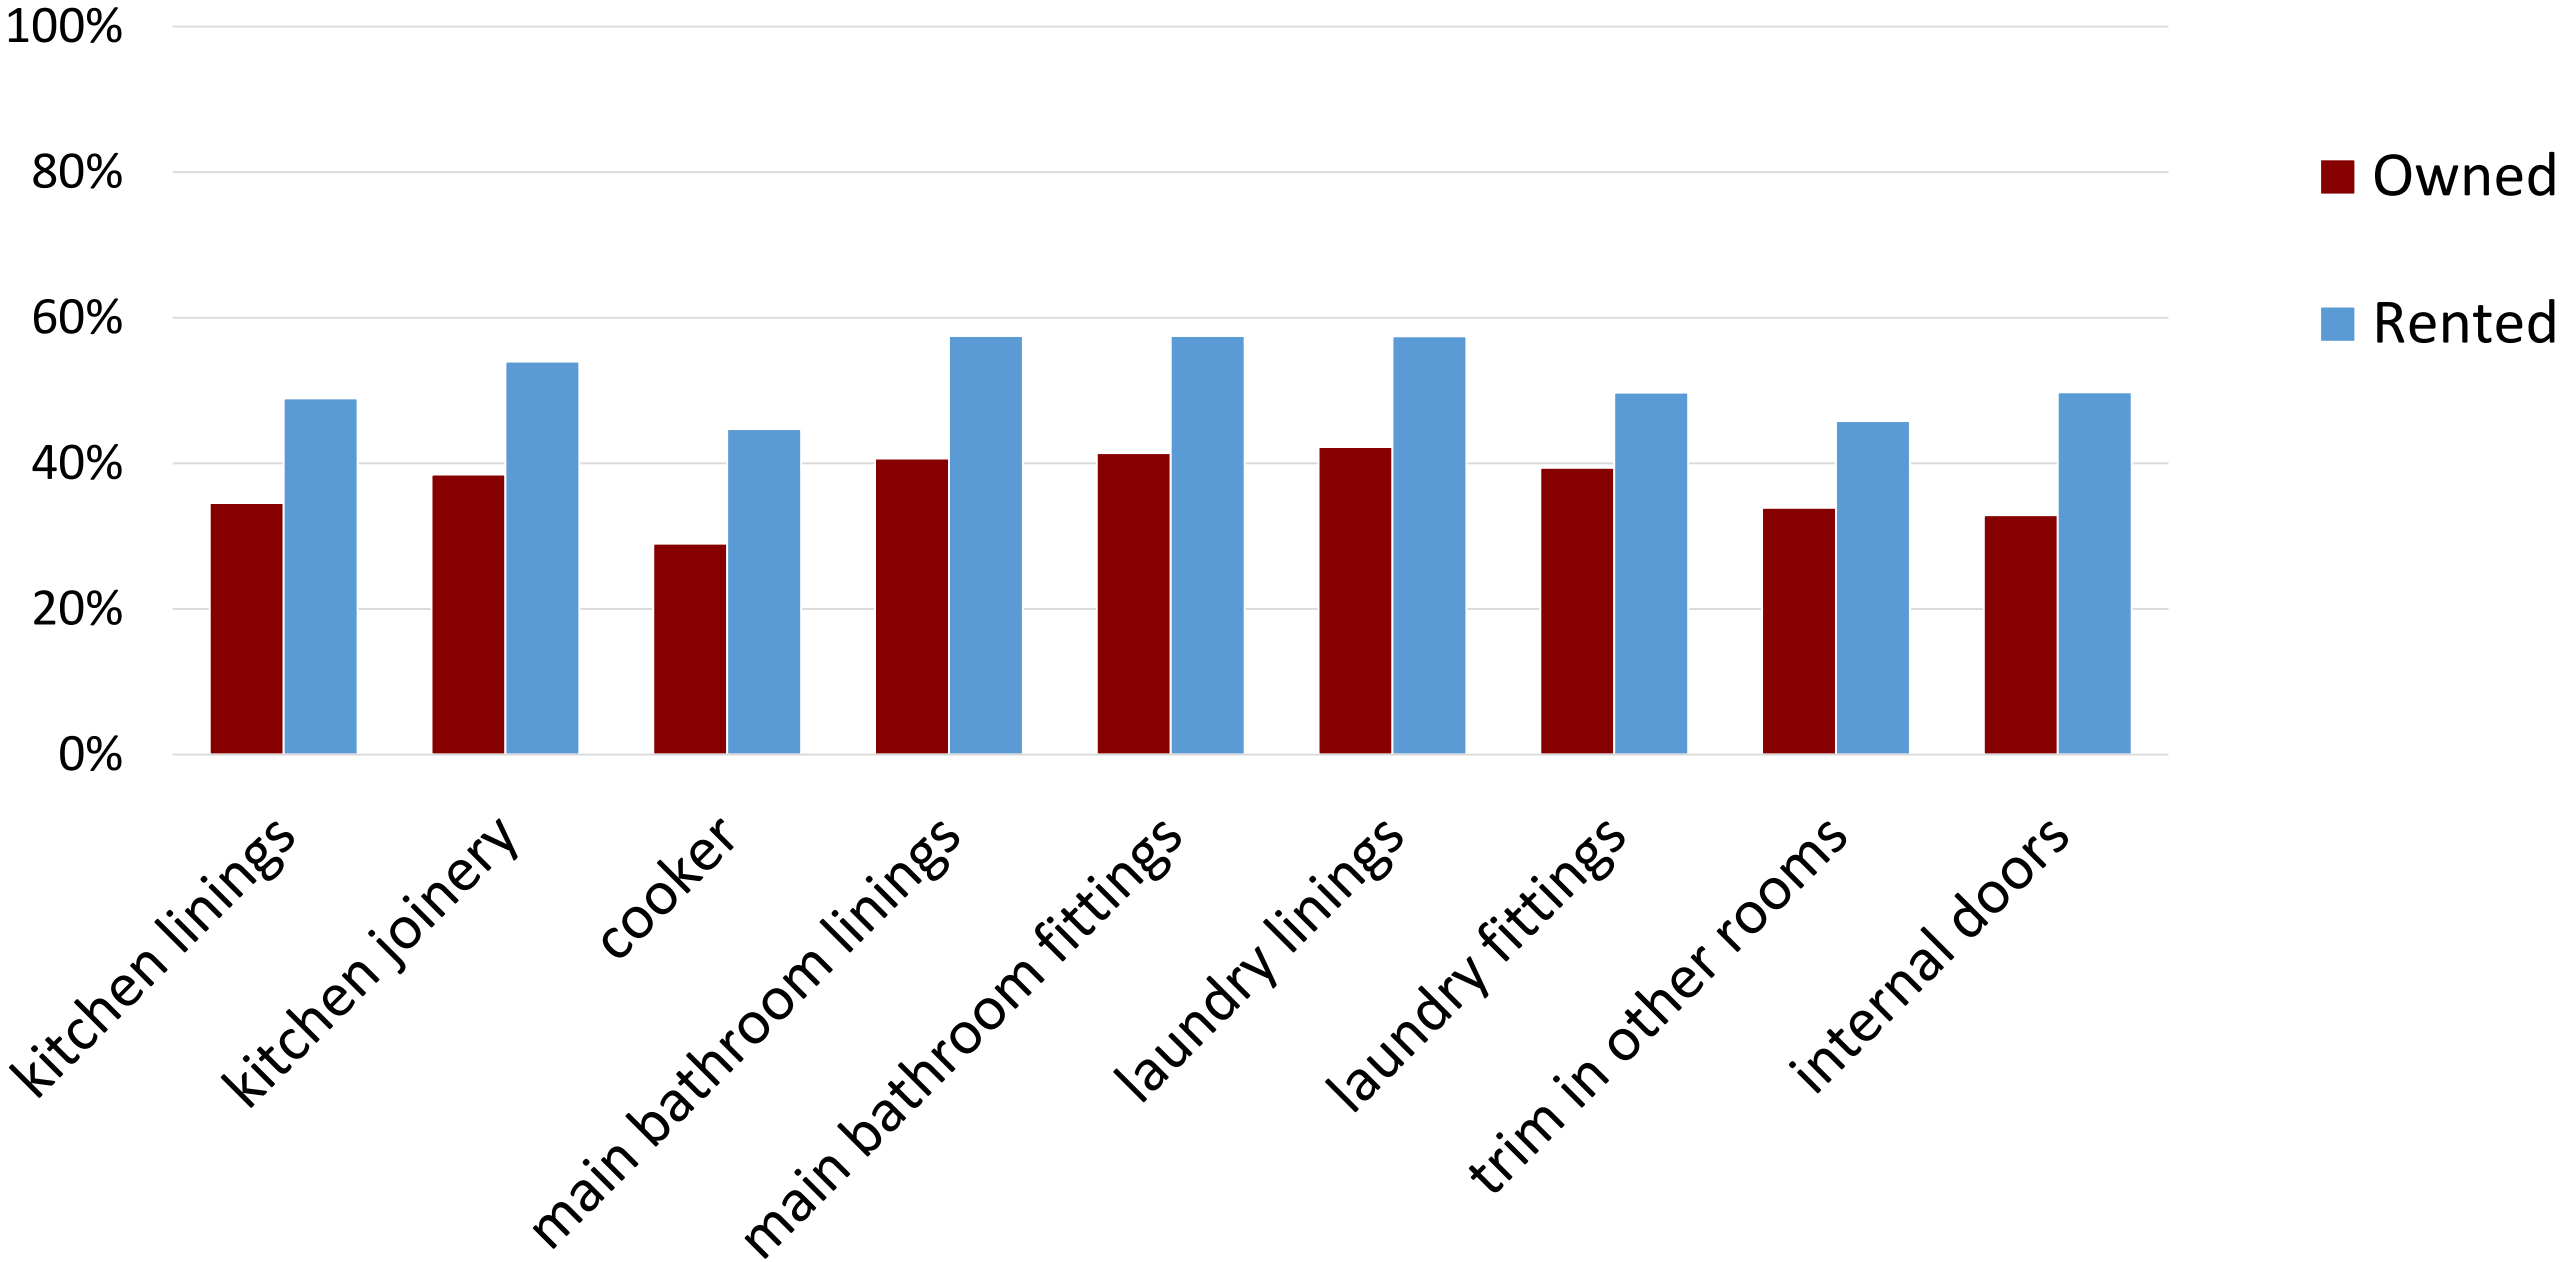
House interior condition ratings: Proportion in moderate or worse condition

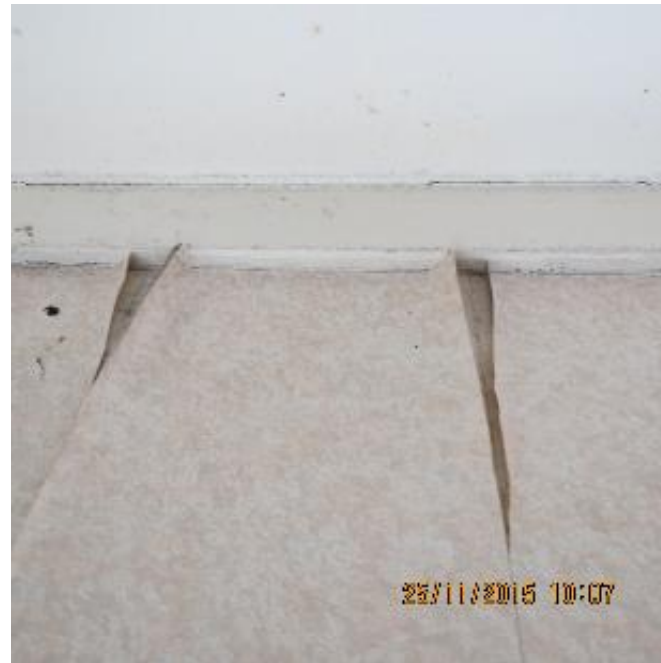
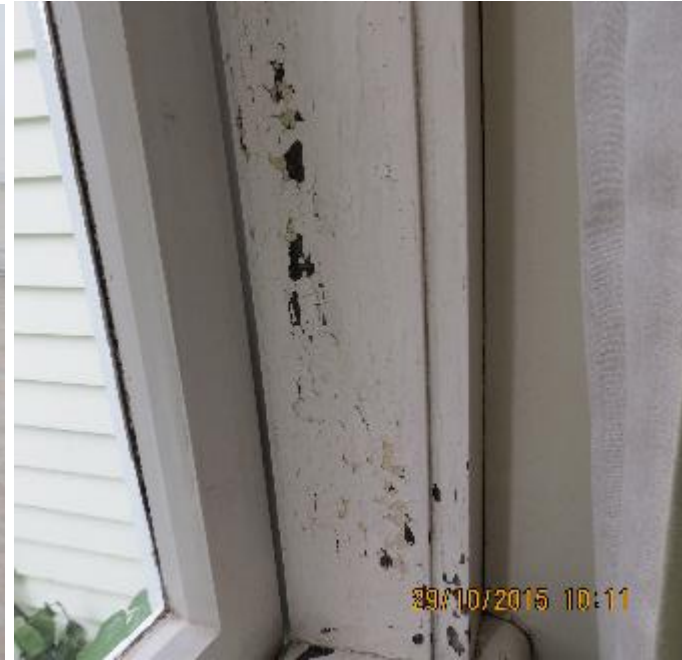
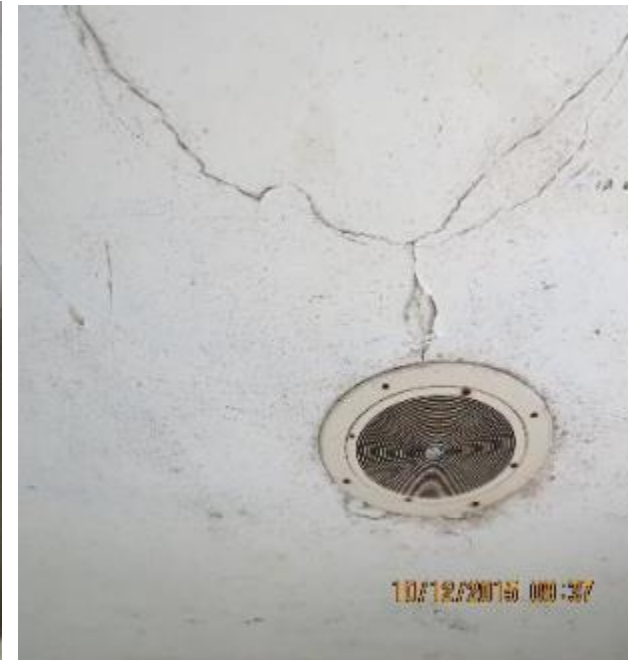
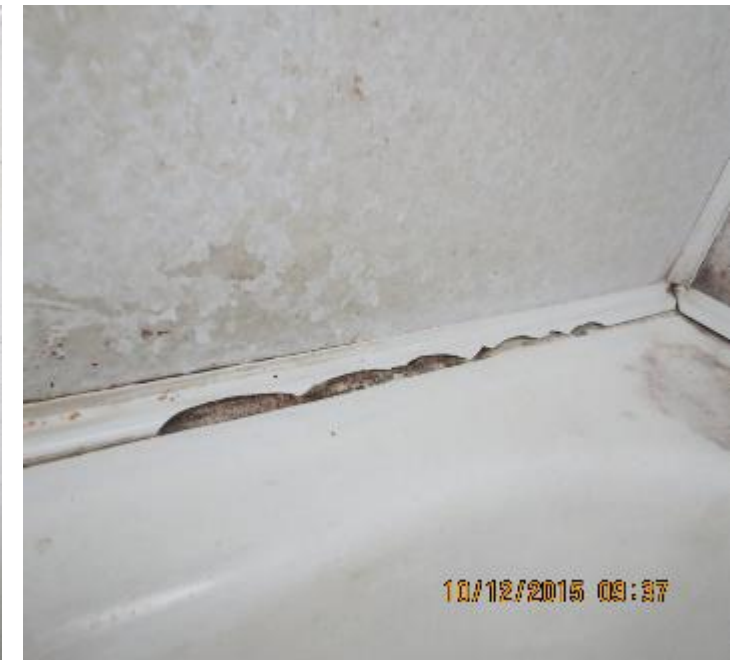
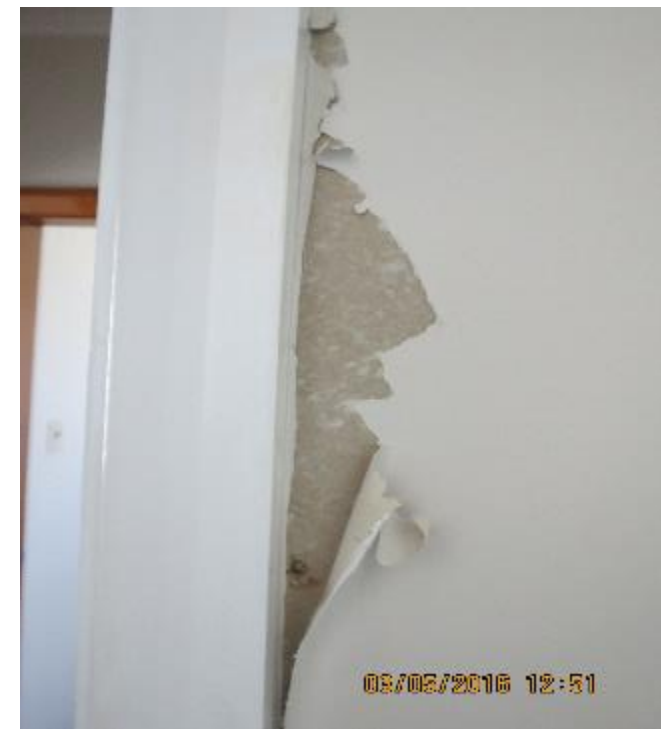
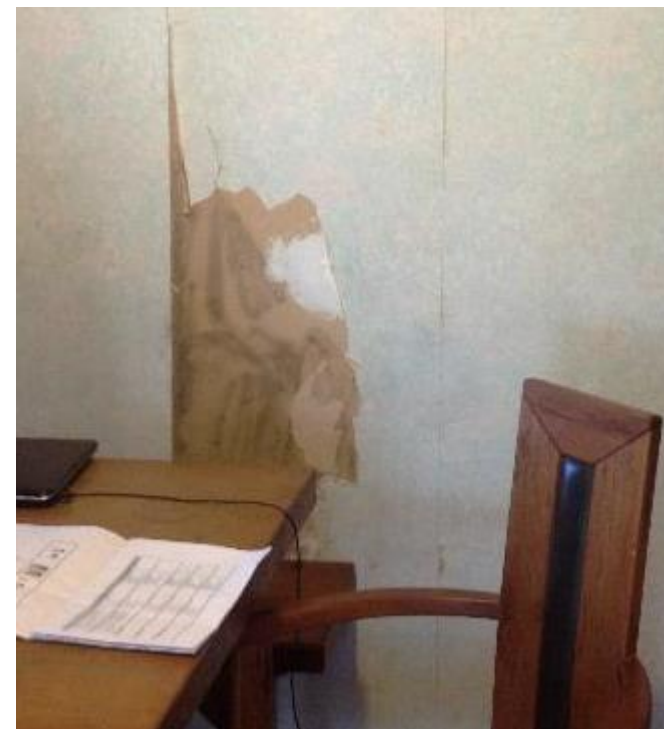
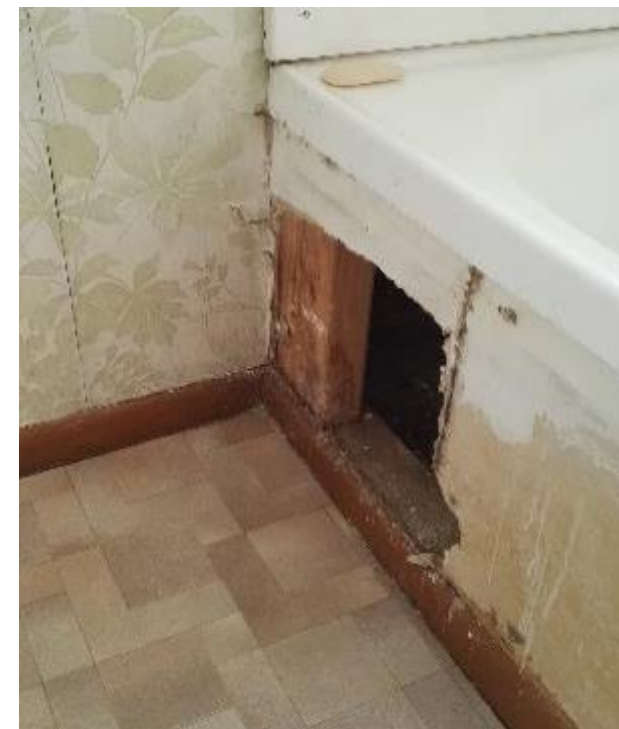
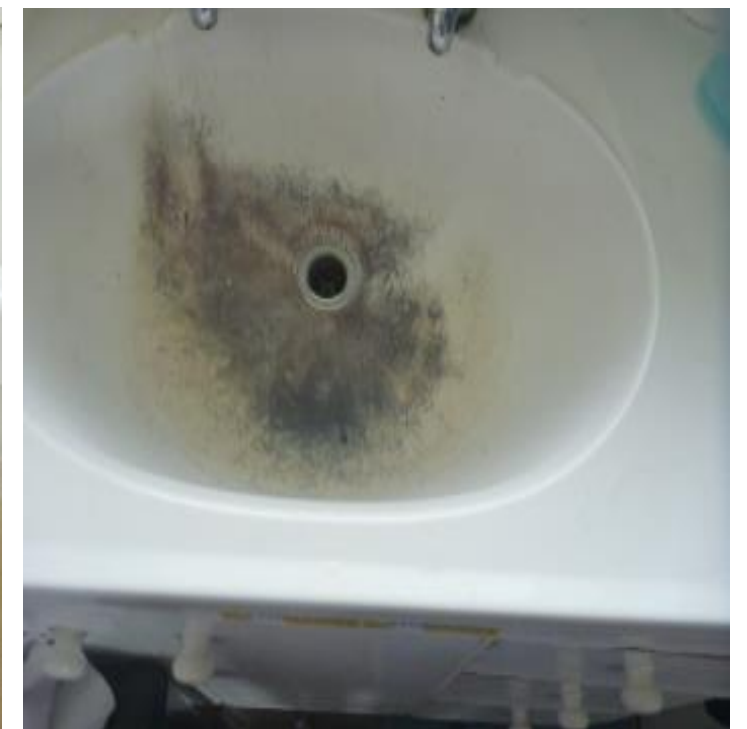
House interior: Defects - examples

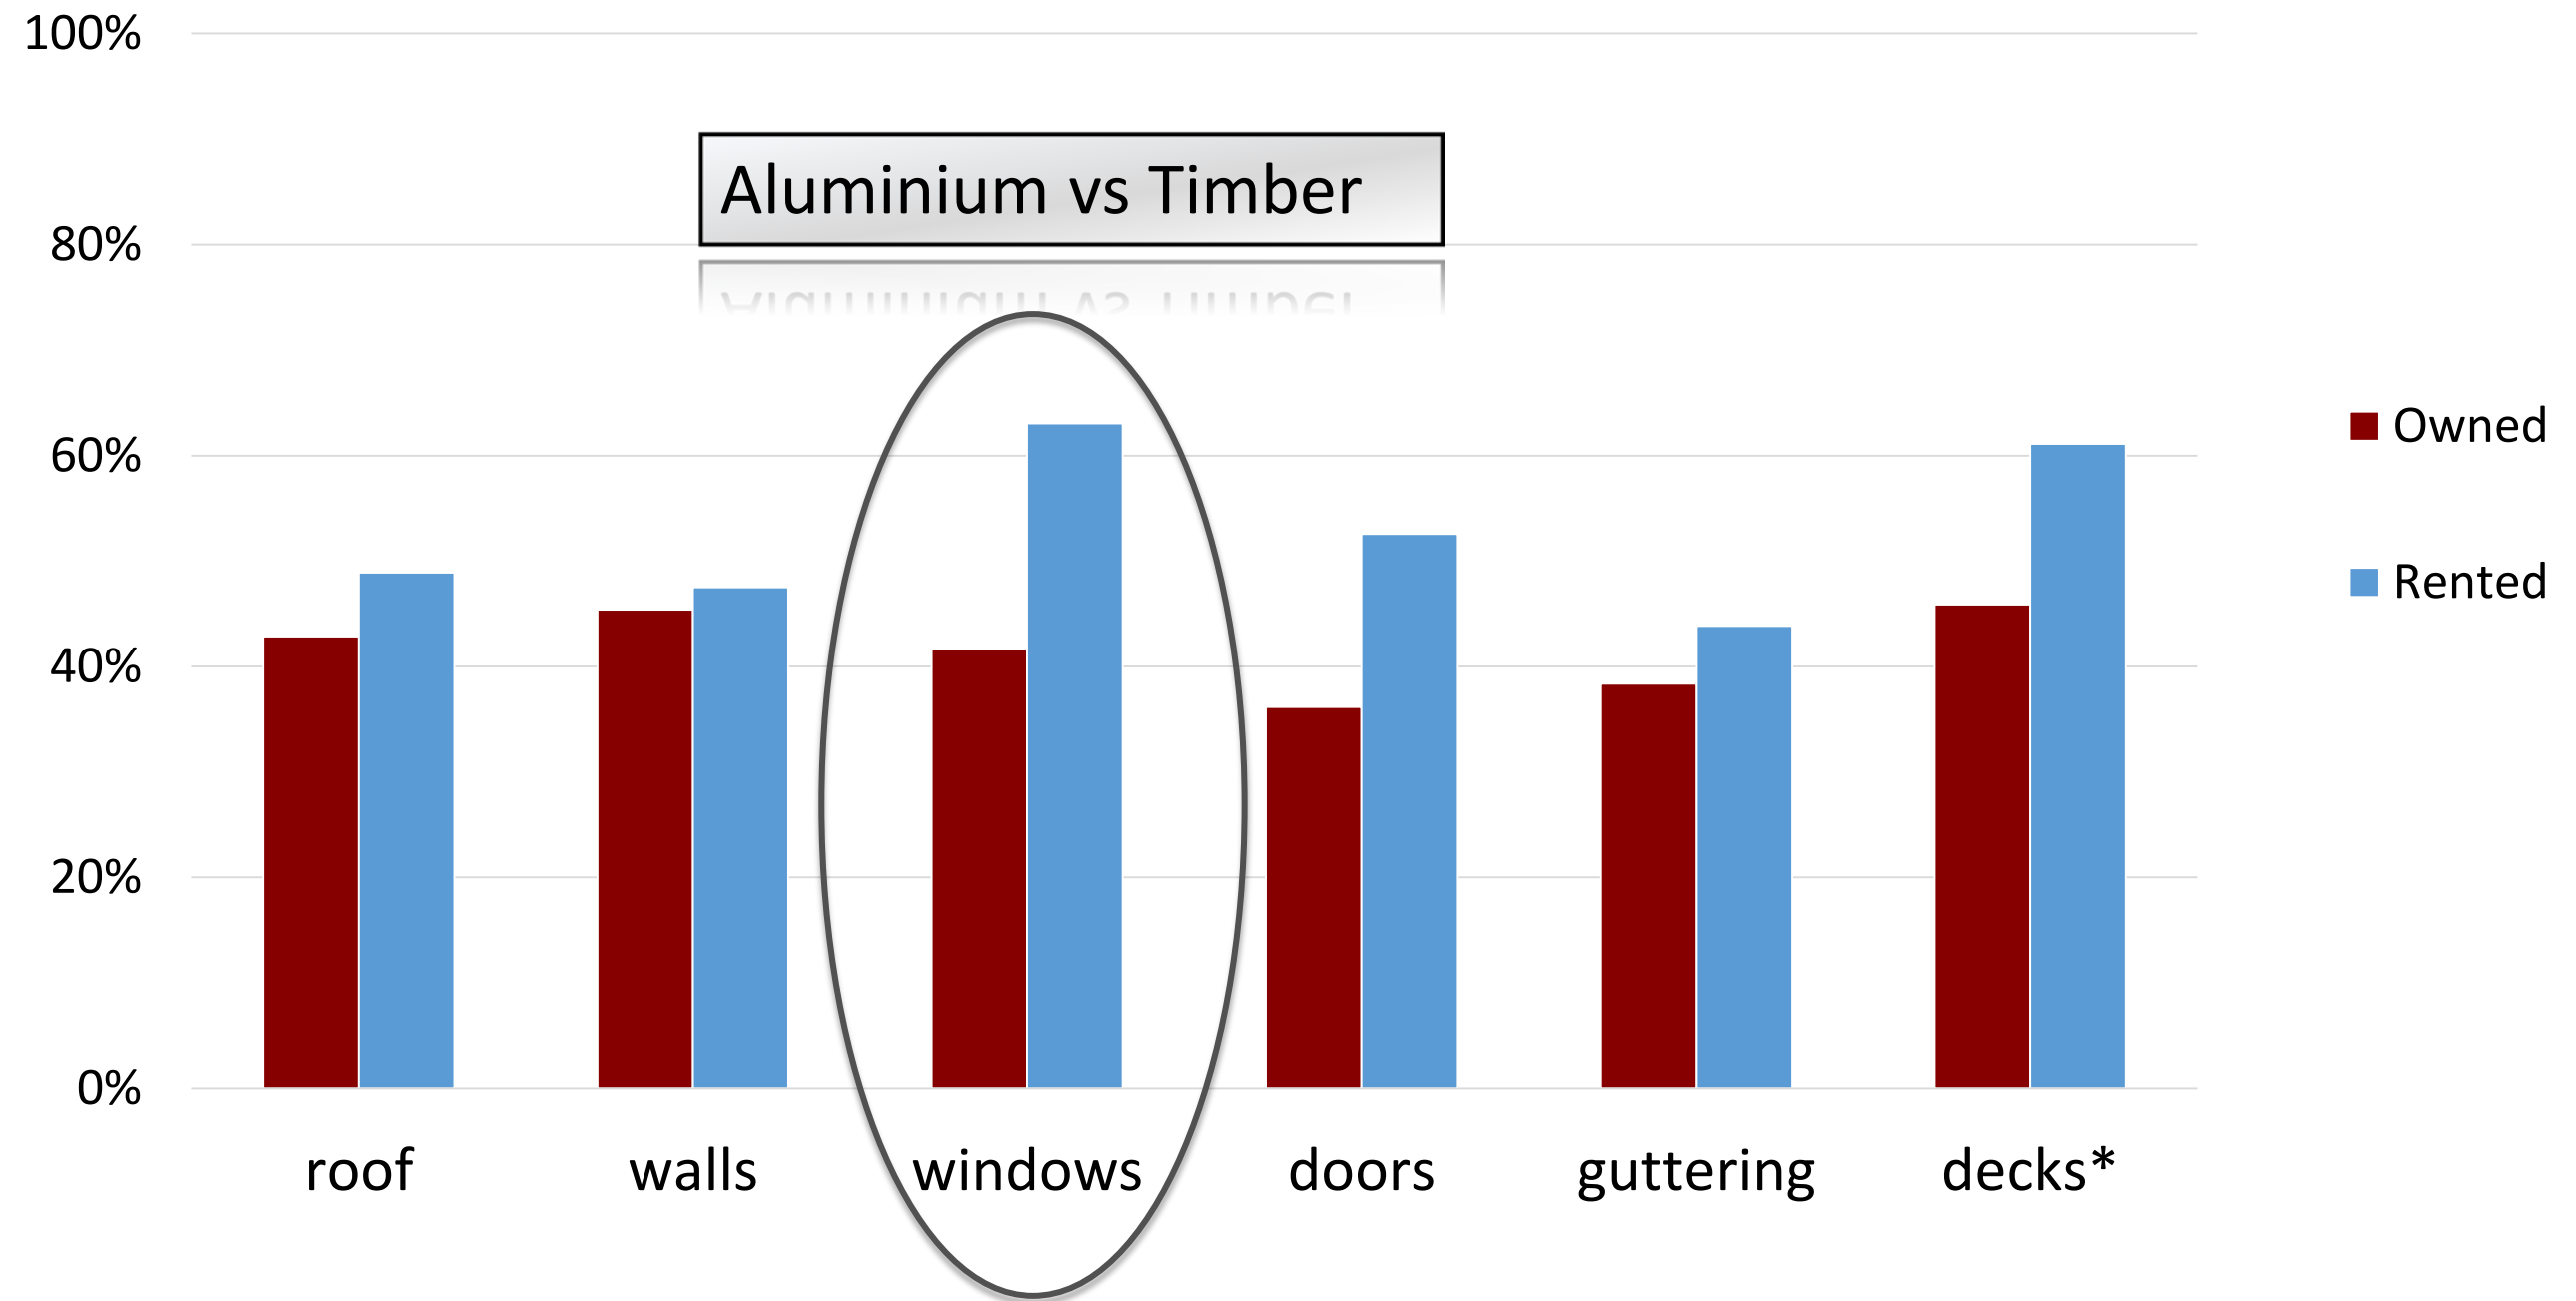
House exterior condition ratings: Proportion in moderate or worse condition

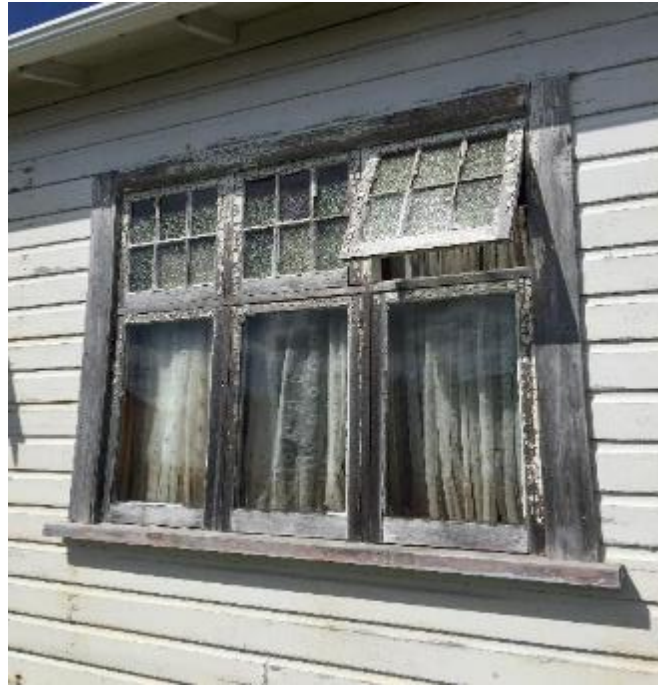
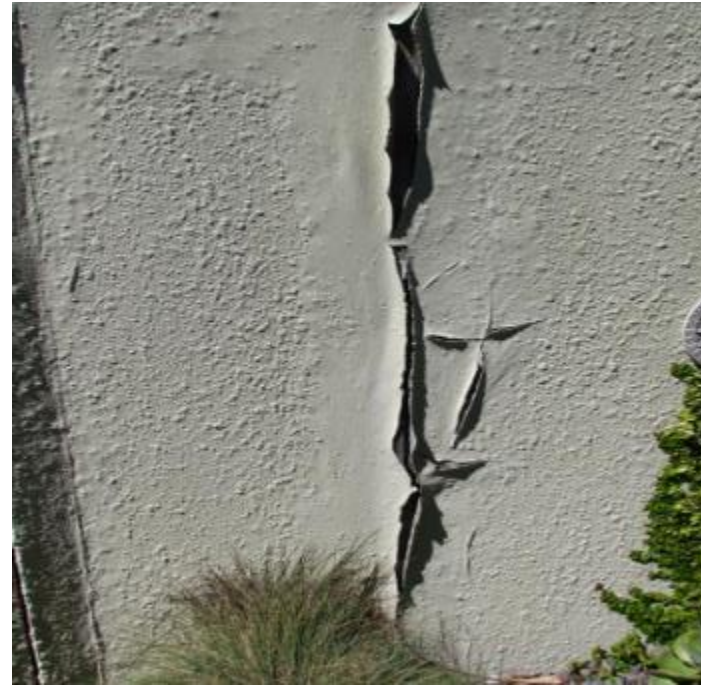
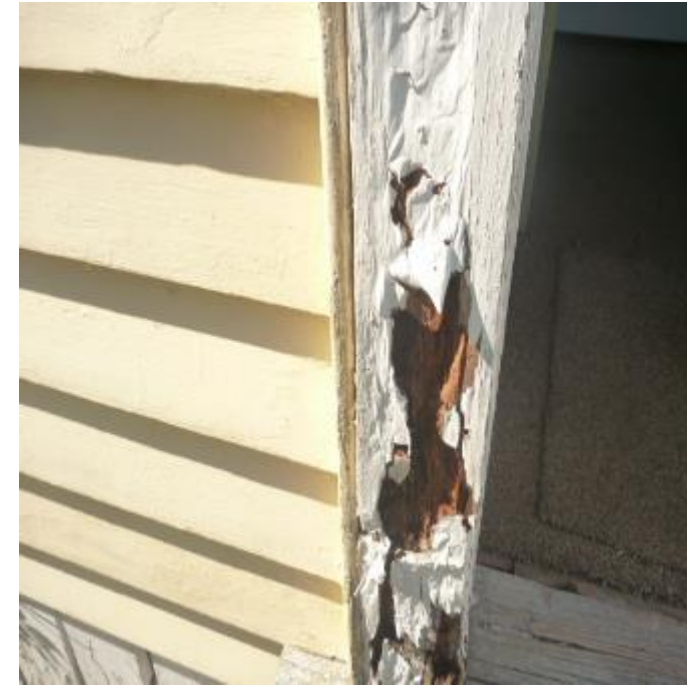
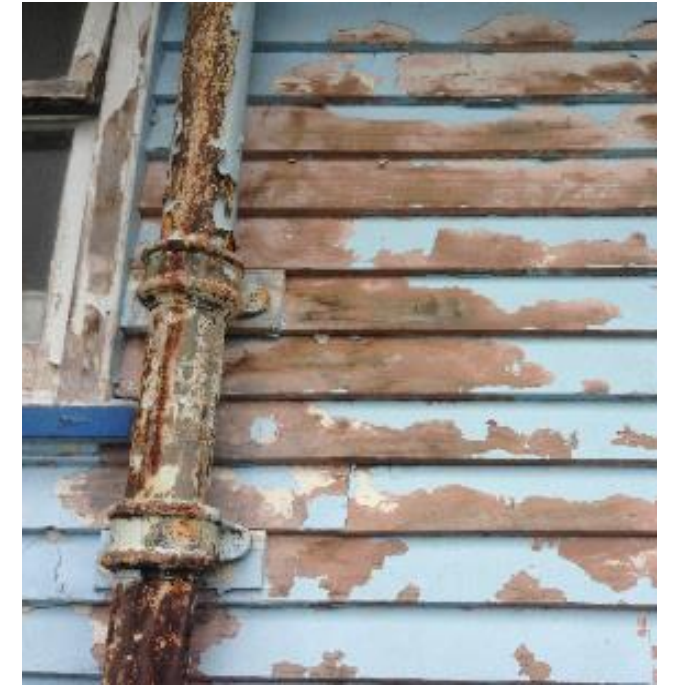
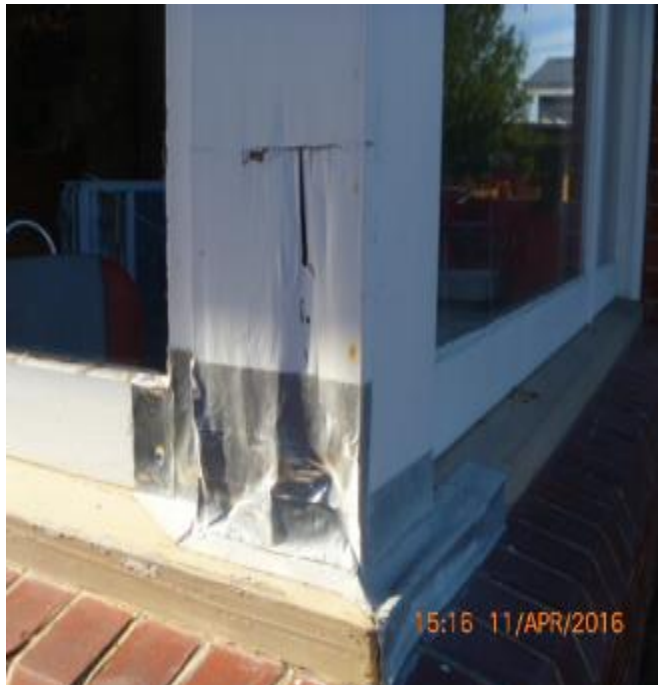
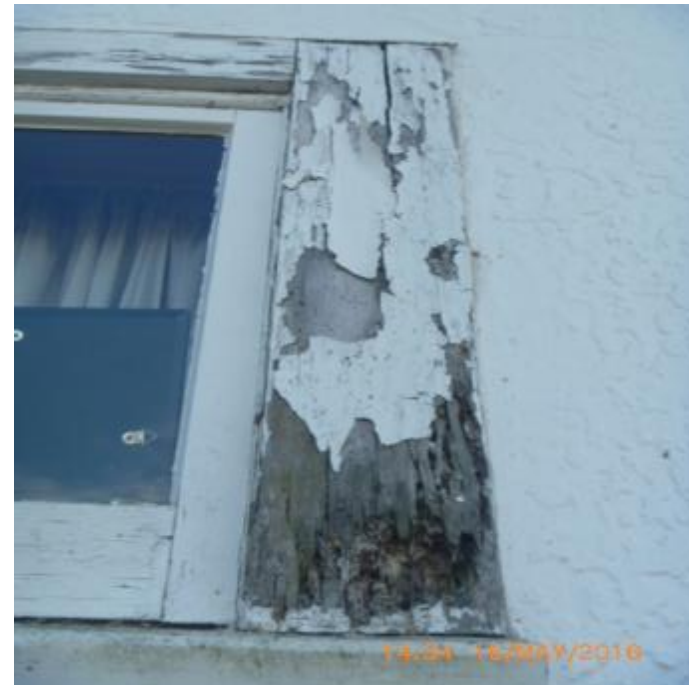
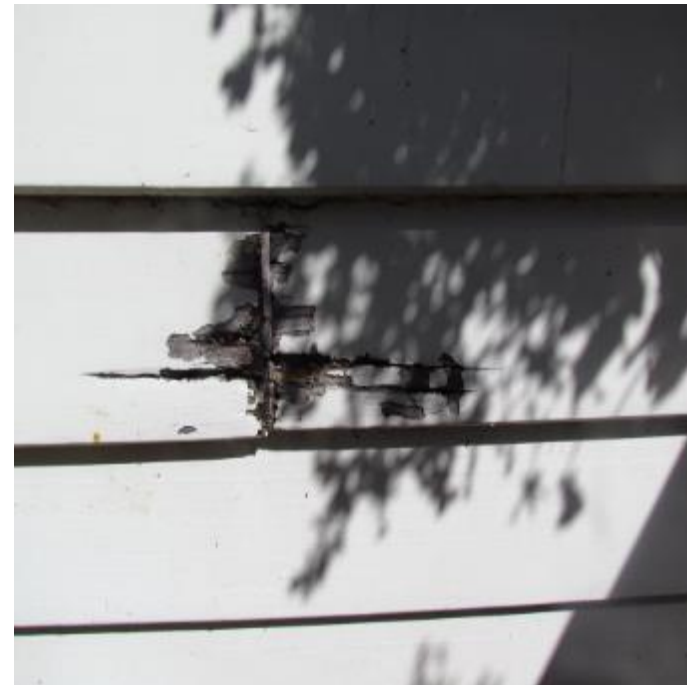
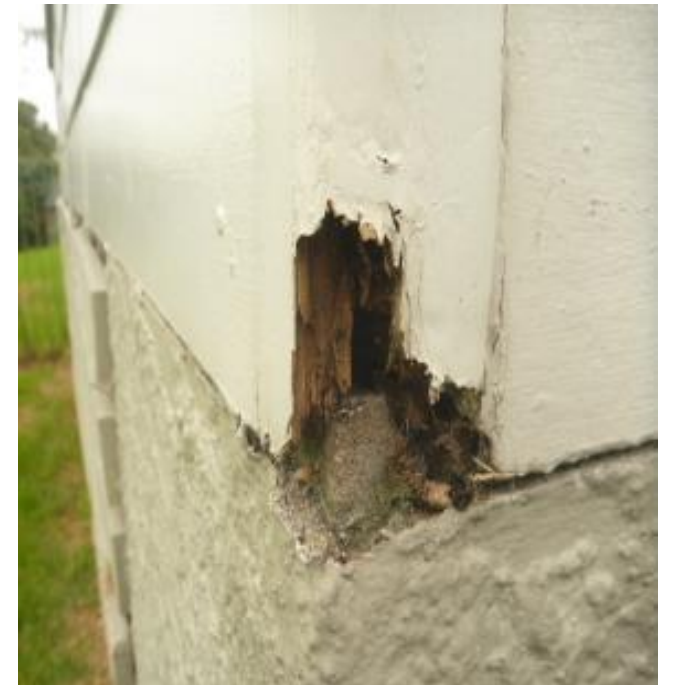
Exterior defects - examples

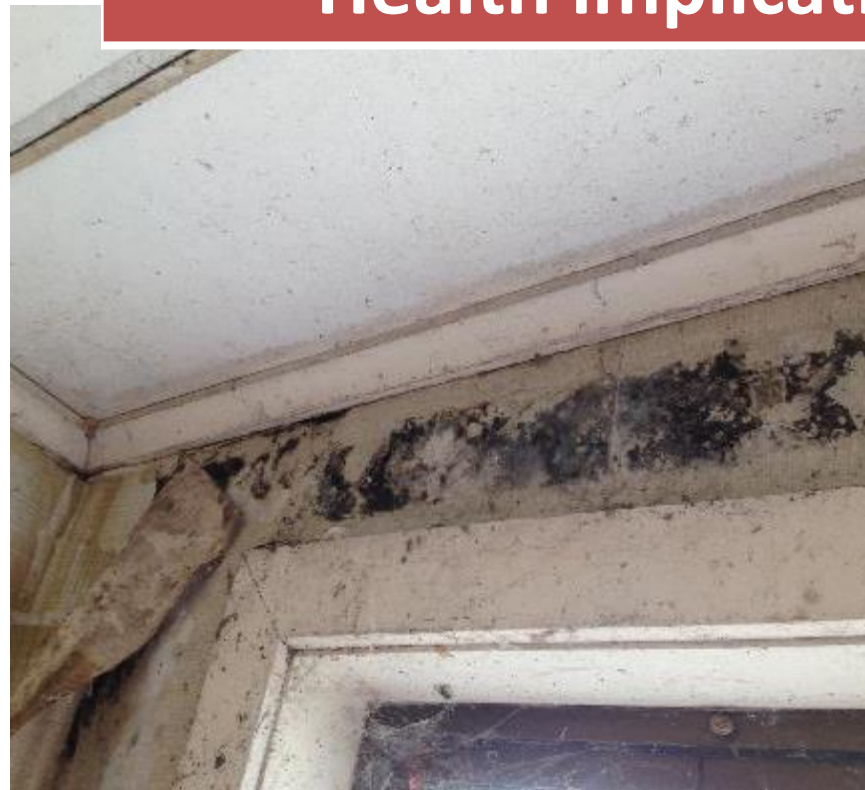
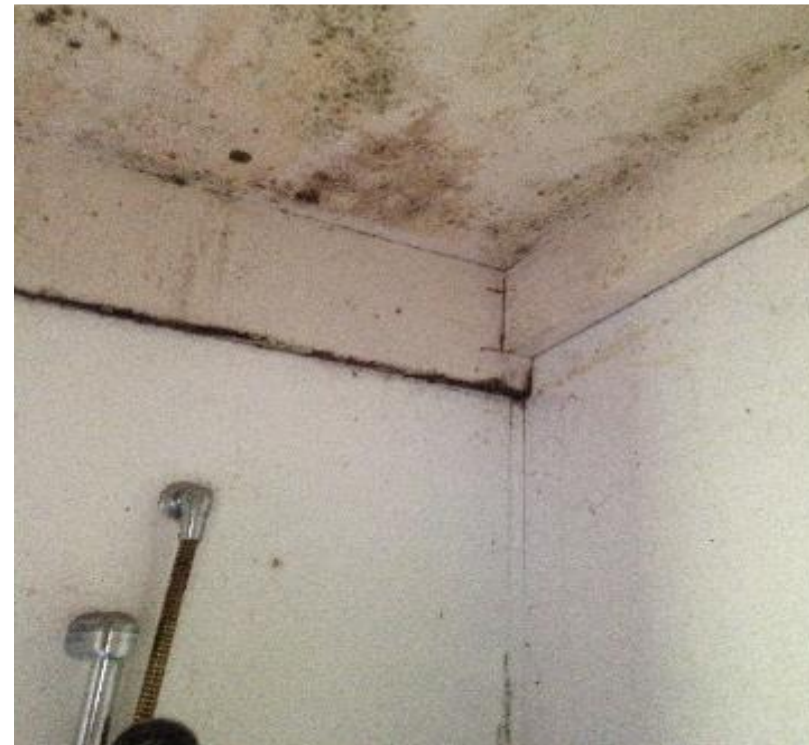
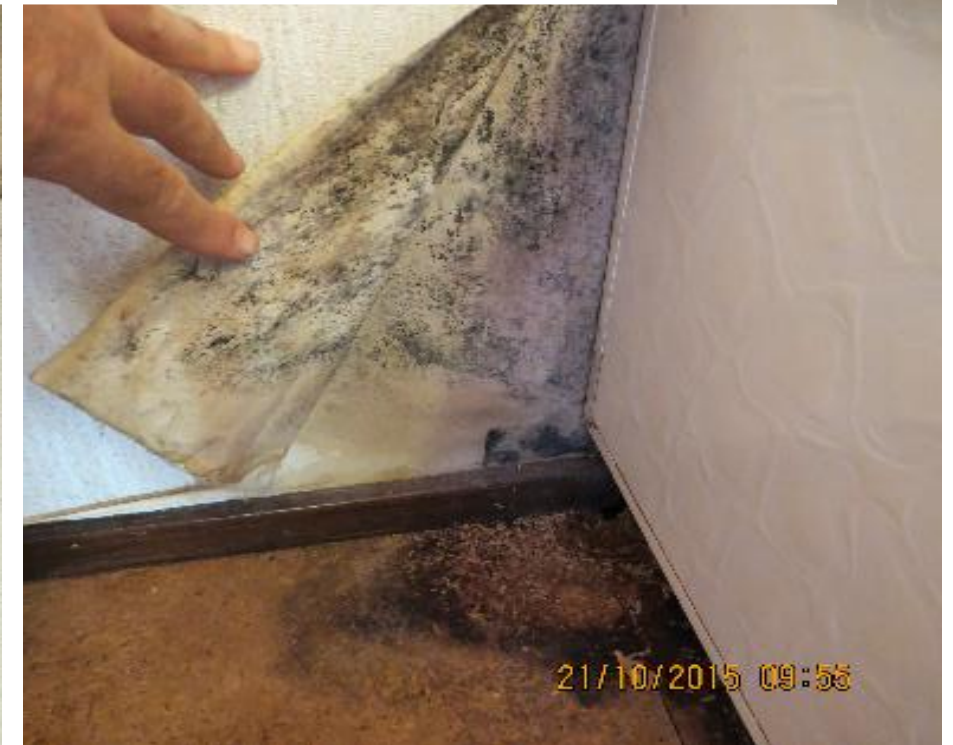
Health implications of living in a damp and mouldy home

- Most houses did not smell damp or feel damp
- Rentals twice as likely to smell damp, three times as likely to feel damp

- Visible mould in nearly half of all houses

- Not contained to high moisture areas of the home

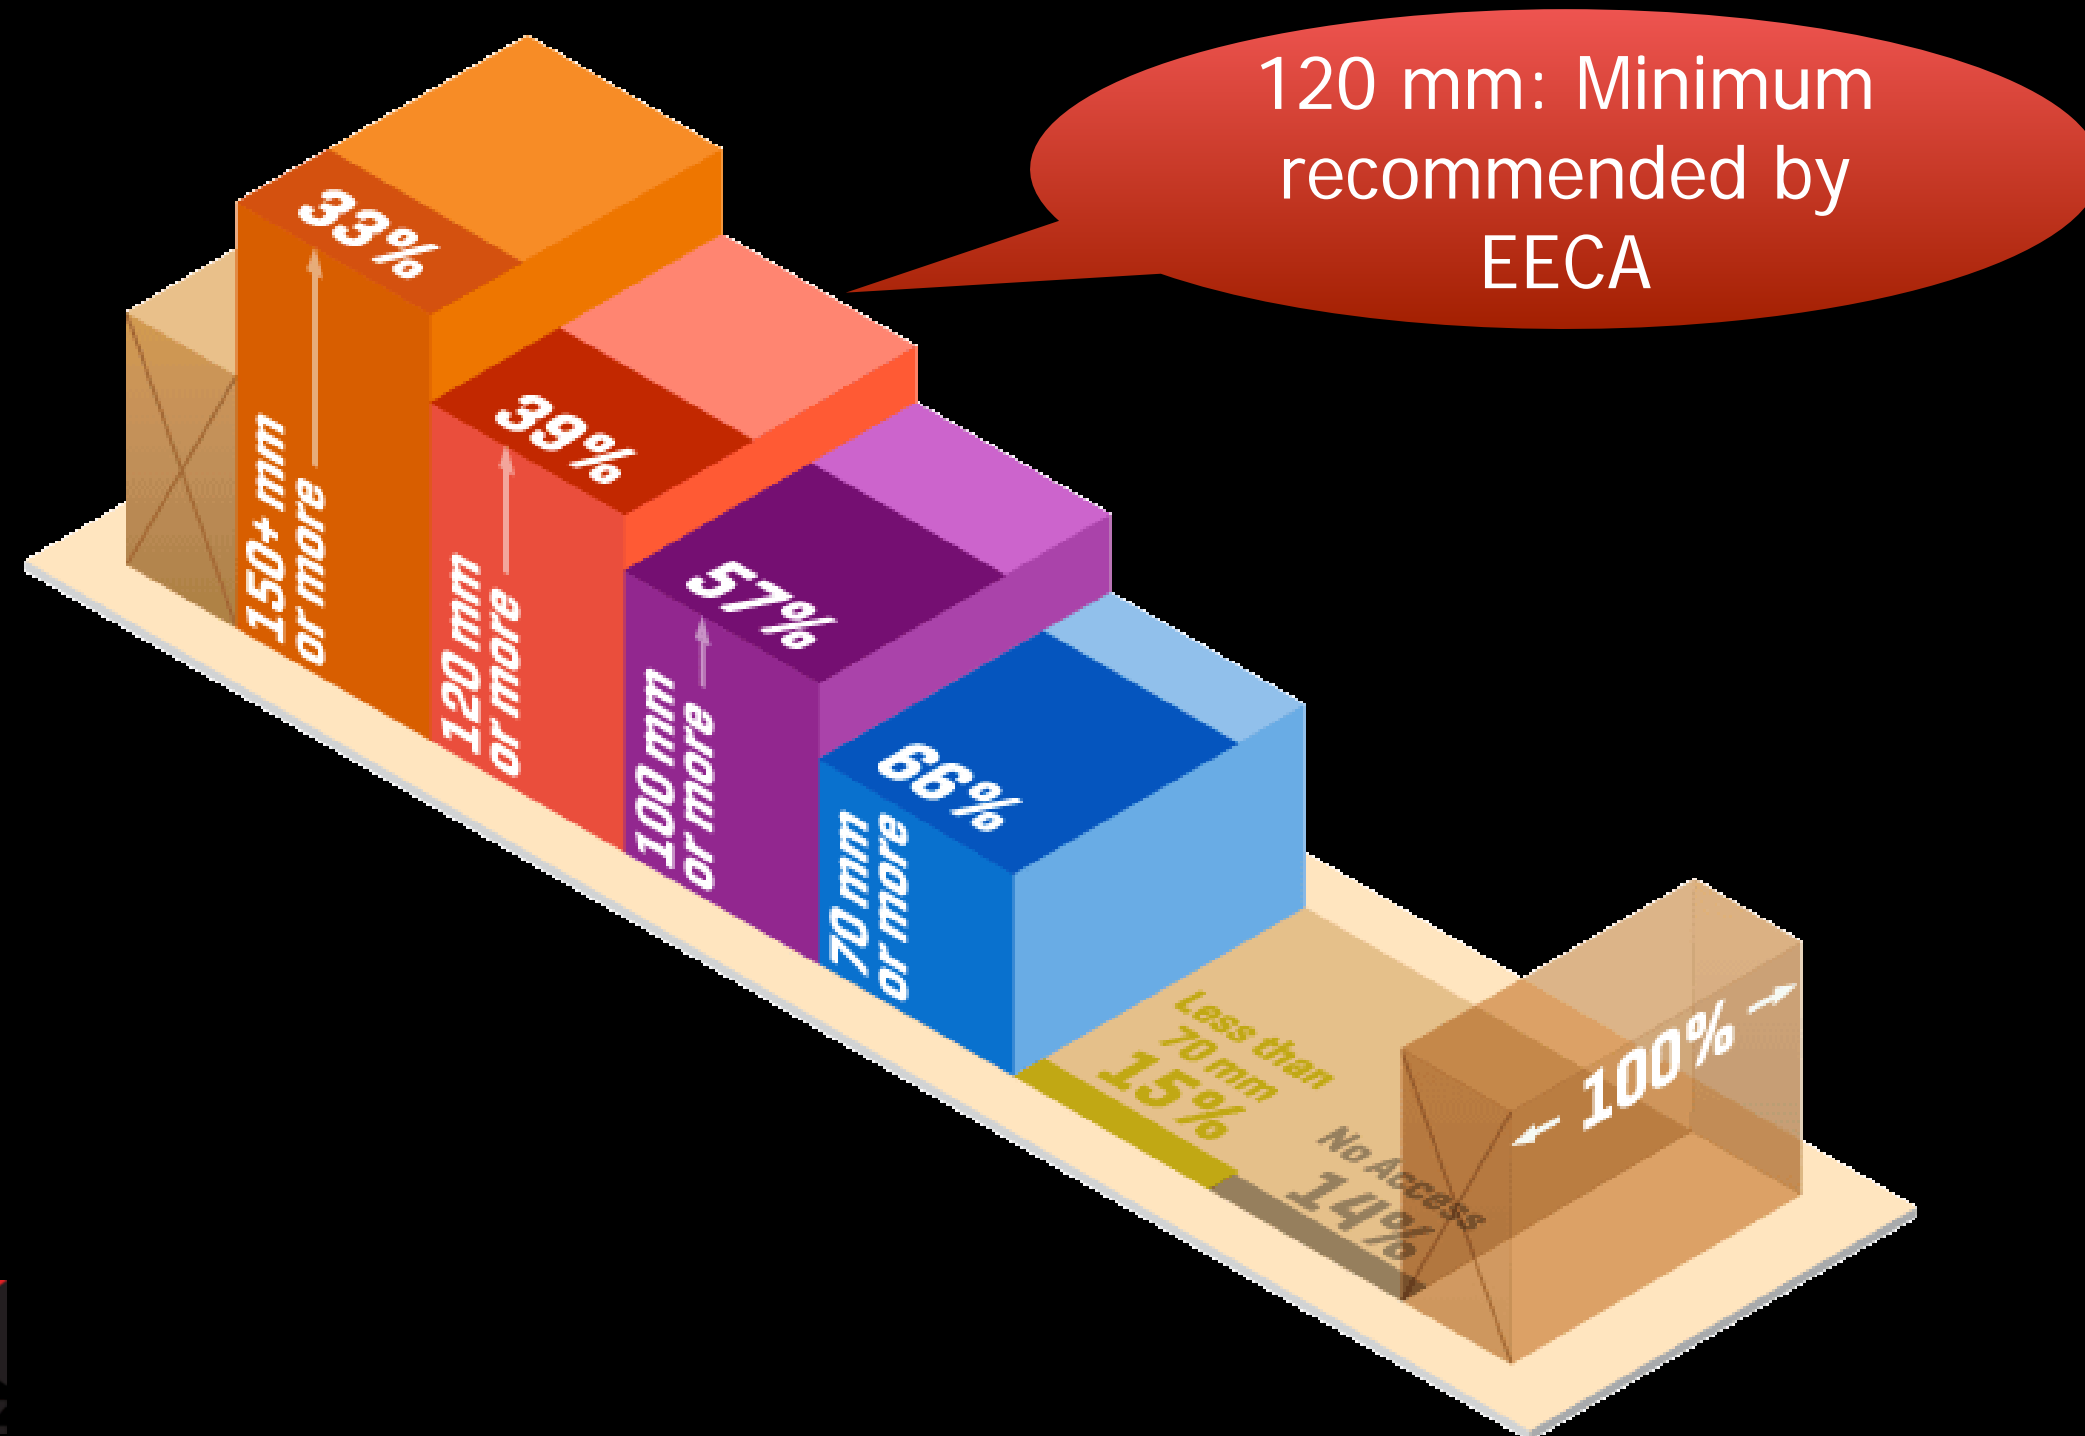
Insulation in the roof space

- 47% with less than 120 mm (or lack coverage)

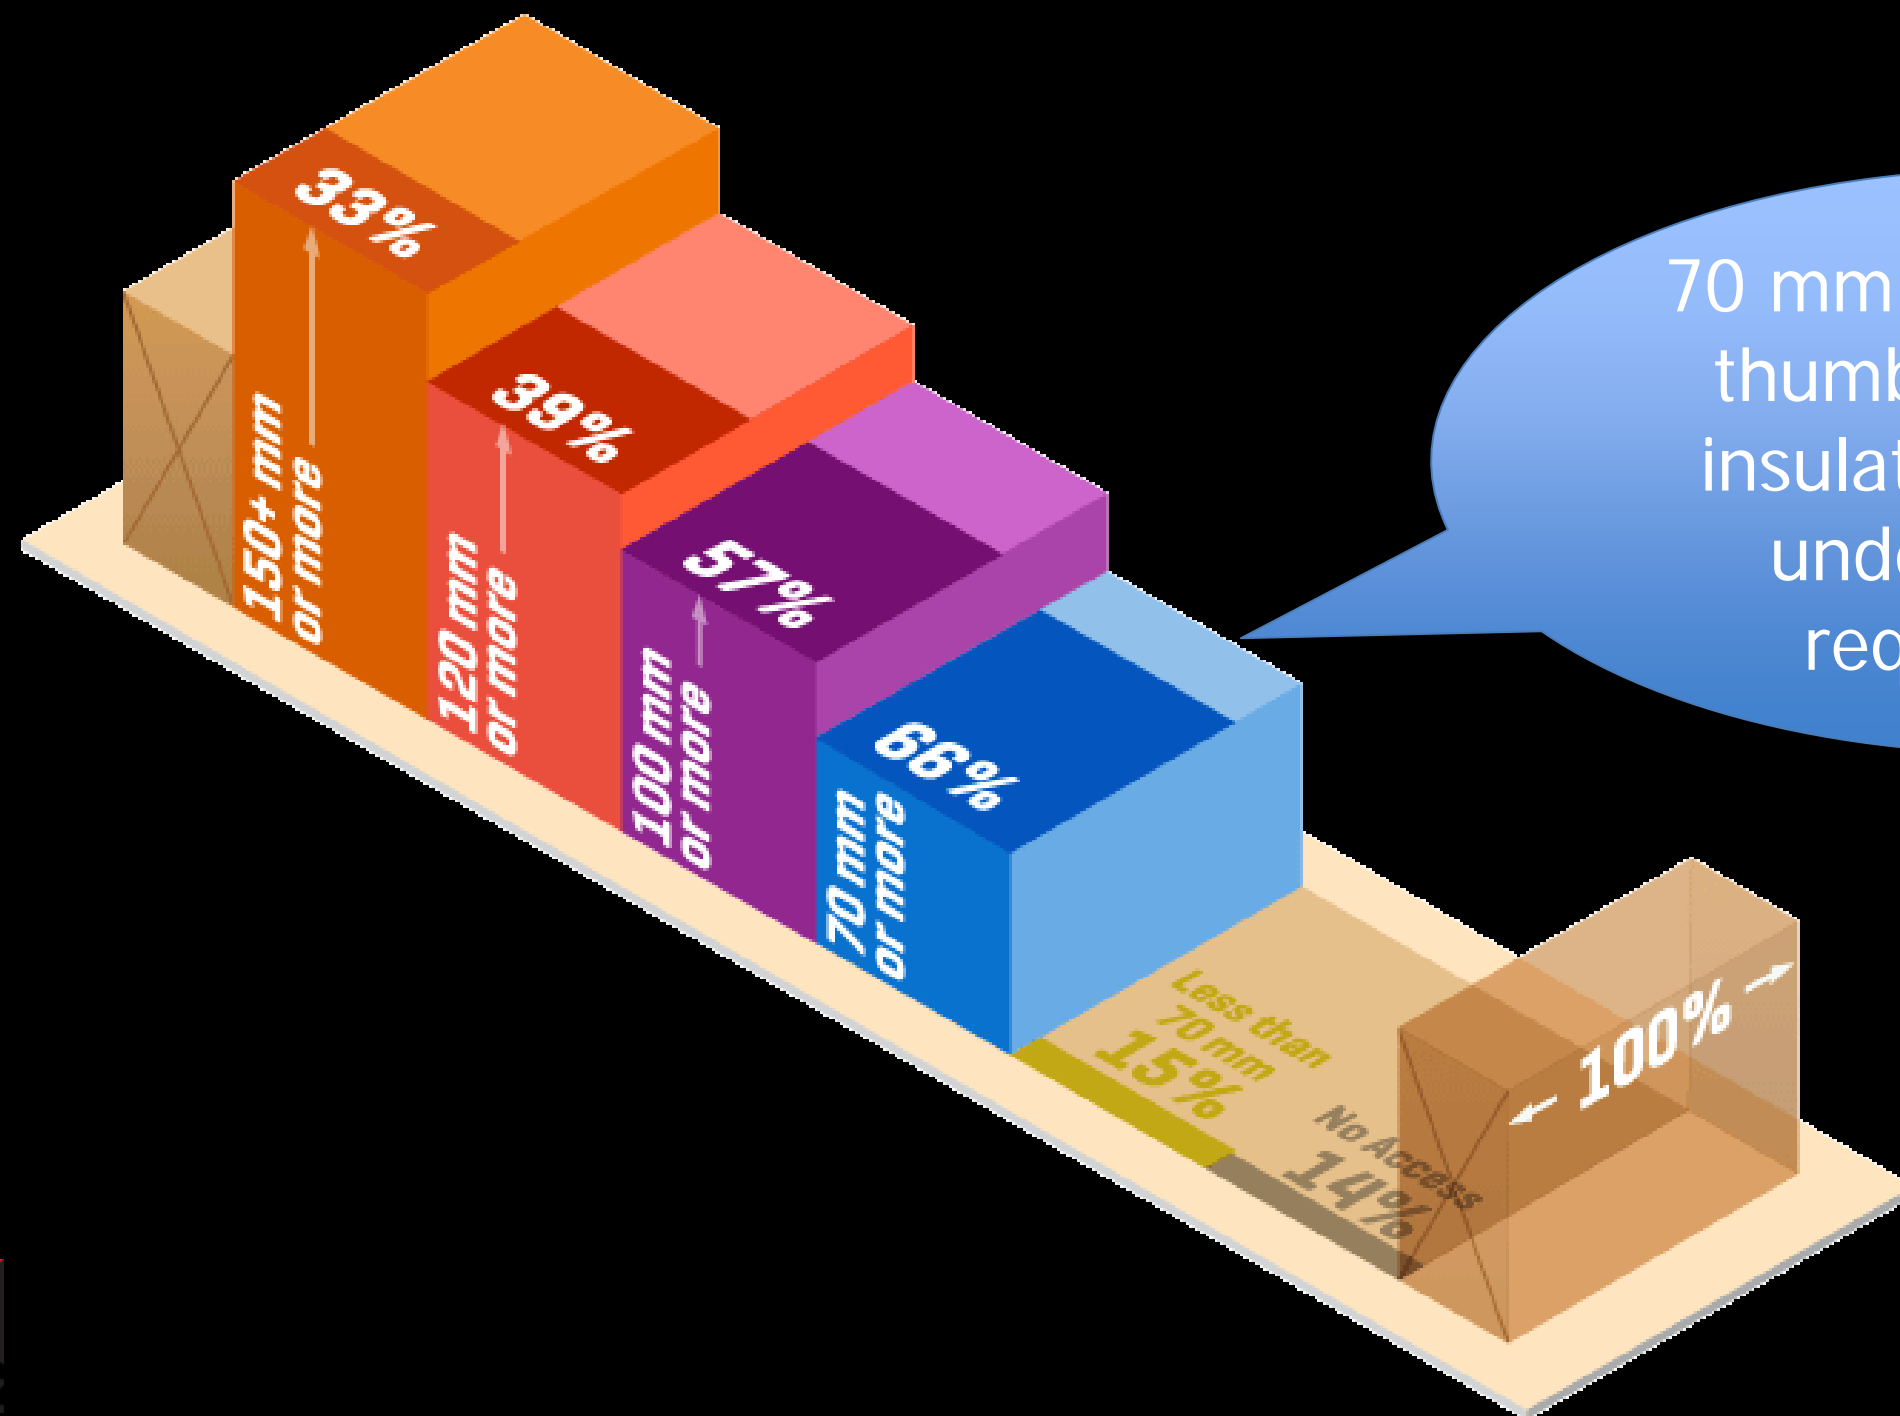
Insulation in the roof space

- 23% of Rentals with less than 70 mm (or lack coverage)

70 mm: Proxy 'rule of thumb' for existing insulation in rentals under new RTA requirements
