Warm, dry, healthy housing?

Insights from the 2015/16 BRANZ House Condition Survey

5 September 2017

BRANZ House Condition Survey 2015/16

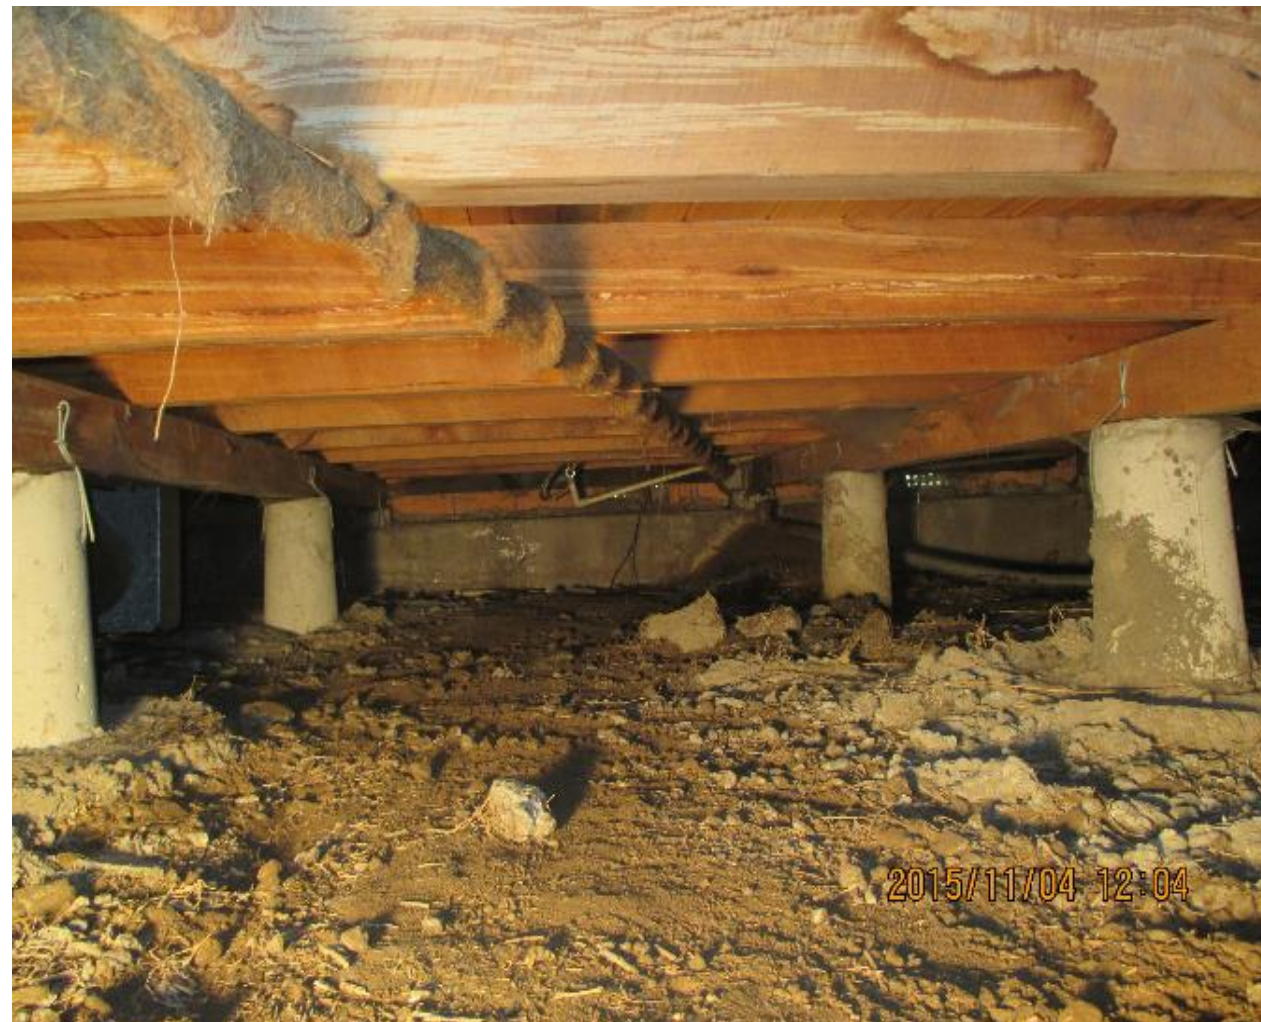
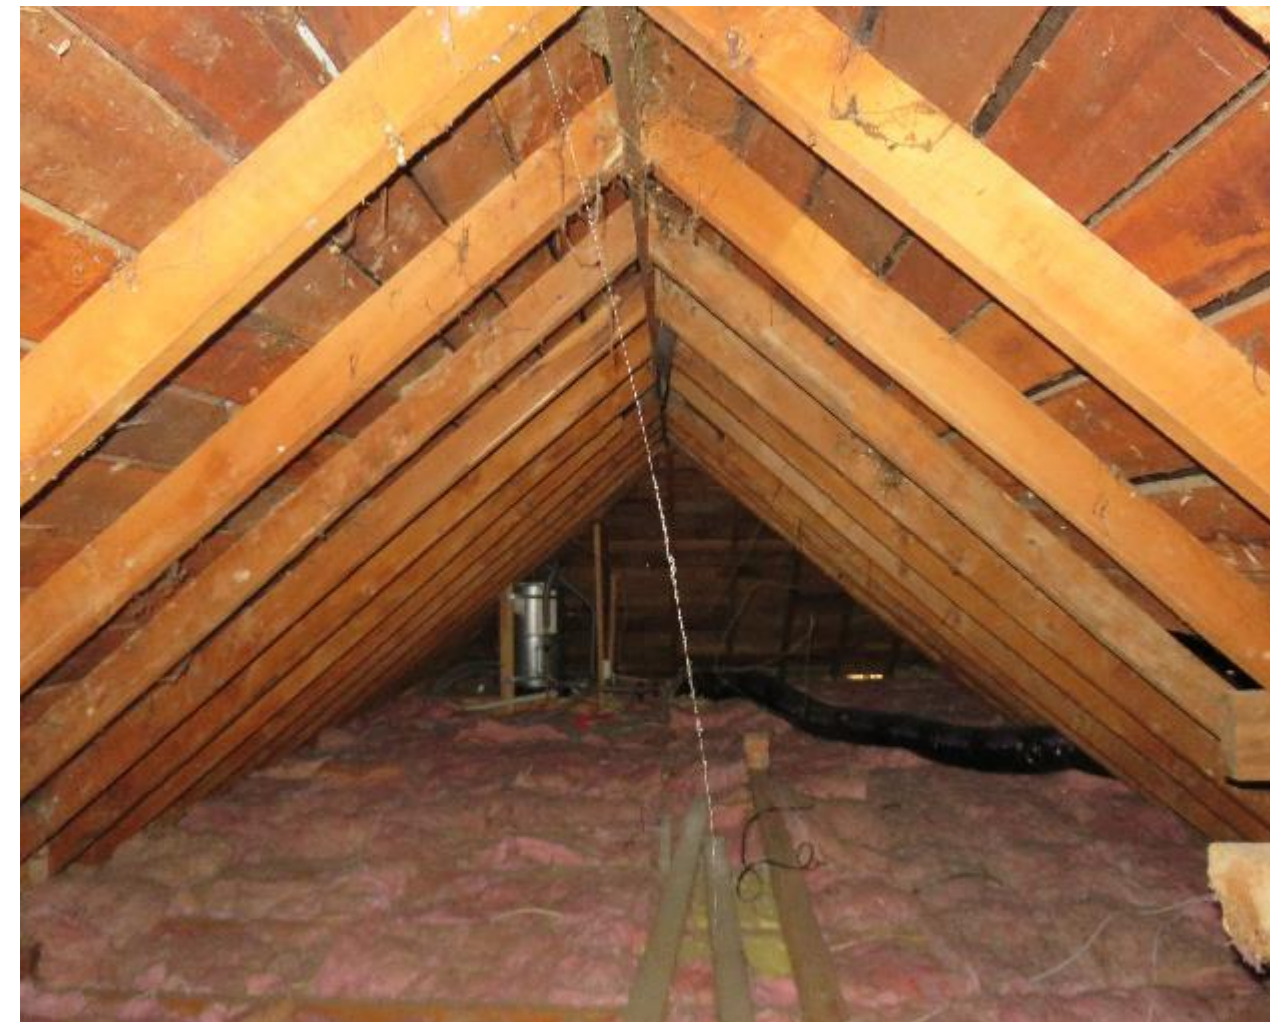
Subfloors

- Bulk insulation more common in owned, foil more common in rentals
- Similar retrofit opportunity in owned and rentals ~20%

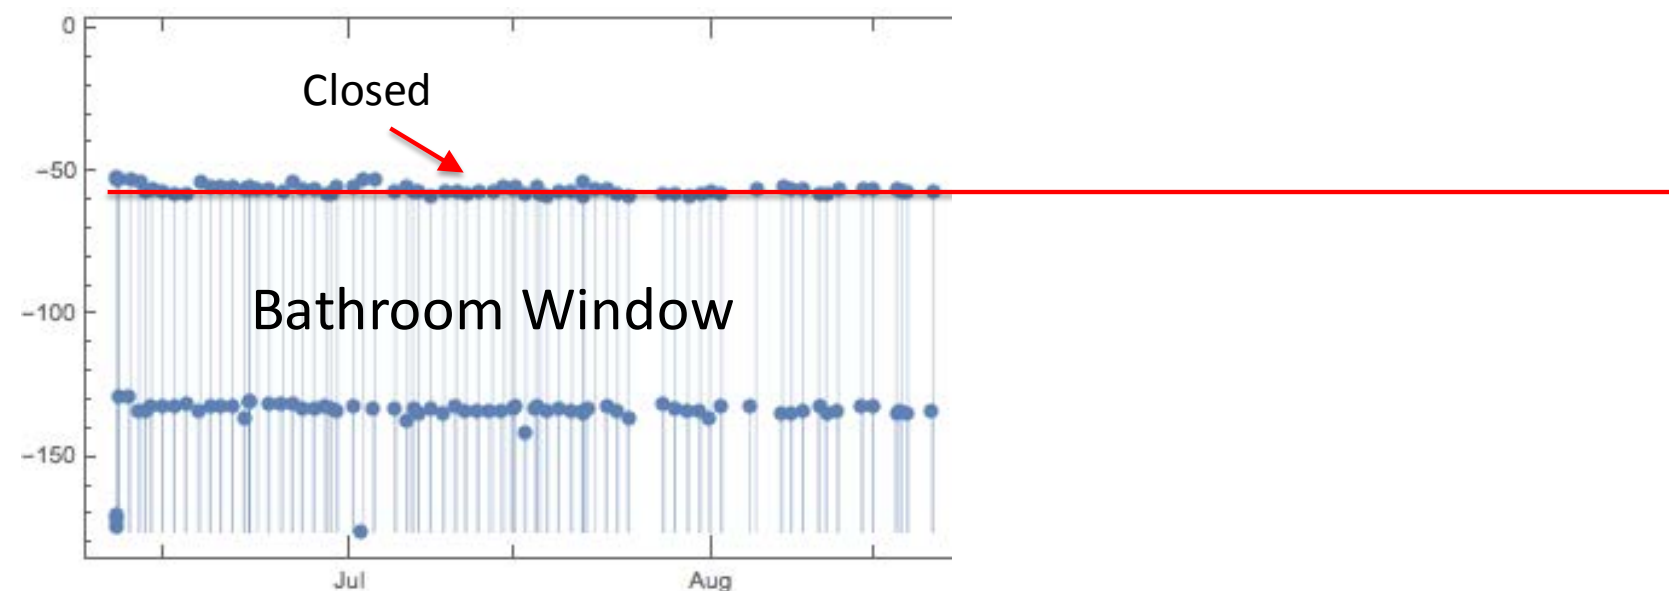
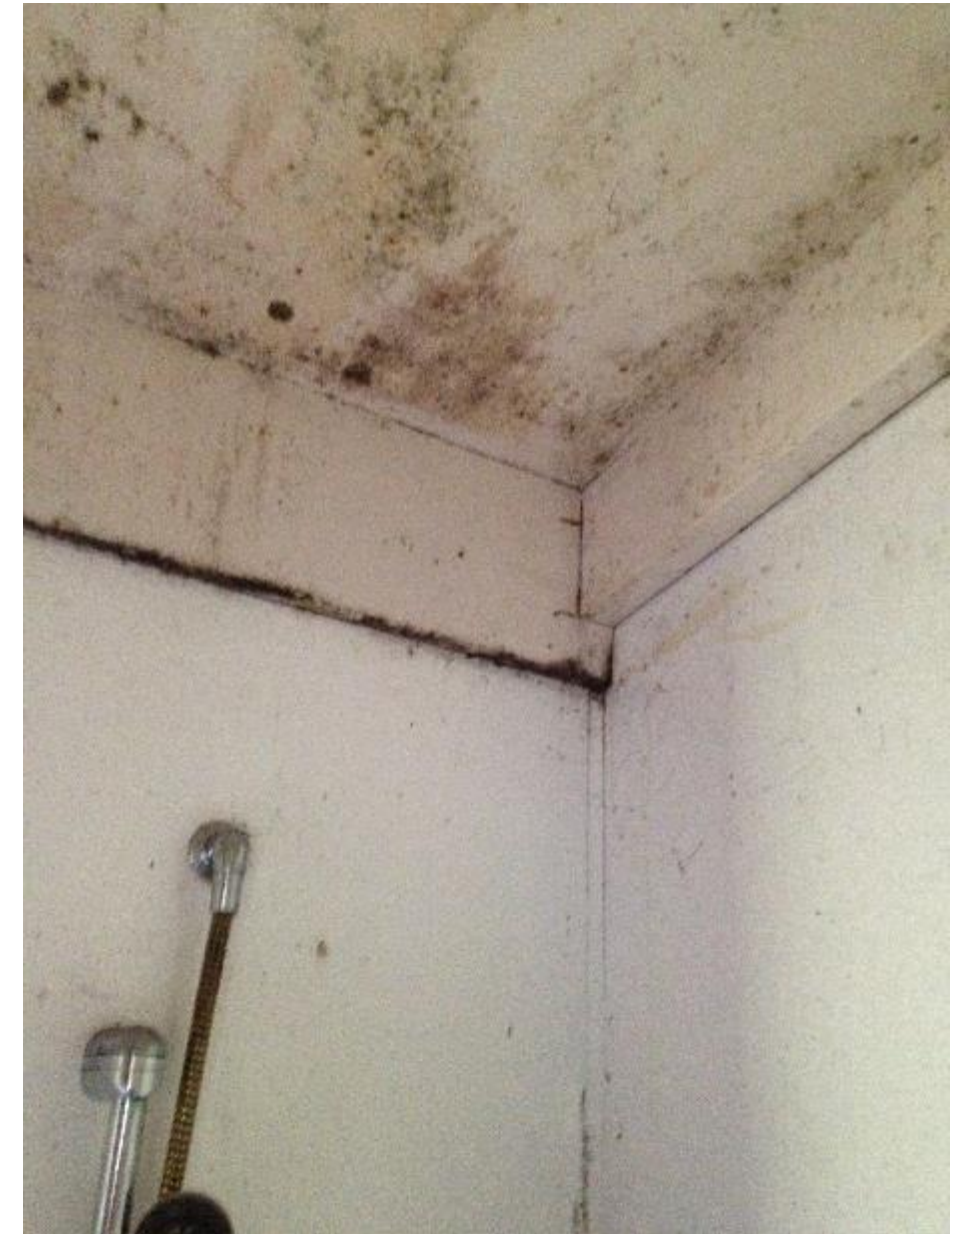
Ventilation in high moisture areas of the home

- Half of bathrooms and kitchens did not have mechanical extract ventilation venting to the outside
- Extractor size, duct material, length and installation important
- Heating important: over two-fifths of rentals without mechanical ventilation and heating in main bathroom
- Occupant behaviour factor

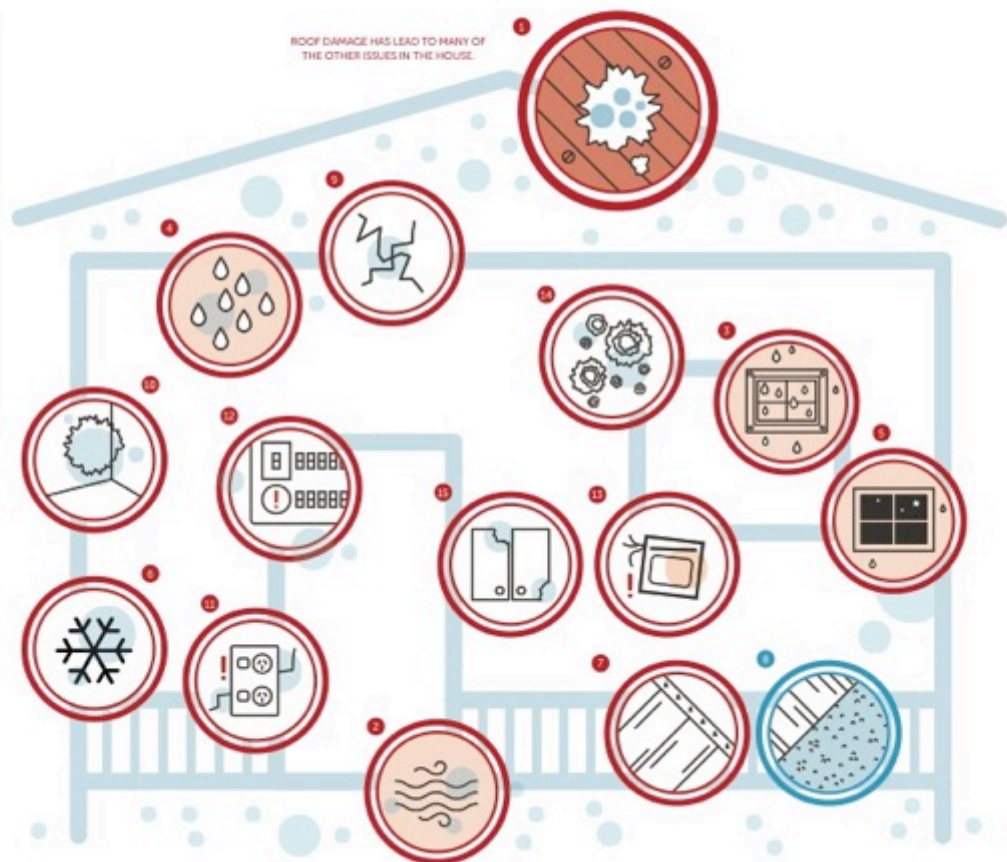
1 ROOF DAMAGE
HOUSE IS NOT WATERPROOF LEADING TO ONGOING LEAKS. LEAKS ARE NOTICEABLE ON CEILING AND WALLS.

2 NO INSULATION
DRAFT AND RISING DAMP THROUGH FLOORS EVEN WITH CARPET INSTALLED.

3 POOR VENTILATION
WINDOWS ARE PAINTED SHUT AND CANNOT BE OPENED.

4 NO EXTRACTOR FAN
IN THE BATHROOM SO MOISTURE CANNOT ESCAPE.

9 CEILING CRACKS
CONTINUOUS WATER DAMAGE, DISCOLOURED PAINT.

10 WATER STAINS
ON THE WALLS FROM EXCESSIVE LEAKAGE.

ROOF DAMAGE HAS LEAD TO MANY OF THE OTHER ISSUES IN THE HOUSE.

11 WATER DAMAGE TO WIRING
CONTRIBUTES TO ELECTRICAL PROBLEMS. POWER SOCKETS CONTINUE TO BLOW.

12 FUSE BOX IS HARD WIRING
THE LANDLORD HAS HARD WIRING THE FUSE BOX SO THAT IT DOESN'T KEEP SHORT CIRCUITING BECAUSE OF THE WATER DAMAGE.

13 BROKEN OVEN, EXPOSED WIRES
DOOR HANGS OFF, NOT FITTED PROPERLY. WIRES ARE EXPOSED.

14 MOULD & MILDEW
IN THE LOUNGE, BATHROOM & KITCHEN.

15 ROTTING KITCHEN CUPBOARDS

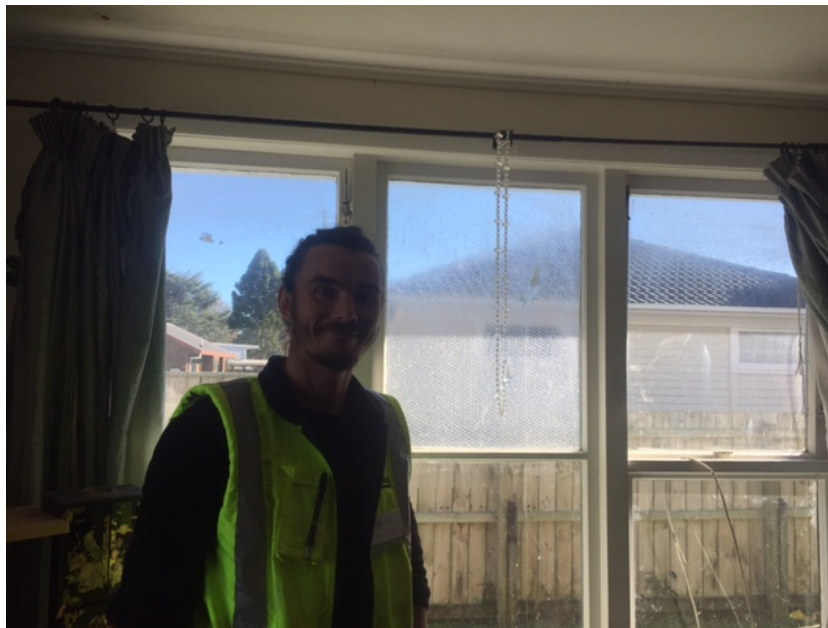
Minor Repair Service				
REPORT				
Inspections and Recommended Actions				
Total Records: 12				
CATEGORY	IMPORTANCE	ACTION	SPECIFIC NOTES	OPTIONS TO UNDERTAKE THIS WORK
Exterior (2 records)	High Priority	No home, gaps in the roof. There are a source of leaks into the ceiling a significant electrical hazard.	Widge that need pointing close to wood summer vent. Two missing tiles can see roof paper from roof gaps.	Landlord to undertake/arrange
	Insufficient	See Commentary from Assessment (Specific notes)	Front door top hinge has dropped and door catching on floor	Habitat for Humanity can undertake for the cost of materials only
Building Sub-Floor (2 records)	High Priority	Install a ground sheet moisture barrier. The exposed soil under the house has been identified as a source of moisture contributing to rising damp coming up through your flooring. This will also help to protect the wooden structure of your house.	No moisture barrier would recommend installation to improve warmth of home and reduce moisture and condensation.	If underfloor insulation is being installed, then we recommend this be quoted at the same time (generally cheaper when coupled with insulation)

High Priority	Install under floor insulation to adequate standard. This is required by law to comply with the K14 of 2016 the flooring has been identified as a source of heat loss in the house	No insulation	You may be eligible for a 50% subsidy. We can refer you to a supplier who can quote and is authorized for the subsidy
Kitchen (1 record)	Insufficient	Recommend installing a rangehood extractor fan above the stove, that is vented to the outside. This will help reduce excess moisture damage in the kitchen due to cooking activities.	No mechanical ventilation	Landlord to undertake/arrange
Bathroom (3 records)	Insufficient	Install mechanical ventilation in the bathroom, vented to the outside of the house. This will reduce moisture damage to the bathroom	No mechanical ventilation	Landlord to undertake/arrange
	Insufficient	Repair damage to walls, ceiling or floor. These create drafts and make it difficult to heat the house	Wear around bath and widening gap needs fixing	Homeowner can undertake at the cost of materials only

Low Priority	Install security latches on windows to allow for them to be able to remain open at times and provide ventilation for the room. This will reduce moisture damage to the house.	-	Habitat for Humanity can undertake for the cost of materials only
Laundry (1 record)	Low Priority	Install security latches on windows to allow for them to be able to remain open at times and provide ventilation for the room. This will reduce moisture damage to the house.	-	Habitat for Humanity can undertake for the cost of materials only
Living Area (2 records)	High Priority	See commentary (specific notes)	No seal around log burner flue/roving to ceiling. Draughts coming in and water damage on ceiling around this area. I suspect related to the missing baffle and lack of pointing to ridge	Habitat for Humanity can undertake for the cost of materials only
	Low Priority	Install security latches on windows to allow for them to be able to remain open at times and provide ventilation for the room. This will reduce moisture damage to the house.	-	Habitat for Humanity can undertake for the cost of materials only

General Household Assessment (1 record)	Insufficient	Install ceiling insulation to adequate standard. This is required by law to comply with the K14 of 2016 - the ceiling has been identified as the primary source of heat loss in the house	Roof insulation, not up to level of rafters and paddy needs upgrading to standard	You may be eligible for a 50% subsidy. We can refer you to a supplier who can quote and is authorized for the subsidy
