# Lake Wainamu and Lake Kawaupaku: Lake Condition in 2007

March 2008 TP356

**NIWA Client Report: HAM2008-024**  
March 2008

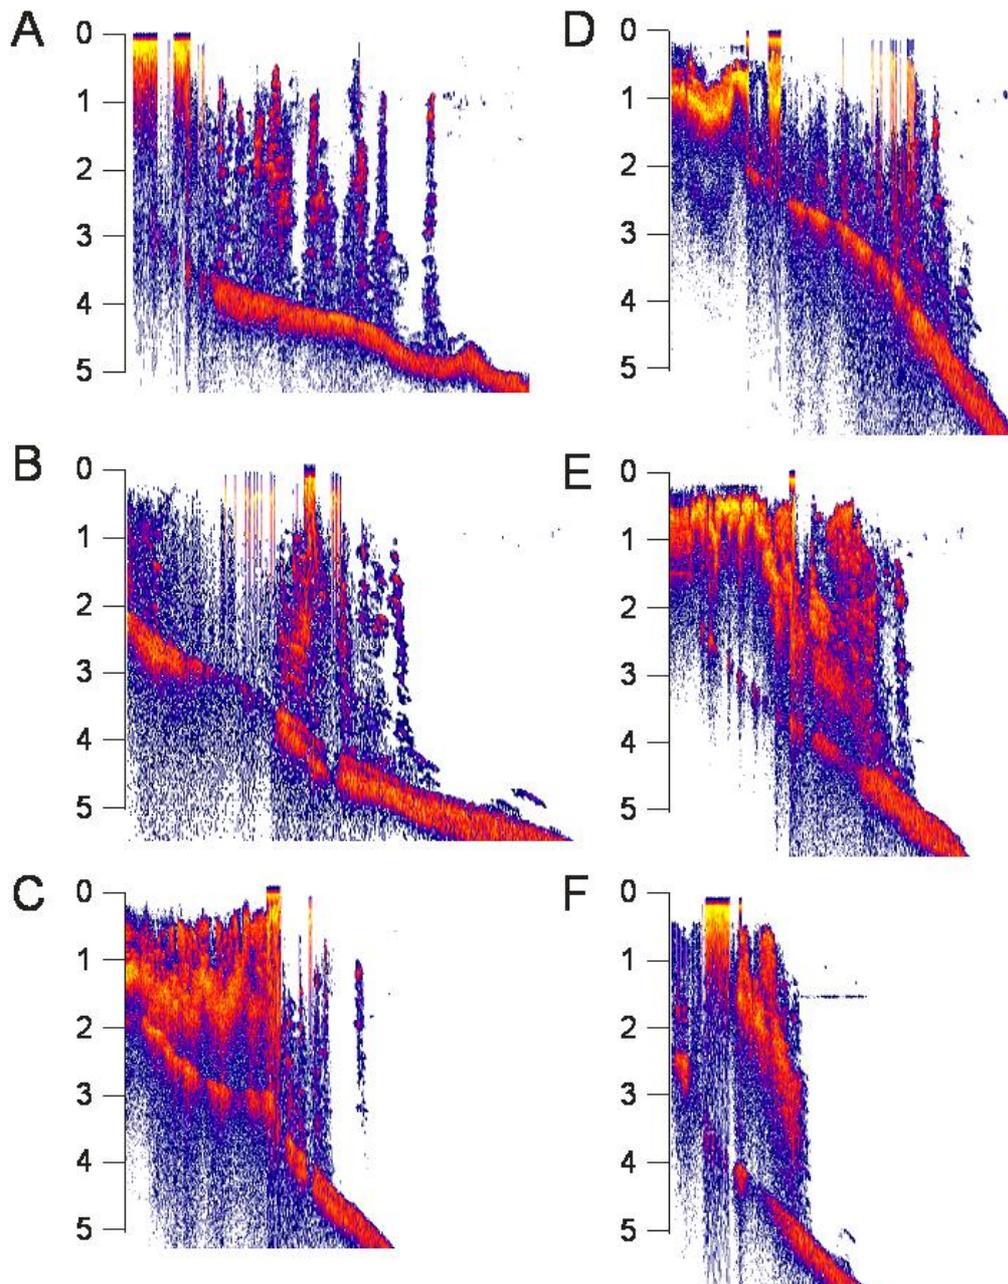
**Figure 1:**

Sonar traces show the depth distribution, height and development of the submerged vegetation, predominantly *Egeria* (Figure 1). Surface reaching beds, shown as tall blocks within the depth range, were present at all sites. All profiles showed an increase in *Egeria* by cover and/or depth extent over identical traces made in 2005 as reported in de Winton et al. (2005). Estimates based on current *Egeria* depth range, together with available lake bathymetry (Rowe et al. 2005), suggest that 18% (2.7 ha) of the lake area (15 ha) supports *Egeria* beds (Figure 2). At a typical biomass for *Egeria* beds of 800 to 1000 g dry weight  $m^{-2}$  we estimate a total lake biomass (standing crop) of 22 to 27 tonne dry weight.

Lake Wainamu sonar profiles from six LakeSPI survey sites showing depth distribution of the vegetation, predominantly egeria beds. Solid blocks are surface reaching beds and absorption of the sonar signal by dense growths also obscures the lake bed trace in places. Note horizontal distance is not to scale.

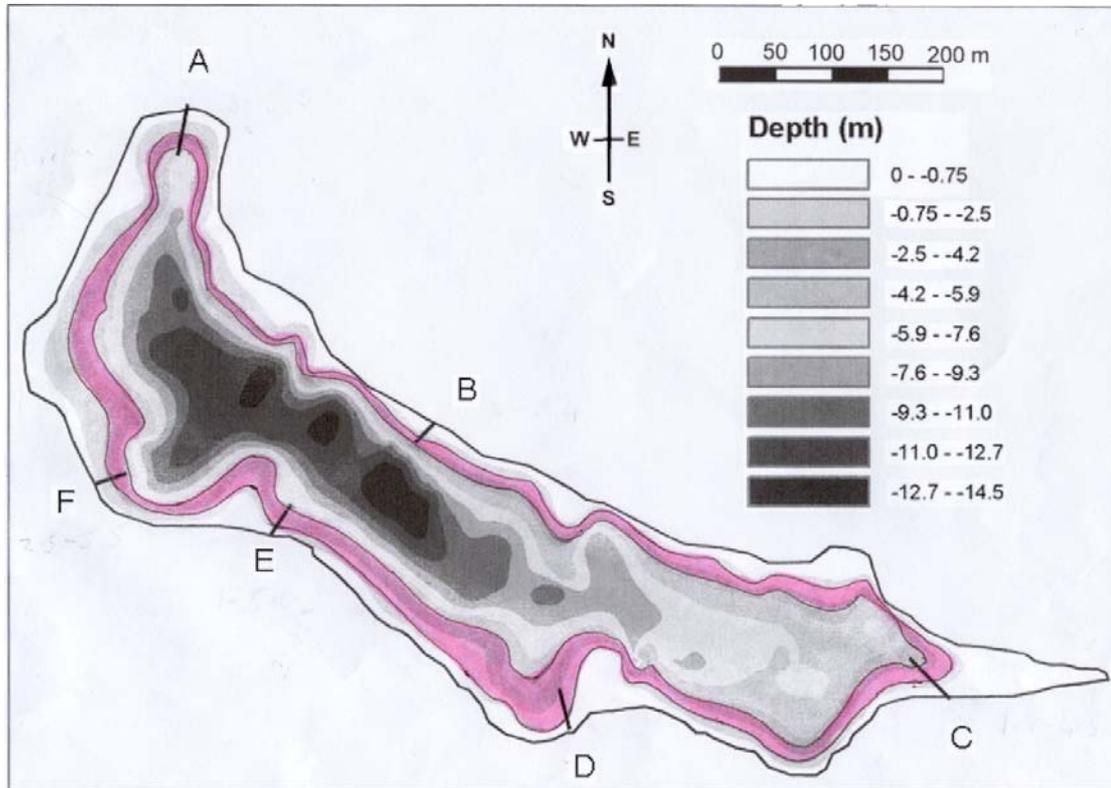
**Figure 2:**

Approximate distribution of egeria in Lake Wainamu, extrapolating from weed bed depth range at six sites and lake bathymetry.

Overall, four native charophyte species were recorded (Appendix 1). *Chara australis* formed patches at variable covers between 2.5 and 3.5 m at three sites and, together with other charophytes, also formed local growths adjacent to reedbeds at Sites C and D (Figure 2).

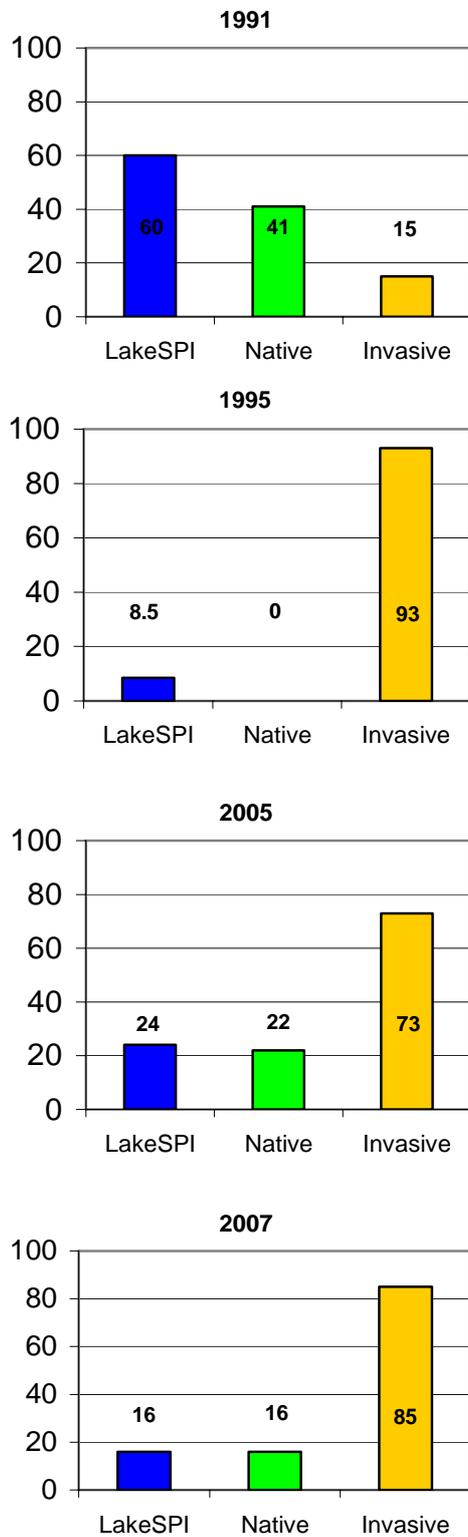
**Figure 3:**

By 1995, egeria occupied almost all available habitat to 4 m depth and had totally replaced the native vegetation. This major change resulted in a greatly reduced LakeSPI score of 8.5%, driven by a large increase in Invasive Condition (Figure 3).

A survey in October 2005 gave a LakeSPI score of 24% (de Winton et al. 2005) based on the restricted development of submerged vegetation and relatively high impact by invasive weeds (Figure 3), although a recent plant expansion was noted in concert with improved water quality. *Egeria* comprised a narrow band outside the reed beds to between 1.6 and 3.8 m depth. Beyond this, low cover ( $< 10\%$ ) clumps of *Egeria* were commonly encountered to a maximum of 4.8 m depth. Other weed species *U. gibba* and *Myriophyllum aquaticum* was also recorded. Charophyte beds ( $> 75\%$  cover) were recorded at four sites along the southern shoreline of the lake to a maximum depth of 4.7 m.

Scores for LakeSPI Index, Native Condition Index and Invasive Condition Index for Lake Wainamu based on historical data from 1991 and 1995 and surveys in 2005 and 2007.

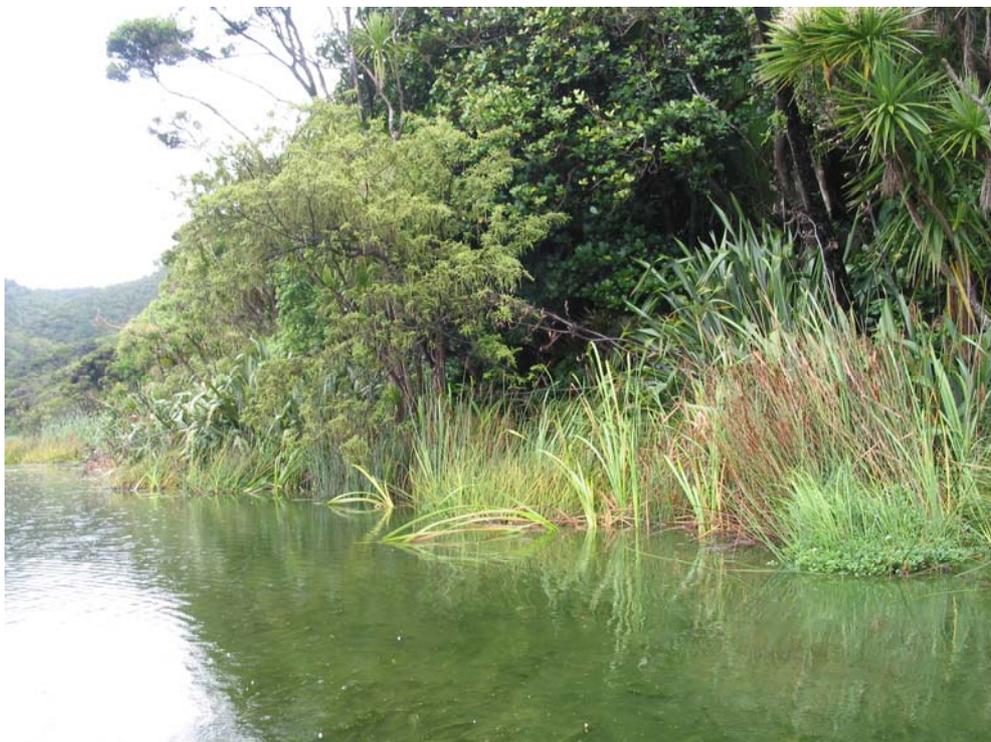
**Figure 4:**

Five sites were described during the November 2007 LakeSPI survey. At this time a dense algal bloom was present in surface layers of the water column. Egeria was present at all sites. Weed beds formed an average cover of >50% (median 76-95%) from depths  $\leq 1$  m down to maximum depths of 4.7 to 6 m, although egeria was sparse in deeper water (>4 m). The canopy of beds reached a maximum of 4.2 m in height, but beds were more commonly between 2 and 2.5 m tall. Surface reaching, flowering beds were common near the lake margin (Figure 4).

The margin of Lake Kawaupaku showing a surface algal bloom and floating, flowering shoots of egeria in the foreground.

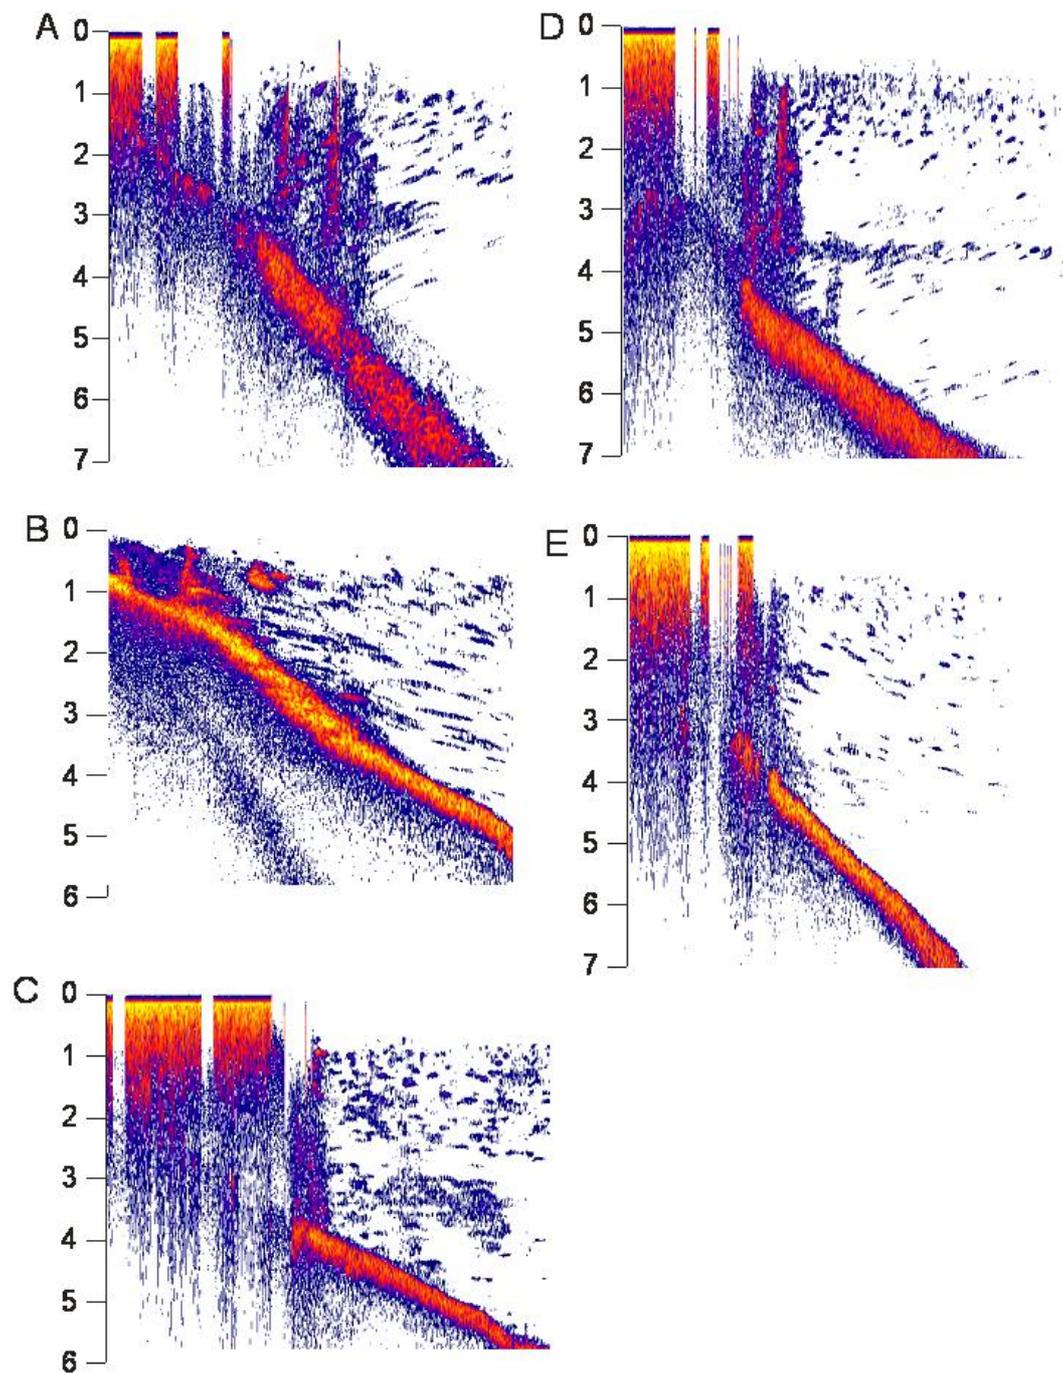
**Figure 5:**

Sonar traces show the depth distribution, height and development of the submerged vegetation, predominantly egeria (Figure 5). Surface reaching beds show as solid blocks in the shallow portion of the depth range but sparse growths at the lower depth boundary are not always detected in the traces. No bathymetric data was found for this lake, but estimates of vegetated littoral distances to depths of 5 to 7 m depth in 1971 (John Clayton, unpublished data) ranged from 6 to 11 m width. Based on a mean littoral width of 8.5 m and the perimeter length of the lake at 1.7 km, we estimate

egeria beds to occupy an area of 1.45 ha. At median egeria covers of 76-95% the total lake biomass (standing crop) of egeria would be 11 to 14 tonne dry weight.

Lake Kawaupaku sonar profiles made at five LakeSPI survey sites showing depth distribution of the vegetation, predominantly egeria beds. Solid blocks are surface reaching beds and absorption of the sonar signal by dense growths also obscures the lake bed trace in places. Note horizontal distance is not to scale.

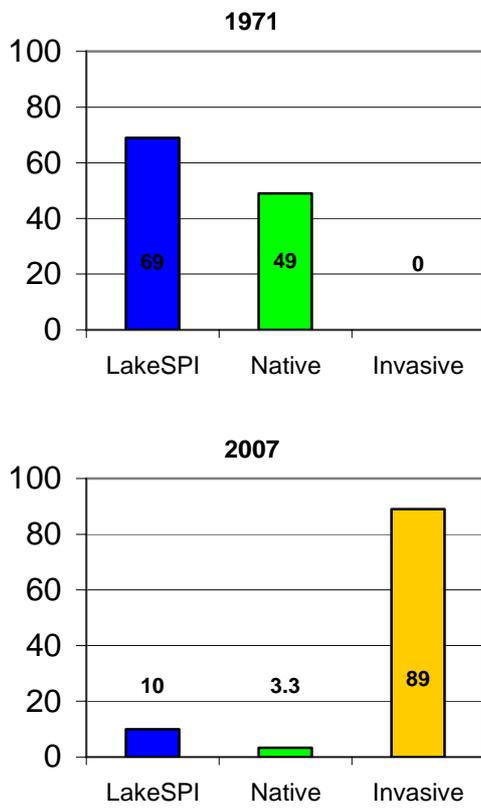
**Figure 6:**

At this time the lake had a relatively high LakeSPI score of 69% (Figure 6), due to the extensive native vegetation and negligible impact by invasive weeds.

Scores for LakeSPI Index, Native Condition Index and Invasive Condition Index for Lake Kawaupaku based on historical data from 1971 and the survey in 2007.
