LakeSPI Assessment of 33 Auckland Lakes: 2017 Update

Technical Report 2017/028

NIWA Client Report: 2017174HN
June 2017
NIWA Project: ARC17202

Auckland Council
Technical Report 2017/028
ISSN 2230-4525 (Print)
ISSN 2230-4533 (Online)

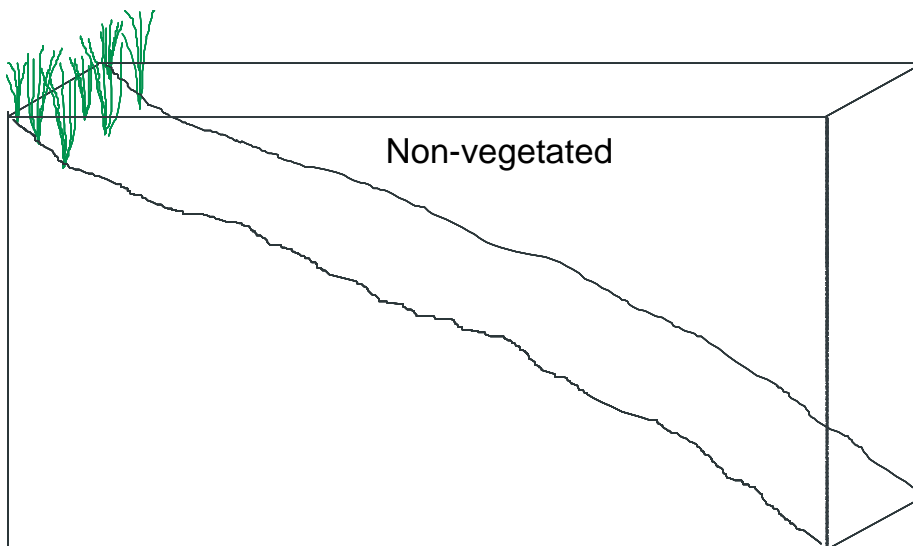
Figure 3.

Depth profile illustrating a non-vegetated lake.

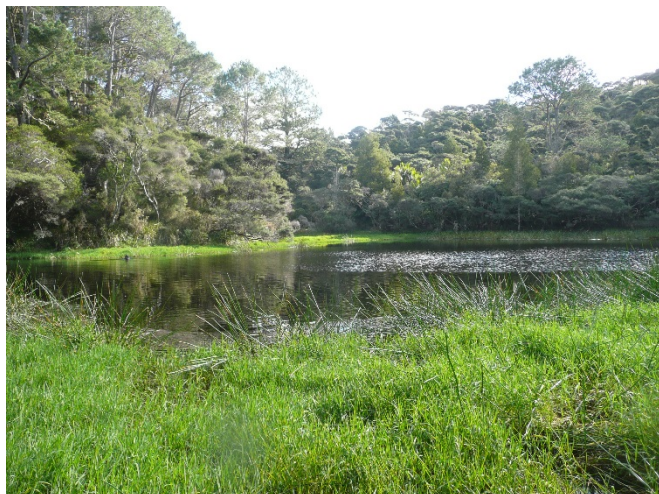
Latest assessment:	2012
Lake condition:	Moderate
Stability:	-
Lake Max Depth (m):	6
Lake type:	Dune

Little Shag Lake is situated within a catchment of native forest/shrubland and exotic forestry in the newly formed Te Arai Regional Park. Lake waters were strongly coloured with humic substances, but relatively clear. Submerged vegetation was restricted to a narrow, near continuous band around the lake edge. The LakeSPI score of 39% (Table 2) reflected dominance by native charophytes (two common species), but with a major contribution from the exotic weed *Utricularia gibba*.

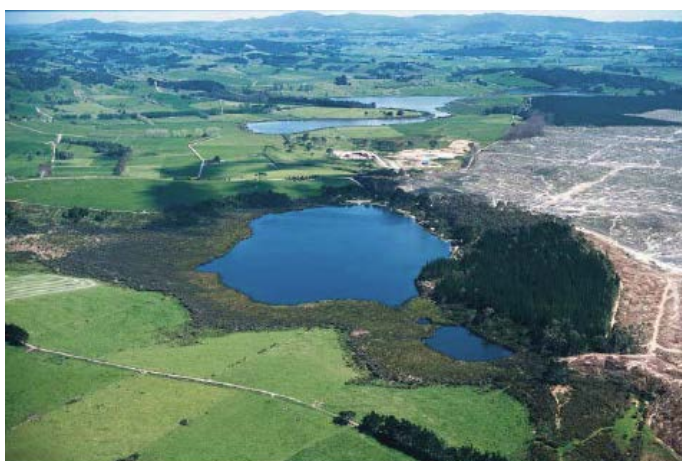
4.1.2 Lake Tomarata

Latest assessment:	2017
Lake condition:	Non-vegetated
Stability:	Declining
Lake Max Depth (m):	6
Lake type:	Dune

The latest 2017 assessment showed the lake has undergone a major vegetation decline since 2012 and currently has a non-vegetated status (LakeSPI Index 0%, Table 4). No submerged plants were detected at four of the five survey sites, with remnants of native charophytes (<1% cover) detected at one site on the western shore. The lake appeared more darkly stained (Figure 6) than previously observed and divers noted disturbance of the bottom sediments that is usually attributed to coarse fish. A continued decrease in kuta (*Eleocharis spachelata*) around wetland margins of the lake was observed, together with some dislodged clumps of other emergent plant species (Figure 6).

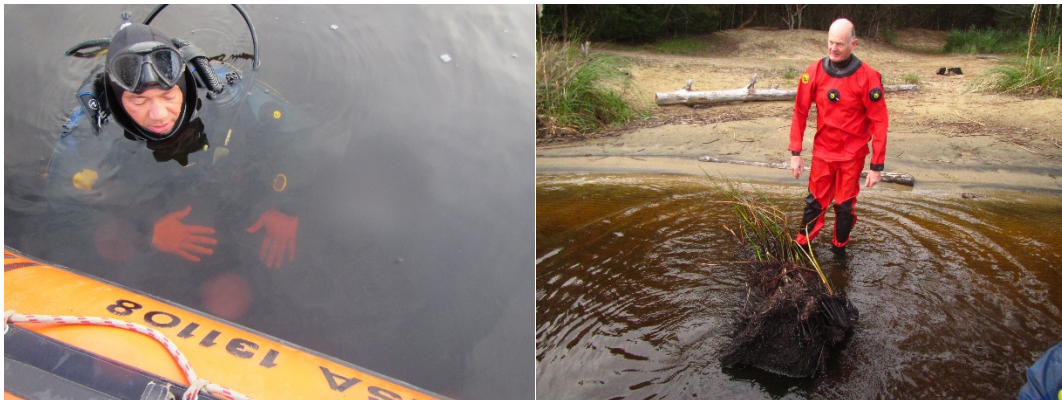
Left; dark staining suggests light limitation may have contributed to the decline of submerged plants in 2017. Right; a clump of dislodged emergents.

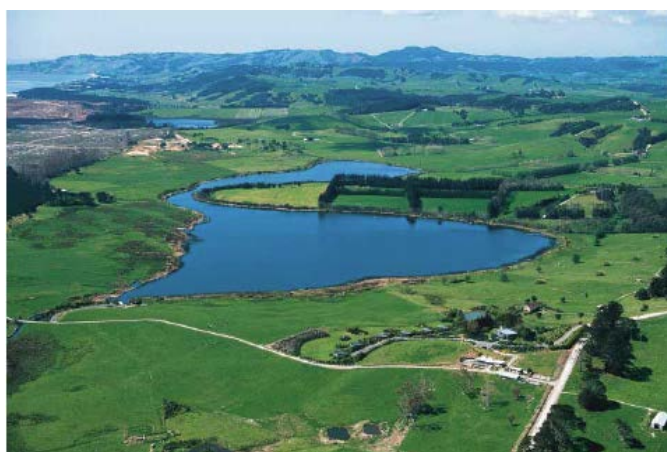
4.1.3 Lake Spectacle

Latest assessment:	2008
Lake condition:	Non-vegetated
Stability:	Stable
Lake Max Depth (m):	7
Lake type:	Dune

Lake Spectacle has not had submerged vegetation on the three occasions it has been surveyed (1988, 1999, 2008), and therefore has received a default LakeSPI Index of 0% (Table 5). In 1999, the lake was reported as having the worst water quality of seven Auckland Lakes assessed (Gibbs et al. 1999) and submerged plants were effectively excluded by low water clarity (<1 m Secchi Disc depth) and floating sudds of marginal vegetation that extended out over 2 m in depth. Herbivorous rudd are known to have been present in this lake since 1979 (FBIS).

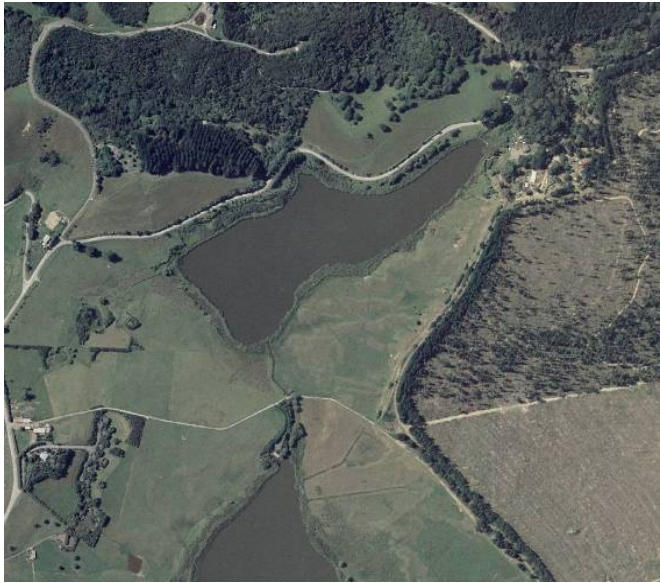
4.1.4 Lake Slipper

Latest assessment:	2008
Lake condition:	Non-vegetated
Stability:	Stable
Lake Max Depth (m):	5.3
Lake type:	Dune

Lake Slipper is connected to Lake Spectacle via a wide drainage channel. Both lakes are likely to have similar water quality issues and like Lake Spectacle, Lake Slipper has been devoid of submerged vegetation during 1988 and 2008 surveys. This has resulted in a LakeSPI Index of 0% (Table 6).

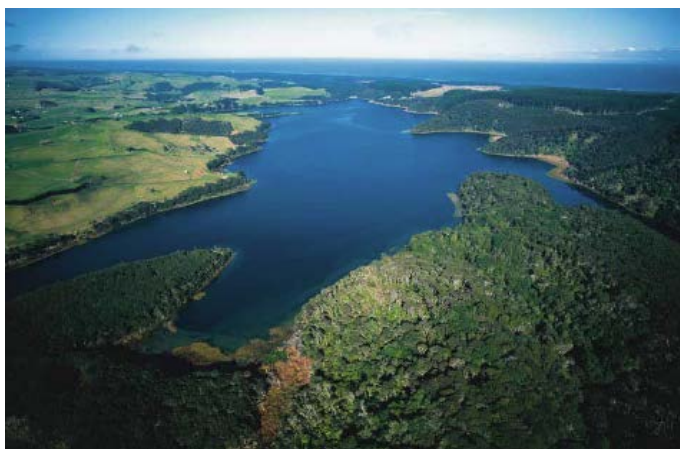
4.2.1 Lake Rototoa (previously Ototoa)

Latest assessment:	2017
Lake condition:	High
Stability:	Declining
Lake Max Depth (m):	27.5
Lake type:	Dune

In 2017 Lake Rototoa continued to show a high status according to LakeSPI (LakeSPI Index 59%) on account of its primarily native plant communities and deeper vegetation development. A Native Condition Index of 55% (Table 7) reflected widespread native charophyte meadows, together with native pondweeds and beds of emergent plants. The expected expansion by the recent (post 2007) invasive weed hornwort (*Ceratophyllum demersum*) had not eventuated (Figure 7) and the Invasive Impact Index remained similar to 2010. Alien bladderwort (*Utricularia gibba*) also remained limited to amongst the shallow reeds and rushes as in 2010 (Figure 7).

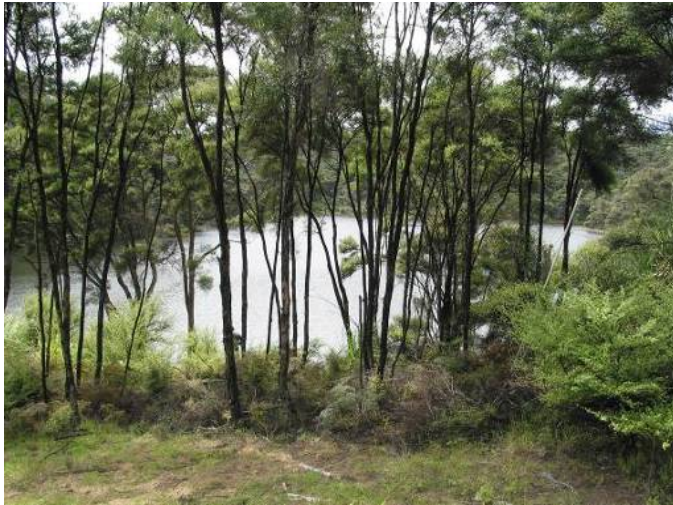
4.2.2 Te Kanae Lake

Latest assessment:	2008
Lake condition:	Poor
Stability:	-
Lake Max Depth (m):	18
Lake type:	Dune

The lake at Te Kanae Road had a poor LakeSPI Index (10%) and one of the highest Invasive Impact Indices (96%) reflecting the impact hornwort is having on the lake (Table 8). Hornwort formed beds up to 3 m in height that extended from the margin of emergent plants to a maximum of 6.6 m depth, and drifting shoots from these beds were noted on the lake bed to depths exceeding 12 m. The only other submerged plants seen were a native milfoil and fragments of the invasive weed *Utricularia gibba* at one site only.

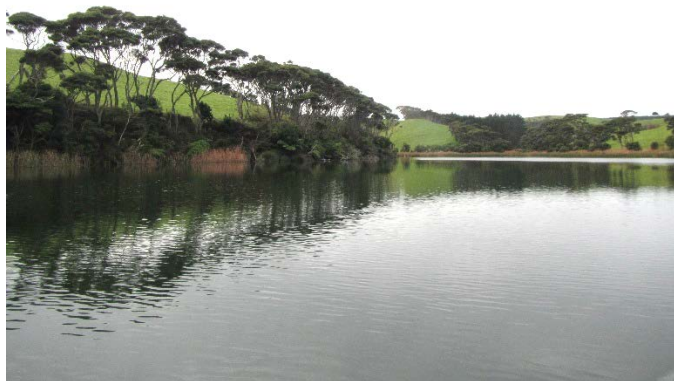
4.2.4 Lake Kuwakatai

Latest assessment:	2017
Lake condition:	Poor
Stability:	Stable
Lake Max Depth (m):	15
Lake type:	Dune

The category of Lake Kuwakatai continues to be poor, with a LakeSPI Index of 8% (Table 9) due to a large impact from the invasive weed hornwort (*Ceratophyllum demersum*). Large hornwort beds extended from the margins to between 6.6 and 7.8 m depth, which in places were up to 5.4 m tall (Figure 9). Emergent marginal plants remained well developed along the northern and eastern shorelines and scattered along the southern shoreline. No native submerged plants were recorded. An algal bloom was noticeable in surface waters at the time of the survey. Large koi carp were observed by divers, and perch, goldfish, tench and rudd are also known from this lake (New Zealand Freshwater Fish Database), but no impacts on hornwort beds were discerned.

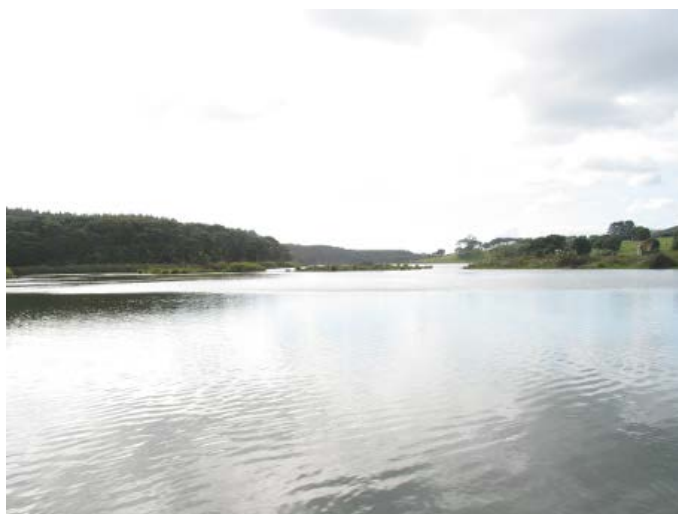
4.2.6 Lake Kereta

Latest assessment:	2012
Lake condition:	Non-vegetated
Stability:	-
Lake Max Depth (m):	2.3
Lake type:	Dune

Grass carp (*Ctenopharyngodon idella*) were stocked into Lake Kereta over 2008 to 2009 to improve amenity values of the lake. Effects of grass carp grazing of weed beds were not immediately apparent because of the small size and probable high mortality of the fish. However, by the 2012 LakeSPI survey it was estimated that over 99.9% of the previous hornwort beds had been removed. Eradication of hornwort had not yet been achieved, however, with shoots commonly found where fish access was restricted such as amongst dense stems of emergent beds of *Zizania latifolia*. The current non-vegetated status of the lake (Table 11) was a direct result of grass carp stocking and therefore is not indicative of lake ecological condition.

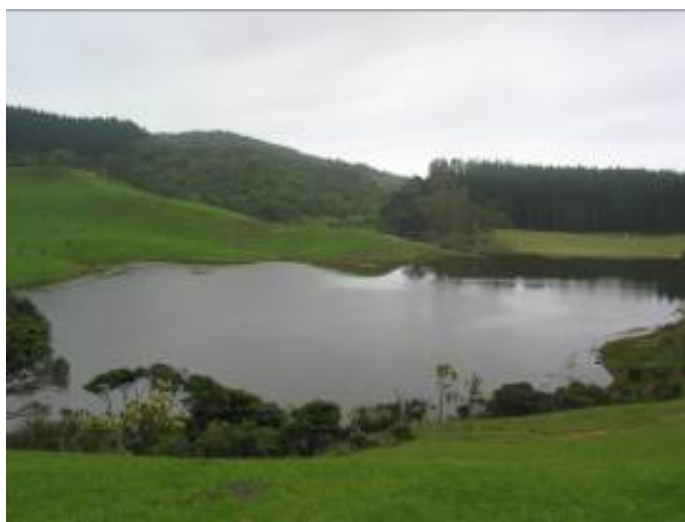
4.3.1 Lake Okaihau

Latest assessment:	2012
Lake condition:	Poor
Stability:	Stable
Lake Max Depth (m):	9.5
Lake type:	Dune

The latest LakeSPI score of 20% in 2012 suggests the lake is unchanged from the previous (2005) assessment of having a poor ecological condition (Table 13). The dominant submerged plant was hornwort (*Ceratophyllum demersum*), although these beds were not as extensive as before. Egeria (*Egeria densa*) was not re-recorded. Native milfoils, turf plants and sparse charophytes were recorded in shallow water.

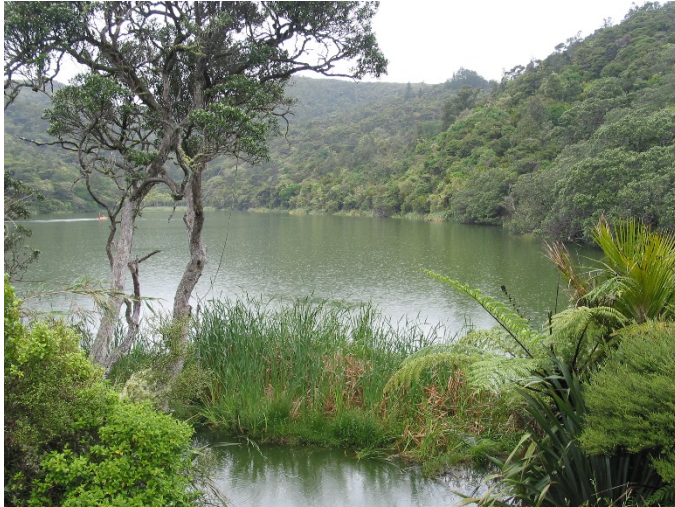
4.3.2 Lake Kawaupaku

Latest assessment:	2017
Lake condition:	Poor
Stability:	Unstable
Lake Max Depth (m):	22
Lake type:	Dune

In 2017 the lake had a poor status according to LakeSPI, with a LakeSPI Index of 8% (Table 14). This low score was due to dominance by the weed egeria (*Egeria densa*) as the only submerged plant recorded. Beds were recorded to maximum depths of between 3.3 to 4.5 m. However, egeria was absent at one site which limited the Invasive Impact Index to 70%, but penalised LakeSPI scoring slightly. Egeria shoots tended to have a large burden of algae and detritus (Figure 10) and an algal bloom at the time of the survey would have created further light stress. It was also noted that browsing damage was common on near surface shoots from waterfowl or fish feeding. Herbivorous rudd and benthivorous-feeding tench have been recorded from the lake (New Zealand Freshwater Fish Database). These observations suggest the lake status is unstable and at risk of a wider vegetation decline.

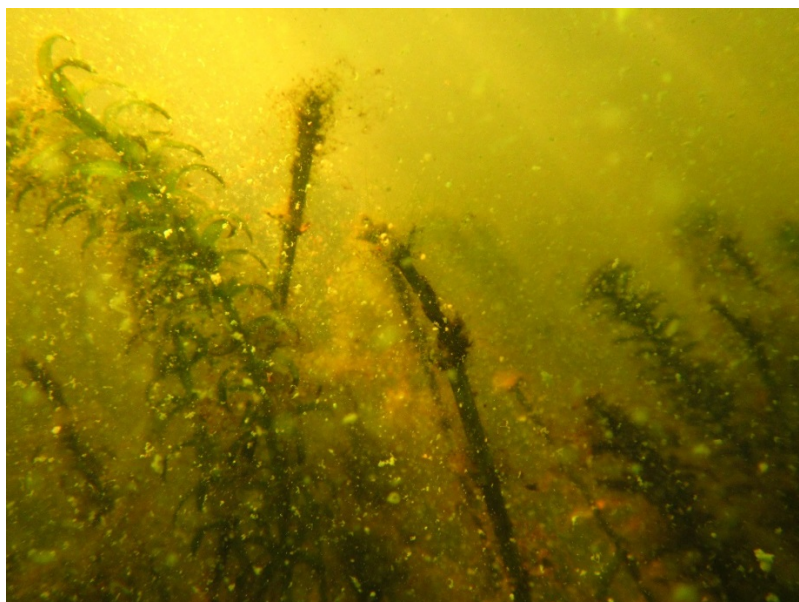
Egeria plants showing a heavy algal burden and signs of grazing.

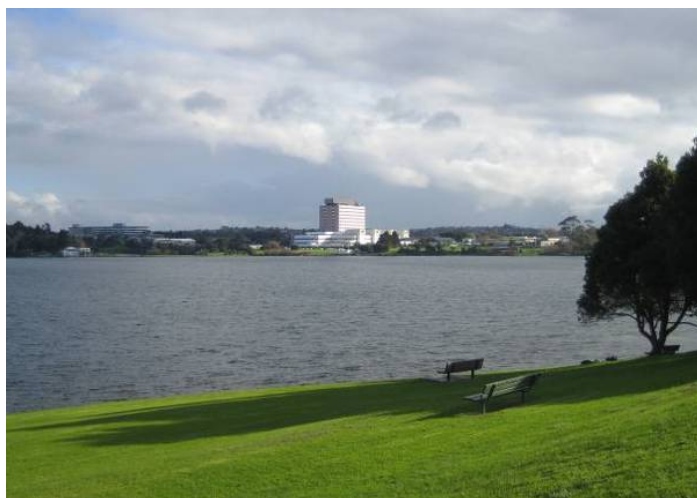
4.4.1 Lake Pupuke

Latest assessment:	2017
Lake condition:	Poor
Stability:	Declining
Lake Max Depth (m):	58
Lake type:	Volcanic

In 2017 Lake Pupuke was assessed as in poor condition according to LakeSPI, with a LakeSPI Index of 18% (Table 17). This represents a substantial and significant deterioration since 2012 in both the Native Condition Index and LakeSPI Index. The main cause was a reduction of charophyte meadows from deeper water. There was also a significant retraction of bottom limits of the weeds across all sites compared with previous surveys in 2008 and 2012. Occasional bands of milfoil and shallow water charophytes continued to be recorded.

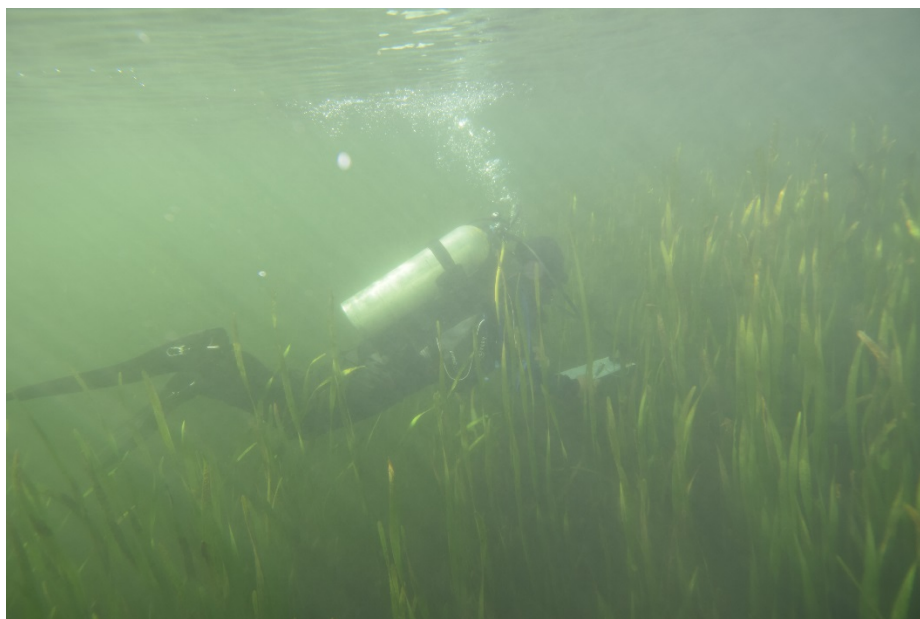
A diver swims over a bed of eelgrass.

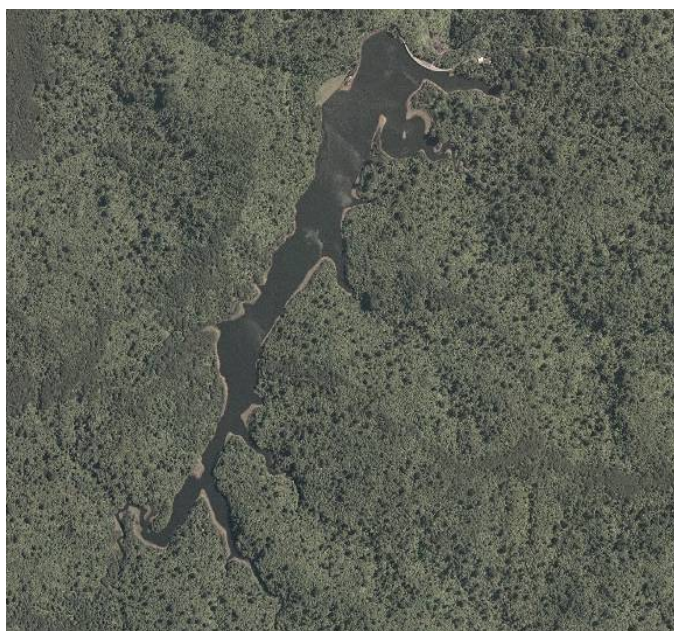
4.5.1 Waitākere Reservoir

Latest assessment:	2008
Lake condition:	High
Stability:	Stable
Lake Max Depth (m):	19.7
Lake type:	Reservoir

Waitākere Reservoir was the highest scoring of this group of reservoirs, with a LakeSPI Index of 51% (Table 19) resulting from the presence of extensive charophyte meadows to 6.9 m depth, moderately impacted by a shallow band (<4 m) of the weed *Juncus bulbosus* (Invasive Impact Index of 39%). Patches of native milfoil were also common. Two other invasive weeds observed included one plant of *Ranunculus trichophyllus* and fragments of *Utricularia gibba* stranded on the dam structure outside of the survey sites. All three invasive species are spread by waterfowl. The high cover charophyte meadows began at between 2.5 and 3.8 m depth, within the range of water level fluctuation of 4.1 m and suggesting the 6-month period of stable water levels prior to the survey was sufficient for charophyte expansion.

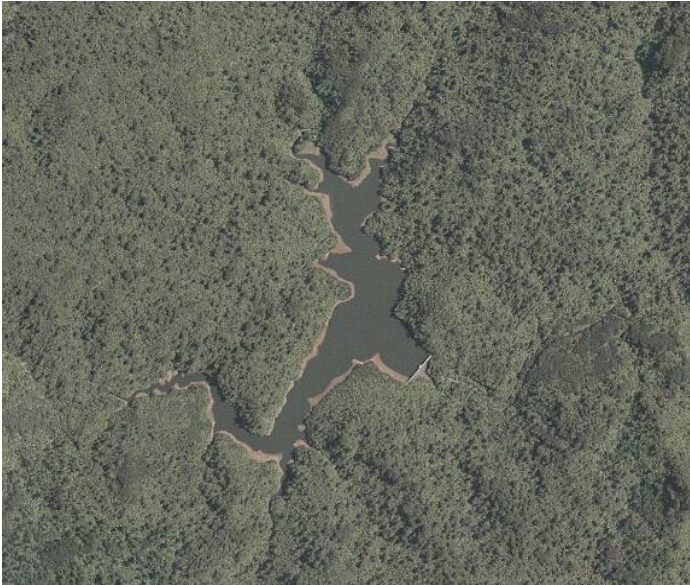
4.5.2 Upper Huia Reservoir

Latest assessment:	2008
Lake condition:	Moderate
Stability:	Stable
Lake Max Depth (m):	33.1
Lake type:	Reservoir

The submerged vegetation was dominated by the weed *Juncus bulbosus*, resulting in a high Invasive Impact Index (53%) and moderate LakeSPI Index of 36% (Table 20). Spread from seed by waterfowl, *J. bulbosus* is less invasive than most other submerged weeds, but in the Upper Huia Reservoir it formed the highest covers of any plant species and was recorded to the maximum vegetation depth of 5.5 m. Native milfoils also commonly contributed to the vegetation, but no charophytes were recorded. All submerged vegetation was within the range of water level fluctuations experienced over the preceding year.

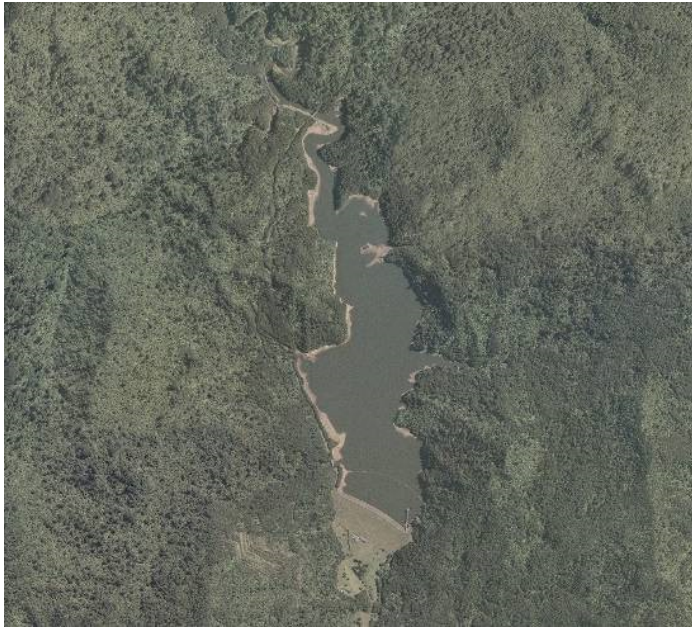
4.5.3 Lower Huia Reservoir

Latest assessment:	2008
Lake condition:	Moderate
Stability:	Declining
Lake Max Depth (m):	33.5
Lake type:	Reservoir

A LakeSPI Index of 31% (Table 21) reflected the paucity of submerged vegetation, limited depth extent and minor impact by the weed *Juncus bulbosus* (Invasive score 33%). The most common submerged plants were native milfoils, the alien marginal plant *Ludwigia palustris*, and *J. bulbosus*. Highest plant covers were <3 m depth, with the deepest plants recorded at 3.6 m. Charophytes were present but not common. Remains of terrestrial shrubs were recorded to 4.6 m, which is in keeping with the 6.8 m increase in water level over the preceding months and suggests that the submerged vegetation recorded was made up of recently colonised plants.

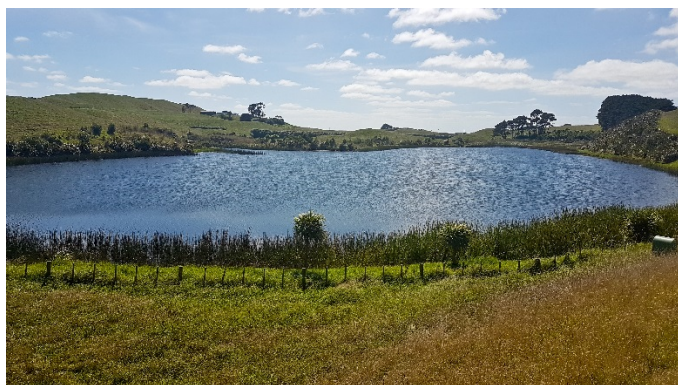
4.6.1 Lake Whatihua

Latest assessment:	2017
Lake condition:	Moderate
Stability:	Declining
Lake Max Depth (m):	11
Lake type:	Dune

In 2017 the lake retained a moderate status with a LakeSPI Index of 41% (Table 24). However, change was apparent in the significantly reduced depth of overall vegetation extent and in the depth of charophyte meadows since the previous survey in 2012. The latest survey showed plants at 10% cover extending to between 5.2 and 6.5 m depth, where 5 years earlier the equivalent depth measure was 7.9 to 9.2 m. Together these resulted in a small but significant reduction in the LakeSPI Index (Table 24).

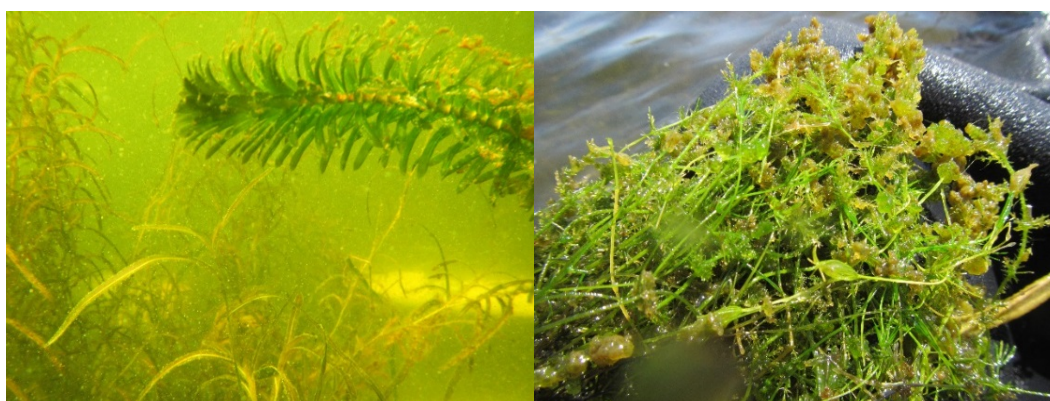
Left; deeper vegetation of tall egeria and native pondweed. Right; diverse native plants retrieved from shallow lake margins.

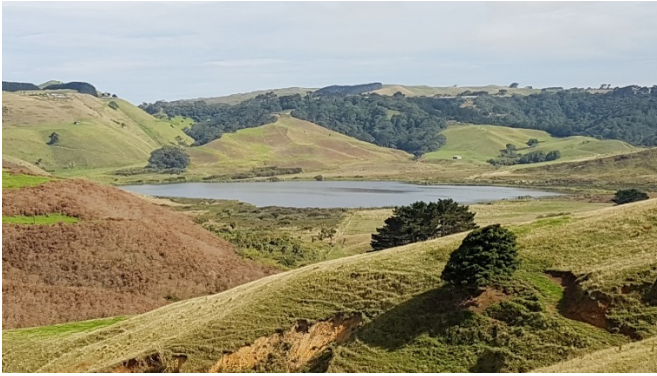
4.6.2 Lake Pokorua

Latest assessment:	2017
Lake condition:	Moderate
Stability:	Unstable
Lake Max Depth (m):	6
Lake type:	Dune

Lake Pokorua remains in a moderate state according to the LakeSPI Index of 39% in 2017. However, a slight reduction in the impact by invasive weed was observed compared to 2012 (Table 25). *Egeria* (*Egeria densa*) dominated only the deeper areas of the lake to 2.2 m depth, and did not form closed canopy beds. Meadows of charophytes (Figure 14) occupied a greater proportion of the shallow areas of the lake to depths between 1.5 and 1.8 m, together with open growths of native pondweeds. This native character is reflected by a moderate Native Condition Index of 64%.

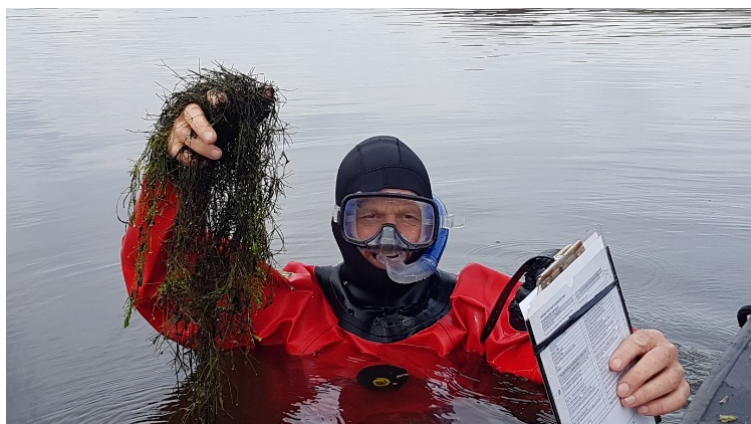
Diver retrieves charophytes to the surface for closer inspection.

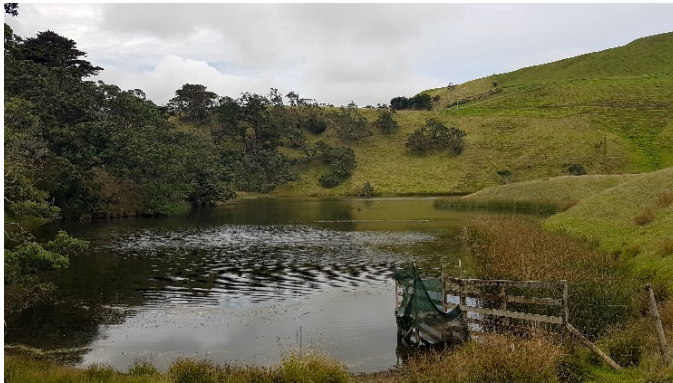
4.6.3 Lake Pehiakura (Small)

Latest assessment:	2017
Lake condition:	Poor
Stability:	Declining?
Lake Max Depth (m):	5.3
Lake type:	Dune

In 2017 the lake had deteriorated slightly and had a poor status according to a LakeSPI Index of 20% (Table 26). *Egeria* (*Egeria densa*) remained the dominant plant (Figure 15), with dense beds extending to almost 5 m depth and covering most of the lake bed. The main change from 2005 was a reduction in the remnant native vegetation in the shallows (Figure 15).

The smaller of the two Pehiakura lakes, this lake again appeared to have better water quality than the bigger lake, but an algal bloom was evident (Figure 15).

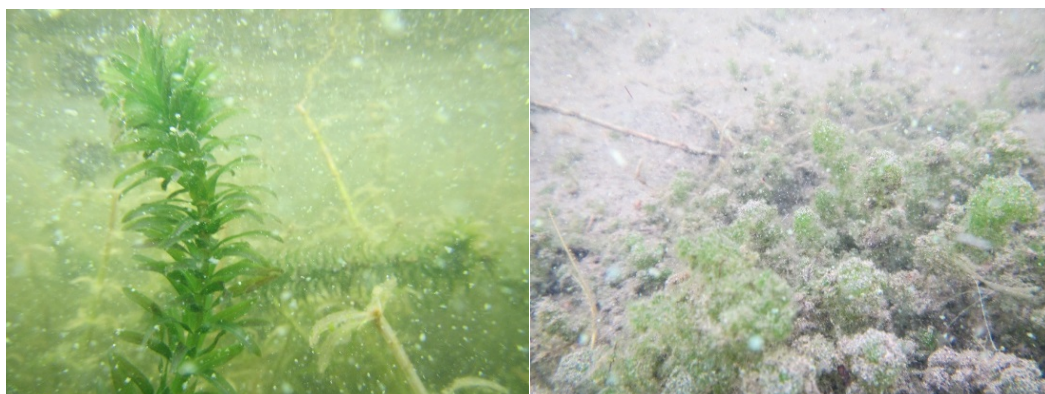
Left; near surface egeria. Right; sparse growths of the charophyte (*Nitella hyalina*).

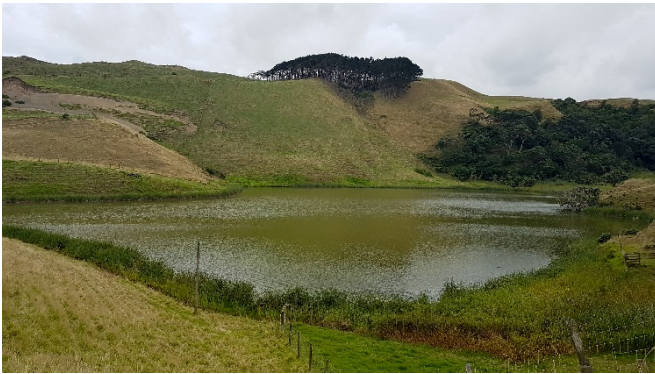
4.6.4 Lake Pehiakura (Big)

Latest assessment:	2017
Lake condition:	Poor
Stability:	Stable
Lake Max Depth (m):	10.7
Lake type:	Dune

This lake remains in a poor state according to the LakeSPI Index of 9% in 2017. *Egeria* (*Egeria densa*) has been the only submerged plant species recorded from all surveys (Figure 16) leading to Invasive Impact Index of $\geq 89\%$ (Table 27).

Dense weed beds were recorded to a maximum depth of between 4.2 to 4.5 m in 2017, compared to 3.5 to 4.3 m in 2012 and 5.4 m in 2005. A narrow, but almost continuous band of emergent plant species exists around the lake margin (Figure 16).

At the time of the 2017 survey water clarity was poor with a dense algal bloom evident (Figure 16).

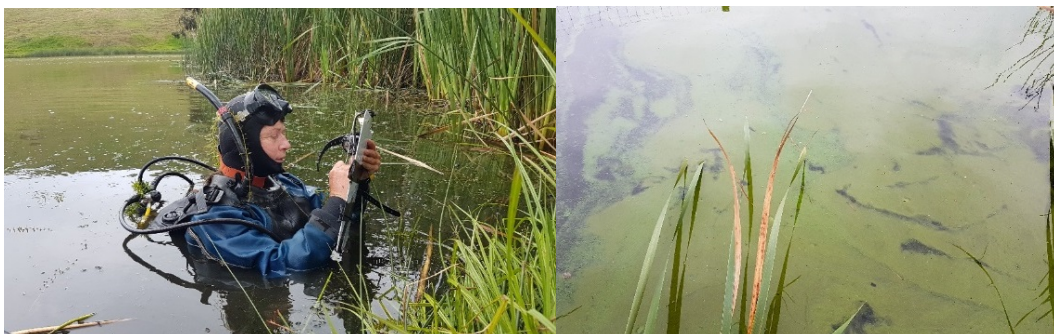
Left; diver records observations amongst the shallow egeria weed bed. Right; algal scums accumulate against the lake margin.

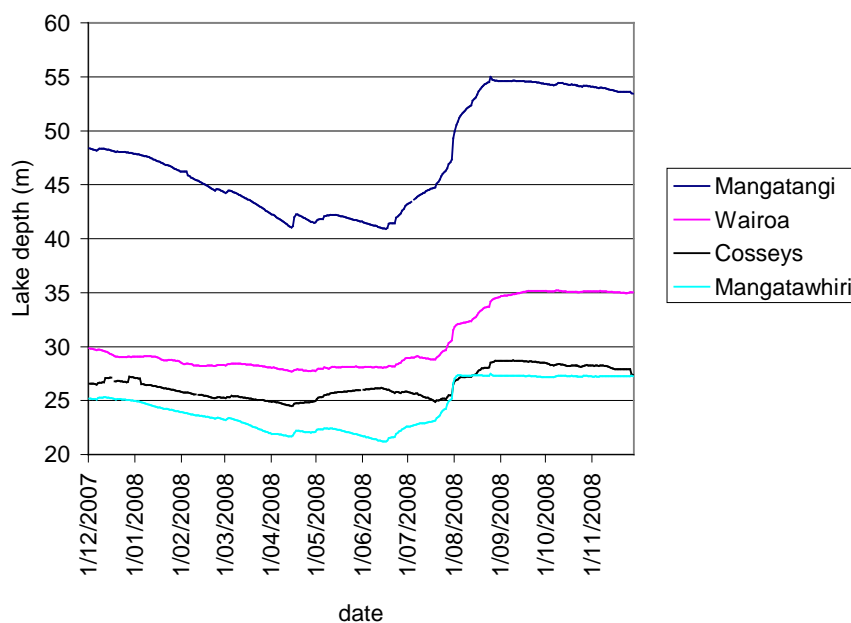
Amplitude of water level fluctuations (m) for the Hunua reservoirs in relation to their depth over the period from 01/12/2007 to 28/11/2008 (Watercare Services Limited data). The LakeSPI survey was in late October 2008.

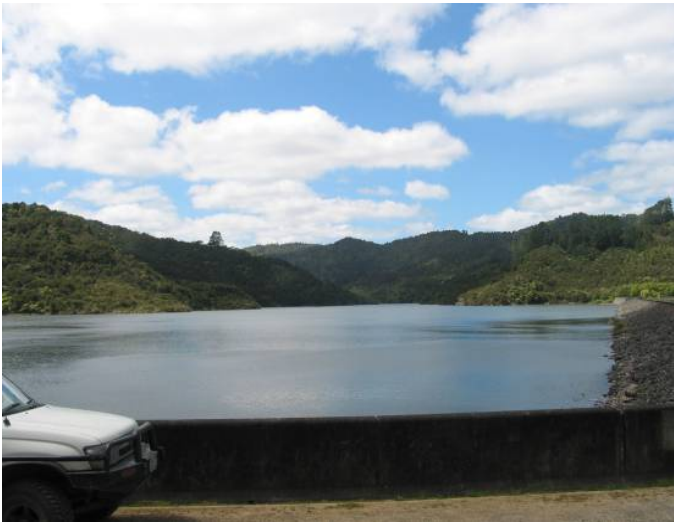
4.7.1 Mangatawhiri Reservoir

Latest assessment:	2008
Lake condition:	Excellent
Stability:	Improving
Lake Max Depth (m):	35.6
Lake type:	Reservoir

The upper Mangatawhiri Reservoir had the highest LakeSPI ranking of the Auckland region (76%) on account of the depth extent of native charophytes that formed high cover meadows down to 10.4 m depth (Table 28). The shallow edge of these meadows began at 6 m depth, corresponding with the water level rise of 6.3 m recorded prior to the survey. Native milfoils and pondweeds were a minor vegetation component found in shallower depths than the charophyte meadows and no invasive submerged weeds were recorded.

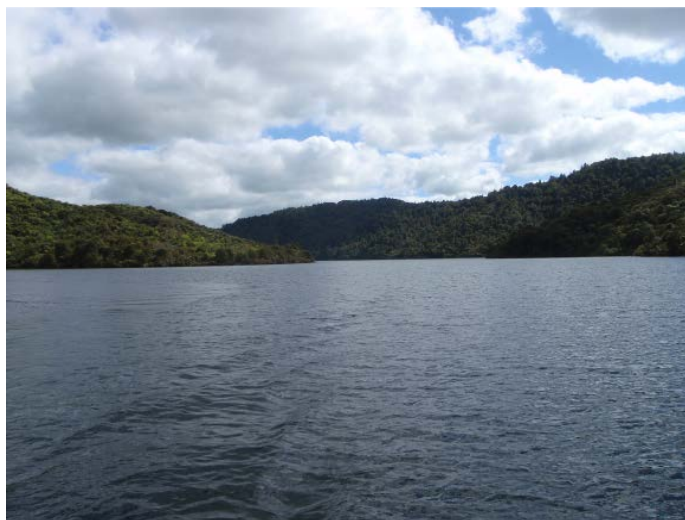
4.7.2 Wairoa Reservoir

Latest assessment:	2008
Lake condition:	High
Stability:	Stable
Lake Max Depth (m):	40.3
Lake type:	Reservoir

A high LakeSPI Index of 66% (Table 29) resulted from the presence of native plant communities growing down to a moderate depth in the absence of any invasive plant species. Beds of native charophytes began at 6.3 to 7.1 m and extended to 8.6 m depth, with occasional plants recorded as deep as 11.7 m. Native milfoils and pondweeds were sometimes present in mid-depths of 3 to 8.2 m and terrestrial vegetation was noted to 4.4 m depth. An increase in water level of 7.5 m prior to the survey would account for the transition from terrestrial to obligatory submerged plants seen between 4.4 and around 7 m depth.

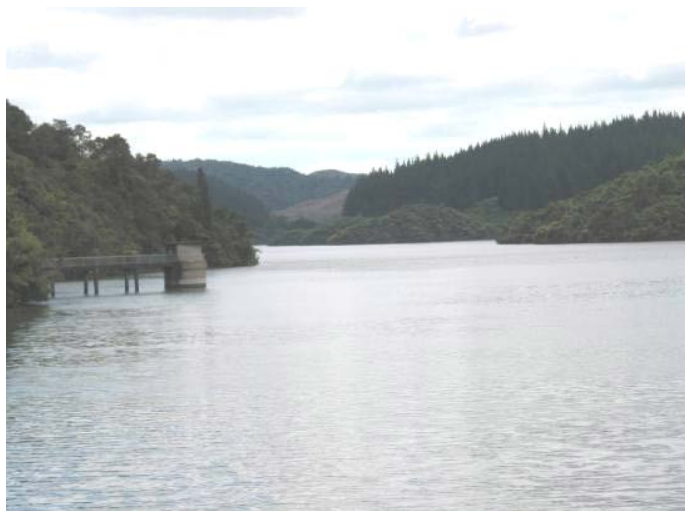
4.7.3 Cossey's Reservoir

Latest assessment:	2008
Lake condition:	Moderate
Stability:	Declining
Lake Max Depth (m):	35.1
Lake type:	Reservoir

The LakeSPI Index of 49% (Table 30) reflected the largely native vegetation character in Cossey's Reservoir that, although it was low in cover and depth extent, had only minimal impact by invasive *Juncus bulbosus*. The sparse submerged vegetation comprised of native charophytes and milfoils while *J. bulbosus* was present at some of the sites. Submerged plants were recorded to 5.6 m depth although most growth was less than 3.3 m, and inundated terrestrial plants were noted to 2.6 m. The water level increase of 4.2 m prior to the 2008 survey was not clearly reflected in the depth distribution of the submerged vegetation.

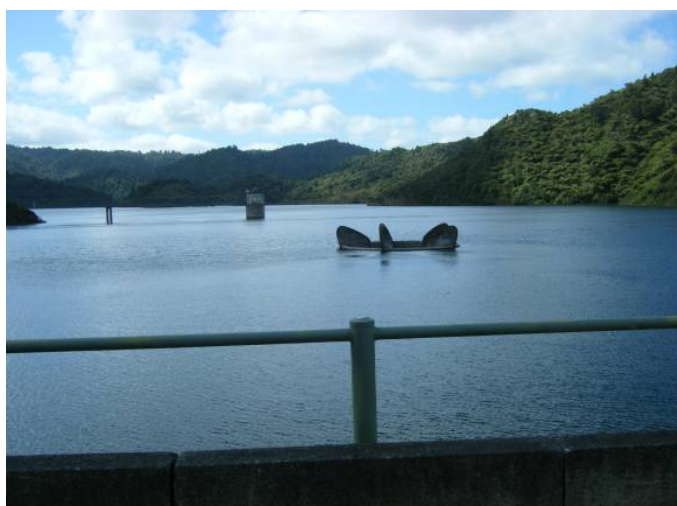
4.7.4 Mangatangi Reservoir

Latest assessment:	2008
Lake condition:	Non-vegetated
Stability:	Declining
Lake Max Depth (m):	54.6
Lake type:	Reservoir

In 2008 small patches of native charophytes were recorded between 13.1 and 15.4 m depth and native milfoils from 6 to 8.5 m. However, these plants were considered to be remnants of previous vegetation after inundation by a 14.1 m rise in water level prior to the 2008 survey, as it is doubtful these patches would survive the maintenance of high levels recorded over the subsequent three or more months (Figure 7). This together with the sparse nature of plant growth ($\geq 10\%$ cover at only one of three sites investigated) results in a LakeSPI Index of 0% (Table 31).

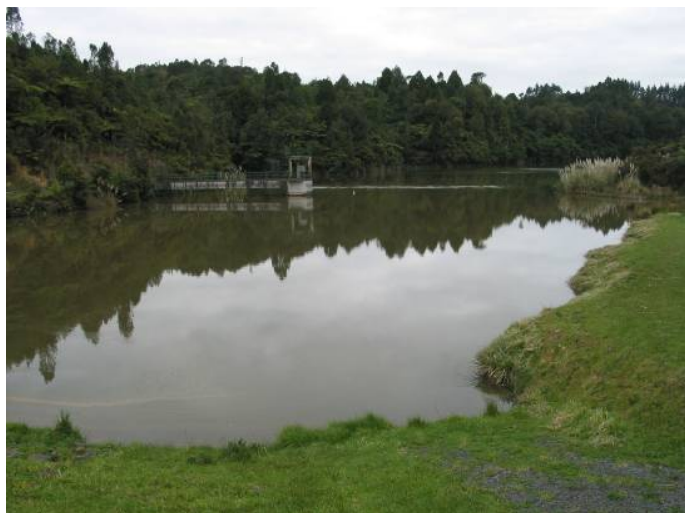
4.7.5 Hays Creek Reservoir

Latest assessment:	2008
Lake condition:	Non-vegetated
Stability:	-
Lake Max Depth (m):	20.7
Lake type:	Reservoir

Hays Creek Reservoir received a LakeSPI Index of 0% (Table 32) on account of the low presence of submerged vegetation. Only occasional charophyte plants were encountered at $\leq 10\%$ cover; below the threshold for generating LakeSPI scores. The low water clarity, with a turbid, 'milky' appearance, suggests light availability restricted submerged vegetation development. However, the presence of koi carp known from the reservoir is implicated both for impacts on water clarity (Rowe 2007) and direct impacts on submerged plants (e.g., Crivelli 1983). In contrast to the other Hunua Reservoirs, Hays Creek had a stable water level (Figure 7).

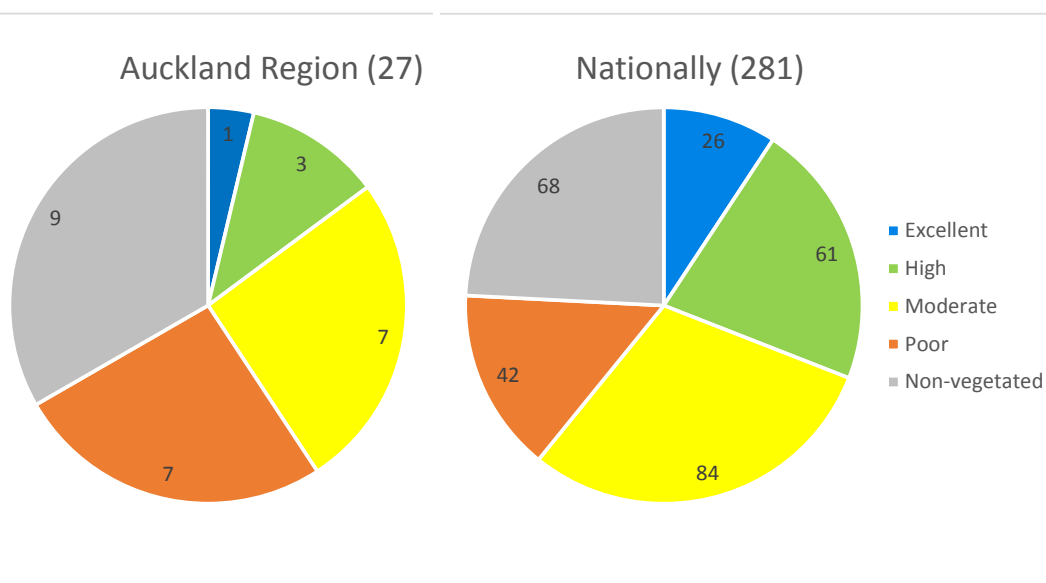
Figure 9.

- Proportion of lakes that fall into each of five categories of LakeSPI Index for the region and nationally, with numbers of lakes assessed shown in parenthesis.
