# Weymouth Beach Faecal Source Investigation

Technical Report 2016/009

Whatley, M., Noble, A and van Duivenboden, R (2016). Weymouth Beach faecal source investigation. Prepared for Auckland Council by Catchment and Incentives and RM PRO Ltd. Auckland Council technical report, TR2016/009

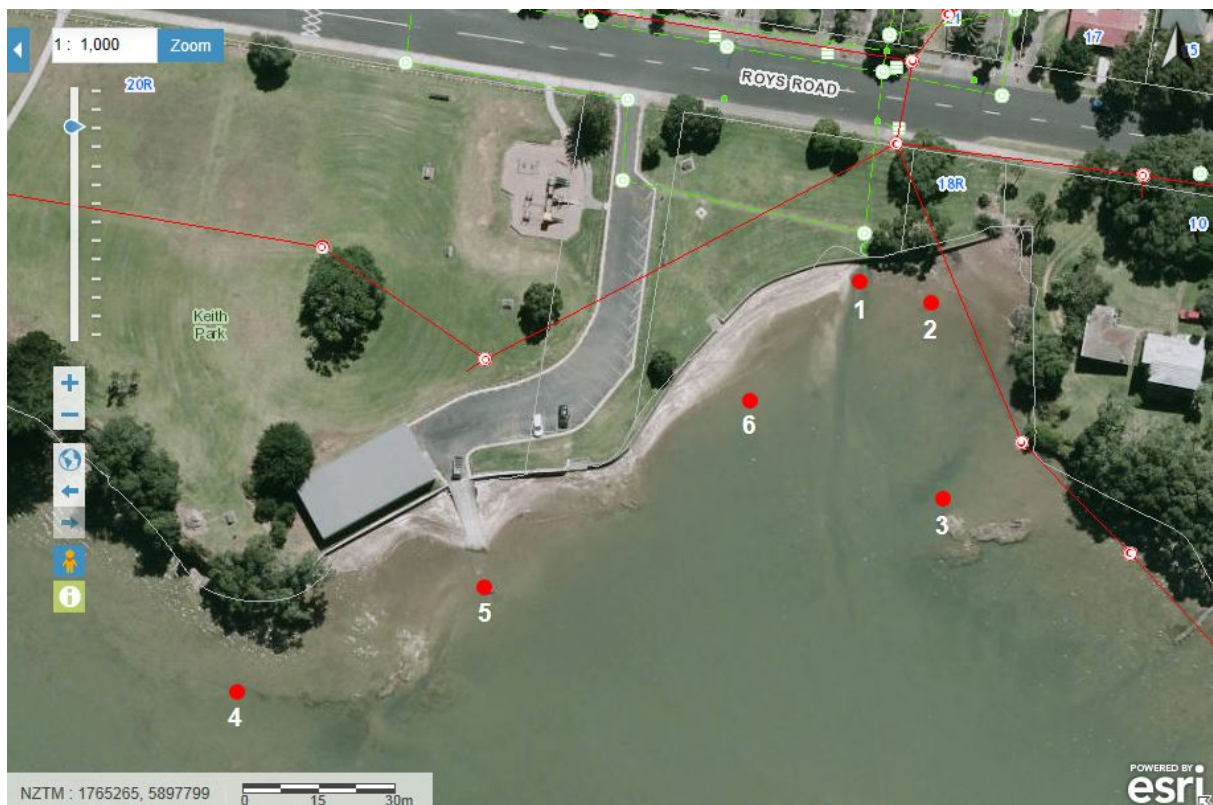
Located in the Manukau Harbour, Weymouth Beach is influenced by both tidal flows and discharges from stormwater outlets and natural waterways, draining both rural and urban areas. Six sampling sites were established during this investigation to capture concentrations and potential sources of faecal indicator bacteria which may enter the beach from the surrounding environment. Site descriptions and locations are outlined in Table 2-1 and an aerial photo showing the position of the 6 sampling locations in relation to stormwater and wastewater networks are presented in Figure 2-1.

Figure 2-1 Location of 6 sampling sites visited during this investigation in 2014 (red dots). Stormwater lines and manholes are shown by green lines and green and white dots, respectively. Wastewater lines and manholes are shown with red lines and red and white dots, respectively.

Table 2-1 Sampling site descriptions
