The Impacts of Recreational Activities on Lake Tomarata's Ecology and Water Quality

Technical Report 2016/033

The impacts of recreational activities on Lake Tomarata's ecology and water quality

NIWA Report No: HAM2016-047

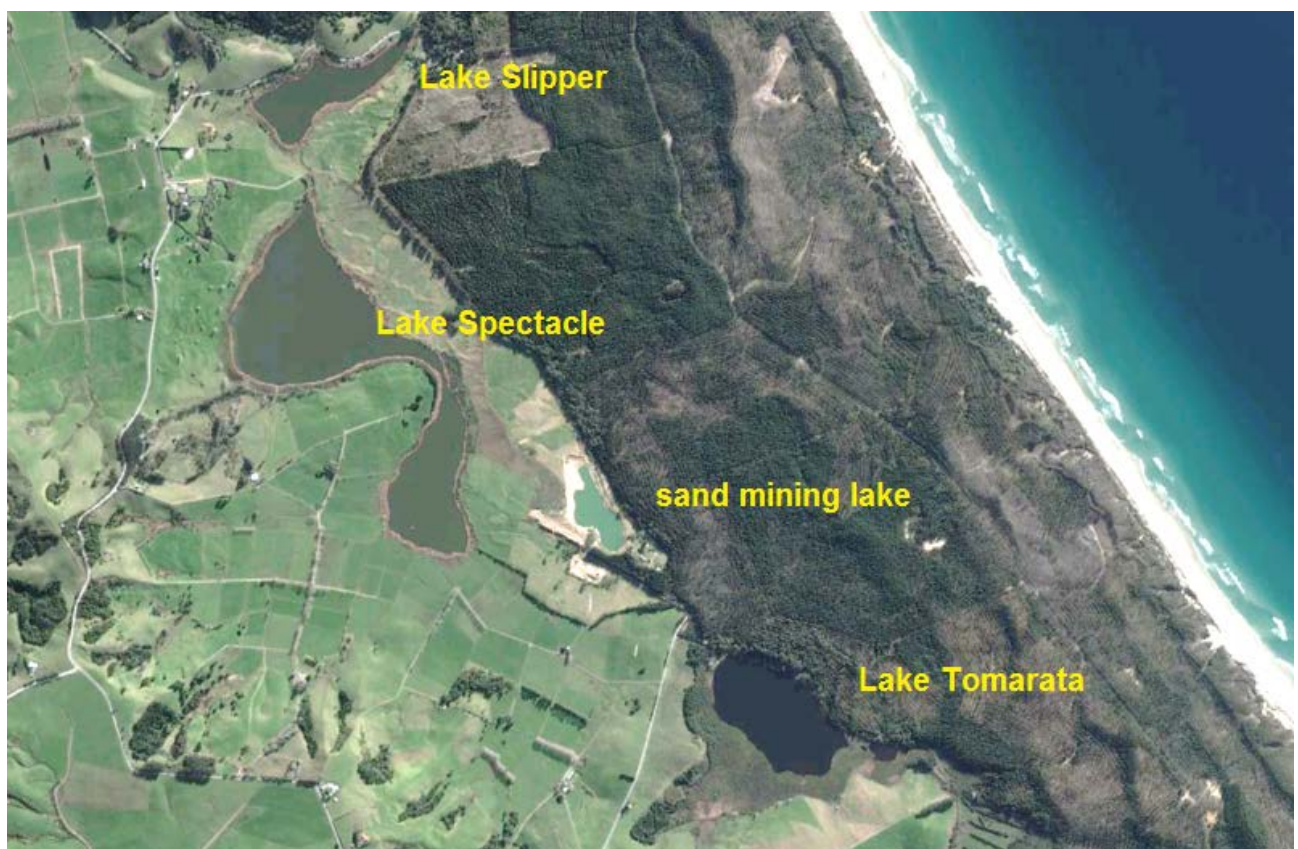
Figure 1: The Te Arai Lakes; Lake Tomarata, Lake Spectacle and Lake Slipper showing pine forestry to the east and dairying to the west. A new lake is being formed as a result of sand mining activities north of Lake Tomarata.

Lake Tomarata is one of three Te Arai Lakes located about 80km north of Auckland on the east coast of the North Island (Figure 1). The lake is nearly 600m long by 300m wide and is 13.9ha in area. It is steep sided and mostly over 4m deep with a maximum depth of 6m. The catchment is about 83ha and is mostly in low-intensity dairying with an exotic pine plantation to the east and north east. It has a 20ha wetland margin to the south and west, which would provide significant buffering for the lake from farm runoff.

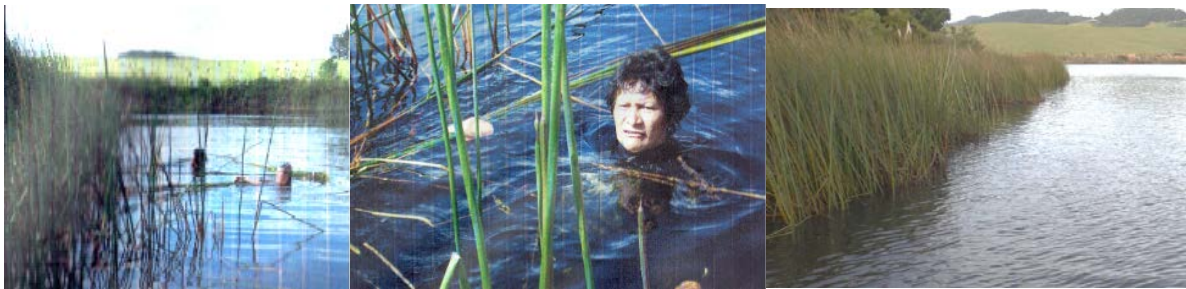
Figure 4: Photos centre and left show a kuta margin (being harvested for weaving) pre-2010 and right the same lake margin 2016 with kuta no longer present (Photos: Debbie Stone).

The marginal wetland vegetation is of high value and includes sedges, raupo, wire rush, umbrella fern, with a manuka canopy further from the lake. Notably it includes two rare species, wire rush *Empodisma robustum* (Conservation Status: Regionally Critical) and the sedge *Machaerina complanata* (Conservation Status: Threatened, Nationally Vulnerable). The tall emergent sedge, kuta (*Eleocharis sphacelata*) was abundant with a 3m wide strip around the much of the lake until 2010. It was up to 3.5m tall, growing from 0 to 3m water depth with up to 75% cover. In 2010 it suddenly died back (Stone, 2010) and it is noted that the kuta has recovered little over the following six years (D. Stone pers. comm. and Figure 4).

Lake users thought the die back was due to unauthorised spraying. However, declines in kuta are reported elsewhere in lakes experiencing increased eutrophication. There have also been suggestions that fluctuating water levels are the cause, but they would likely need to be in the order of 1.5m or more judging by the impacts of lake level lowerings in Waikato hydro-lakes (author's observations). Kuta is also susceptible to wave damage and is only found in more sheltered locations within larger lakes. This raises the possibility that increased boating activity, particularly of the wakeboarding type, is implicated (see section 4.5).

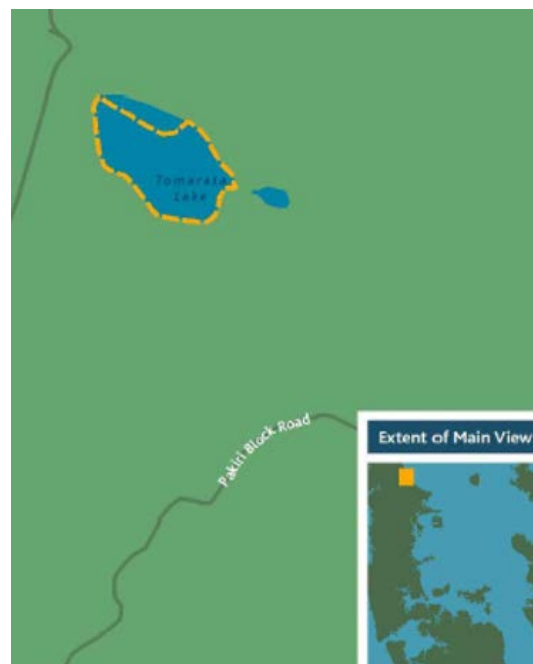
Figure 6: Map of Lake Tomarata showing the area of the lake reserved for power boating and water skiing within the yellow dotted line (Auckland Council 2014).

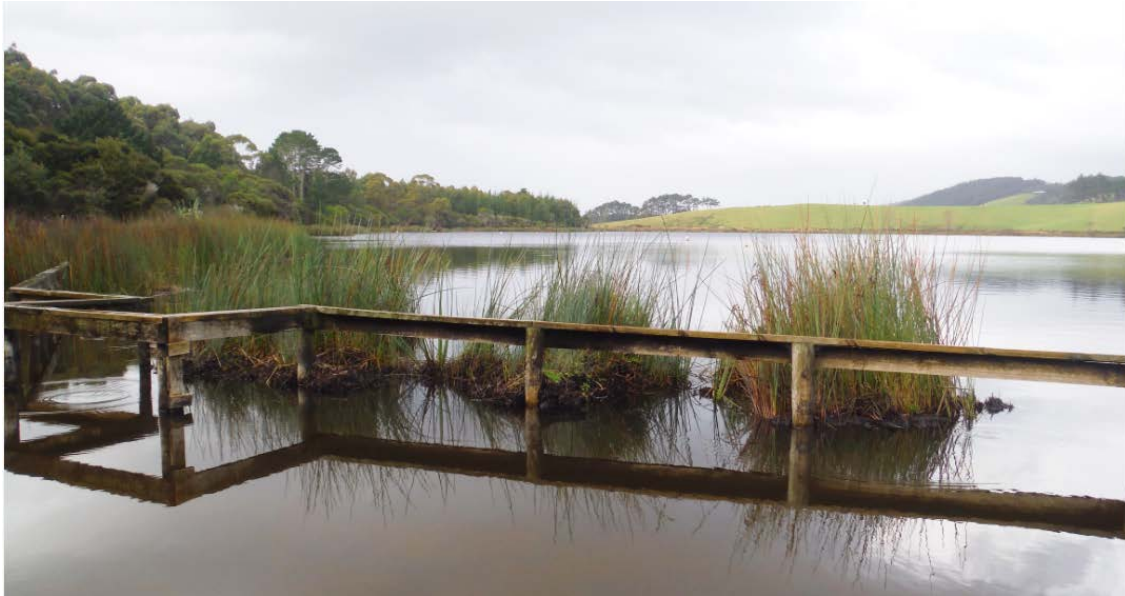
Figure 7: Floating rafts of vegetation broken off the marginal wetland (Photo: Debbie Stone).

Emergent plant species in Lake Tomarata are subjected to unnatural wave heights and this may be limiting the growth of species such as kuta and *M. articulata*. Signs of damage include floating clumps of *M. articulata* appearing on the lake in recent years (Ms D. Stone pers. comm, Figure 7) and possibly include the kuta dieback. If the kuta dieback was the result of illegal spraying instead, as locals suggest (Stone 2010), then this could also be the result someone trying to enlarge the area for water skiing.

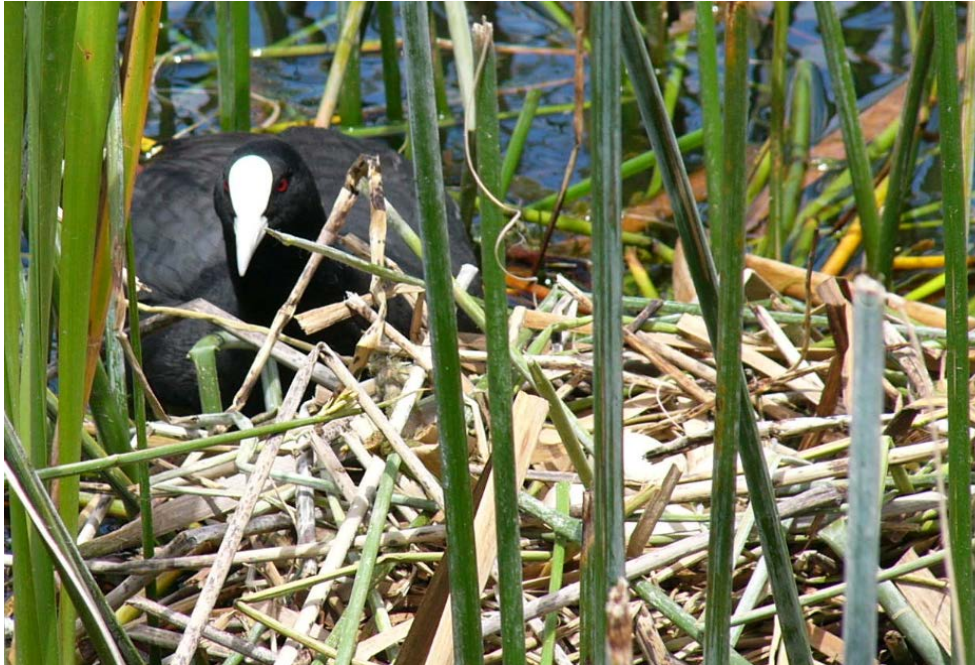
Figure 8: An Australian coot nesting in kuta on a sheltered margin of Lake Tarawera. Such floating nests are susceptible to damage from large waves.

in sheltered areas. Their nests (Figure 8) are easily damaged or destroyed by unnaturally large waves. Dabchicks have been reported from the Te Arai lakes (Robertson et al. 2007), but the lack of a resident population on Lake Tomarata may reflect power-boat disturbance as they are widespread in similar dune lake habitats in Northland (Wells and Champion, 2015).
