# Waiuku Estuary: Aquatic Environment Information Review

Technical Report TR2014/003

Mills, G. (2014). Waiuku Estuary: Aquatic environment information review. Prepared by Diffuse Sources Limited for Auckland Council. Auckland Council technical report, TR2014/003.

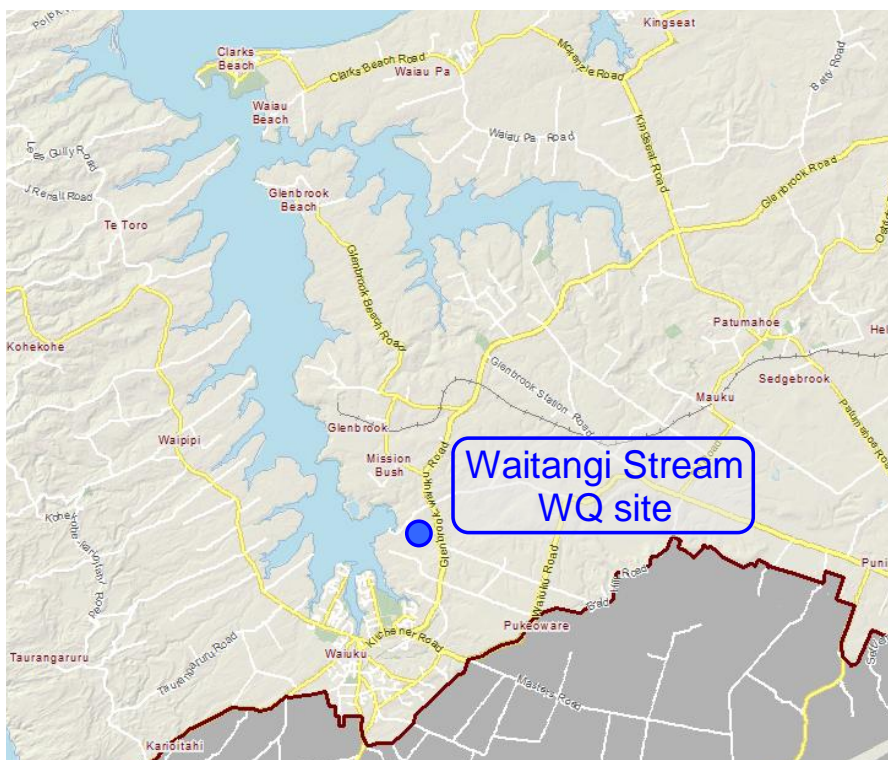
Figure 3-1 Location of the Auckland Council Waitangi River water quality monitoring site

There is no known long term freshwater monitoring data for any of the major freshwater inflows into the Waiuku Estuary. However, a relatively new Auckland Council monitoring site on the Waitangi River (Figure 3-1) has been sampled, at monthly intervals, since January 2009. Data have been reported in Lockie and Neale (2012 & 2013). The information summarised in section 3.2.1 has been drawn from these reports.

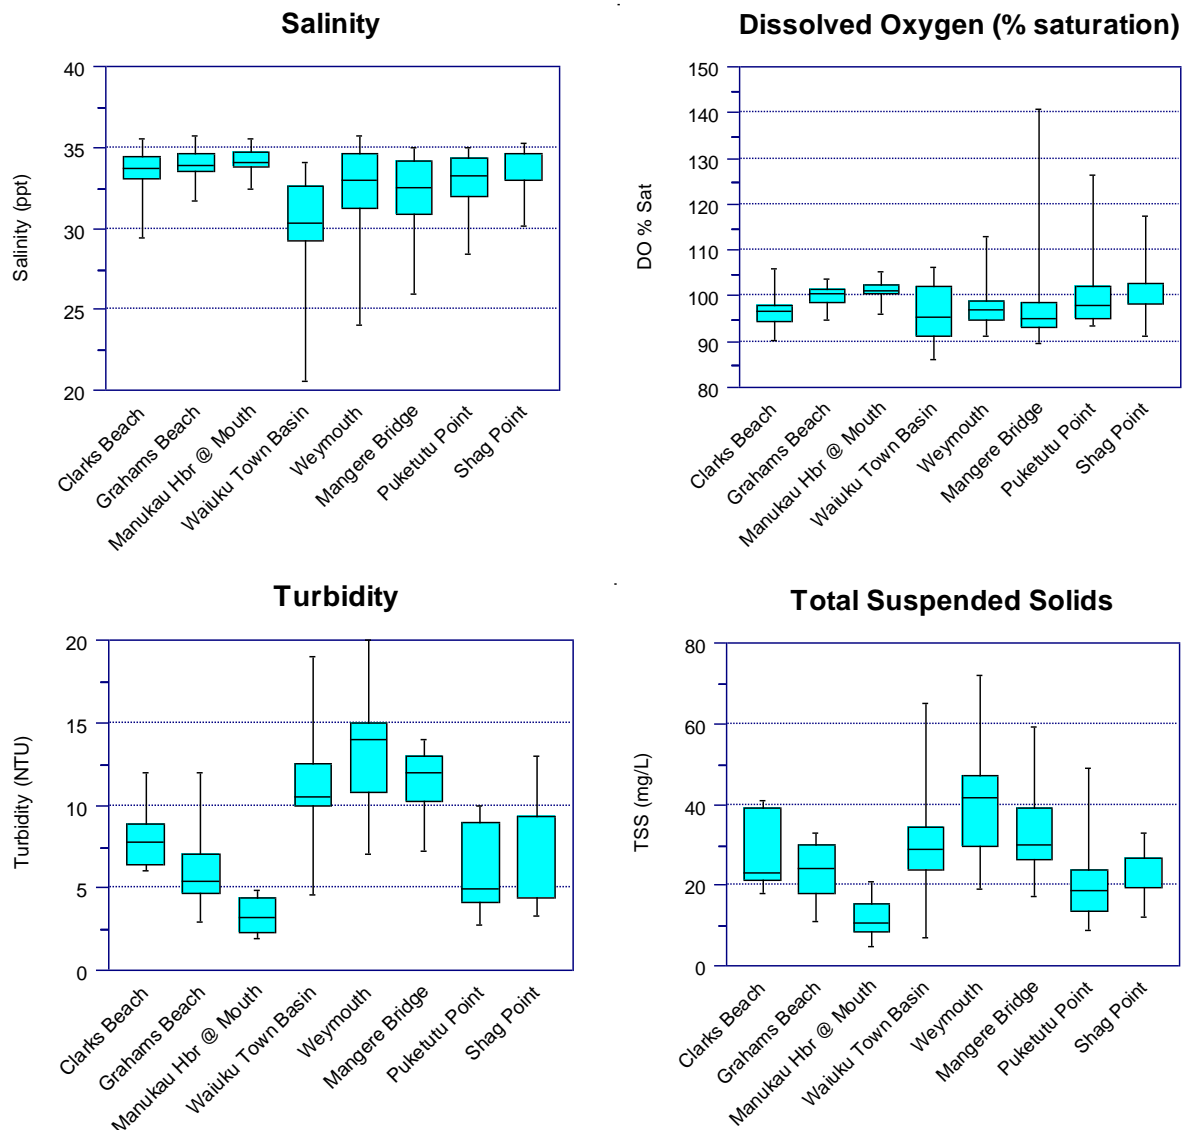
Figure 4-2 Comparison of Manukau Harbour saline water quality monitoring sites.

Data are from the Auckland Council water quality database, for the period 1st August 2012 to 24th May 2013 (the total monitoring period for the Waiuku Town Basin site). Box plots show the range of the data, with the coloured boxes spanning the 25%-ile and 75%-ile of the data, with the median crossing the box.

Water quality characteristics are shown graphically in Figure 4-2 and Figure 4-3, which plot the results for nine key water quality parameters at the 8 monitoring sites in the Manukau Harbour (including the Waiuku Town Basin and Clarks Beach sites). To ensure direct comparability across the sites, the data used for this assessment was for the period 1st August 2012 to 24th May 2013 (10 monthly samples), which is the monitoring period for Waiuku Town Basin site.

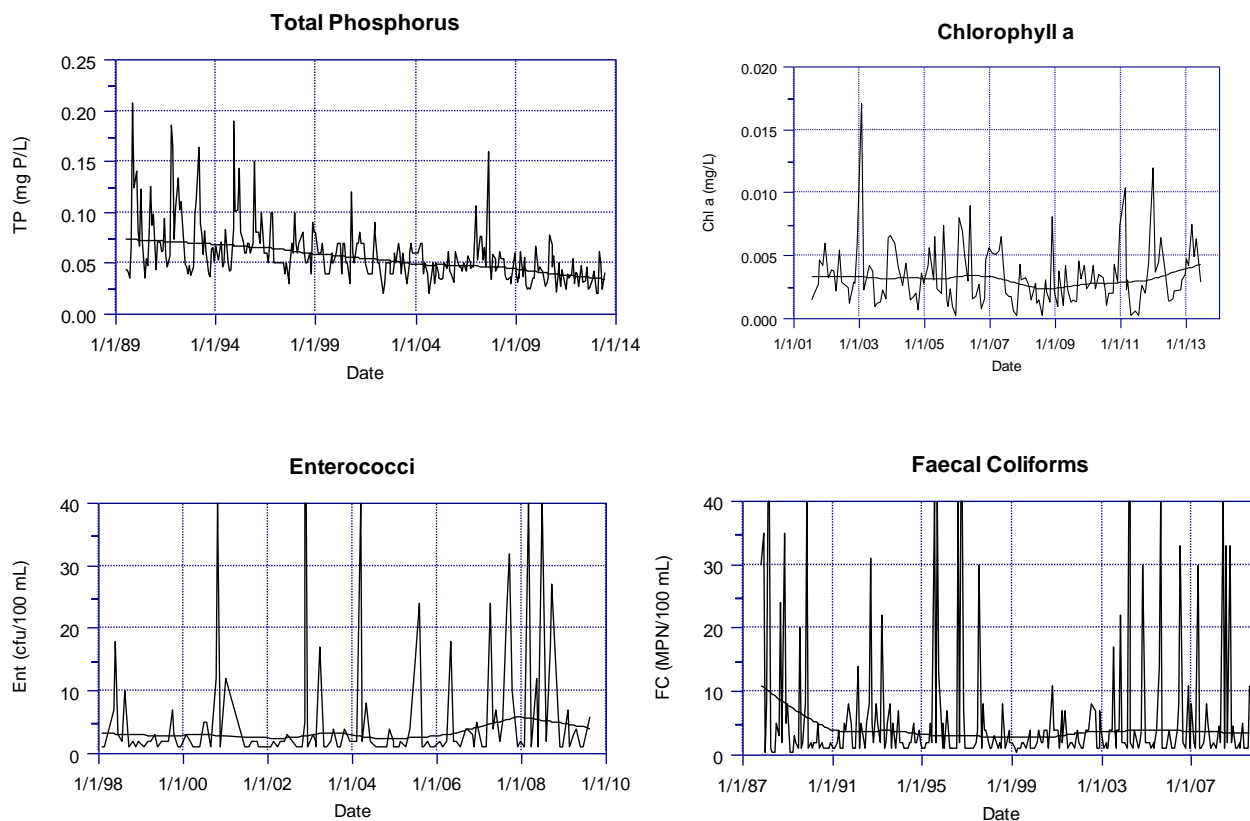
Figure 4-5 Water quality trend plots for Clarks Beach monitoring site (continued). The line of best fit is a LOWESS (30% smoothing span, TimeTrends software).

Examination of the plots shown in Figure 4-4 and Figure 4-5 reveals that the data show a high degree of temporal variability, reflecting the effects of short term episodic events (e.g. rainfall and storms), regular seasonal patterns, longer-term variations due to factors such as the El Niño–Southern Oscillation, and major changes in land use or point source discharges (e.g. for the Manukau Harbour, the upgrade of the Mangere WWTP in the early-mid 2000s). While the overall trend may be a decrease, there may be periods within the long term trend record where increases occur. The results from trend analysis are therefore very much dependent on the period examined.

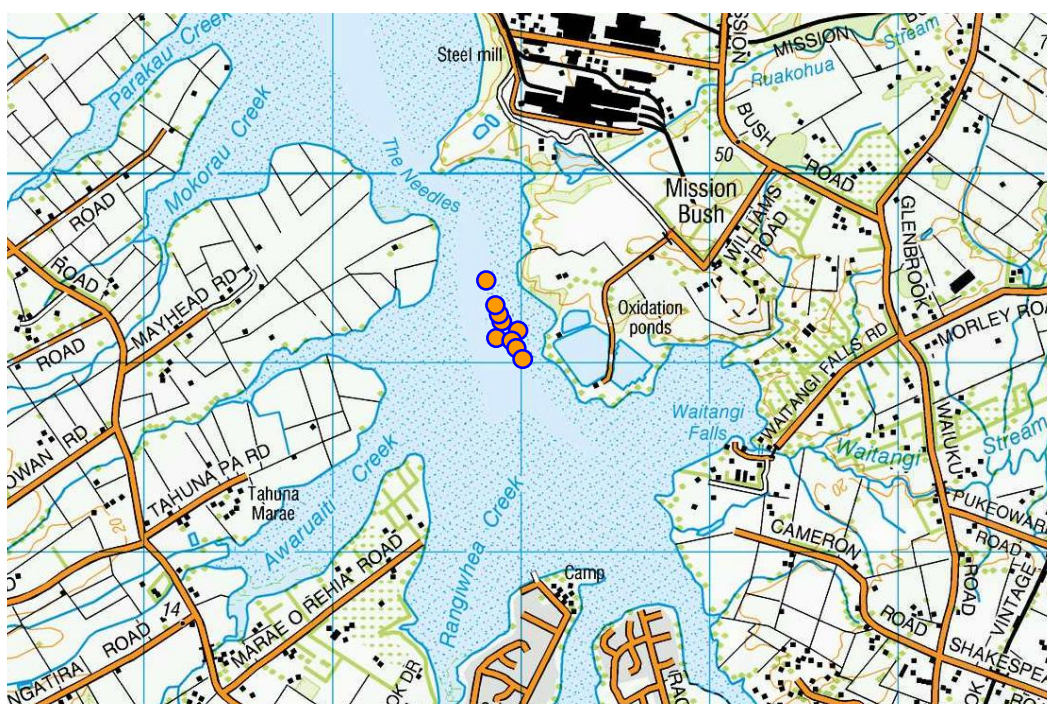
Figure 5-3 Sediment sampling locations used in the Waiuku WWTP effects investigation. Locations are indicative only, based on general descriptions given in Bioresearches (2007b).

The exact sample locations were not given (or shown) in the Bioresearches (2007b) report, but the descriptions (as given above) are sufficiently accurate for the data summary presented here.

Approximate locations, as inferred from the descriptions, are shown in Figure 5-3.

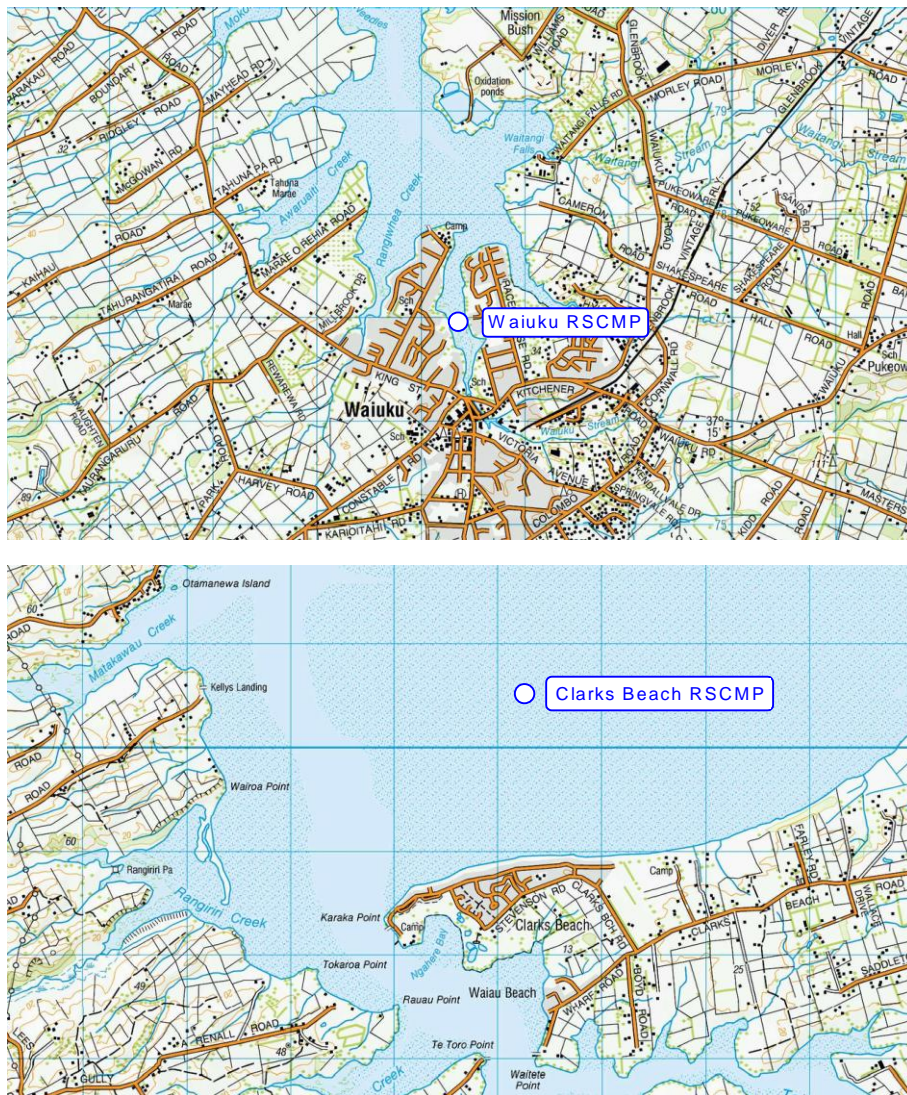
Figure 5-4 Locations of the Waiuku and Clarks Beach regional sediment chemistry monitoring programme (RSCMP) sites.

- The Clarks Beach site, located approximately 1.5 km offshore from the beach, on a large exposed intertidal sand flat in the Manukau Harbour. This OZ site has been sampled once, in 2002, as part of the former Regional Discharges Project (RDP).

Site locations are shown in Figure 5-4.

These sites were sampled using the ARC blueprint protocol. Samples were analysed for Cu, Pb, and Zn (extractable and total recoverable metals; 3 replicates per site), and sediment texture (1 composite sample per site).

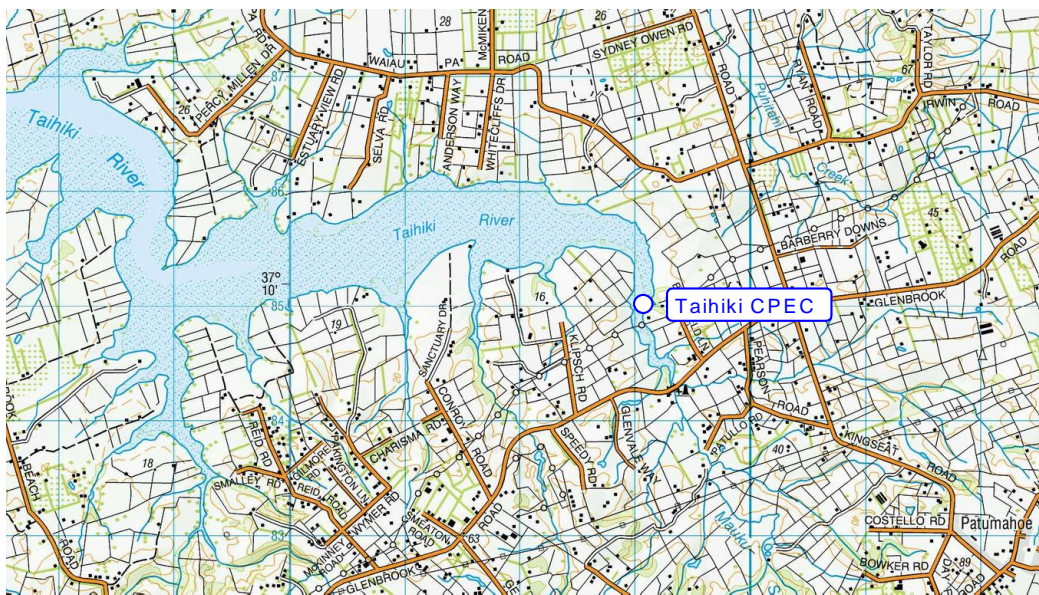
Figure 5-5 Location of the site sampled in 2008 for analysis of emerging contaminants (Stewart et al. 2009, Stewart 2013).

One of the sites was located in the upper reaches of the Taihiki Estuary (Figure 5-5). The upstream catchment is predominantly rural (agriculture and horticulture), and is drained by the Mauku Stream. The sediment here is muddy.

contamination sources, including wastewater discharges, stormwater runoff, historical landfills, and marinas. A site in the headwaters of the Taihiki River estuary was also included (Figure 5-5). The primary influence on this site is agricultural catchment runoff.

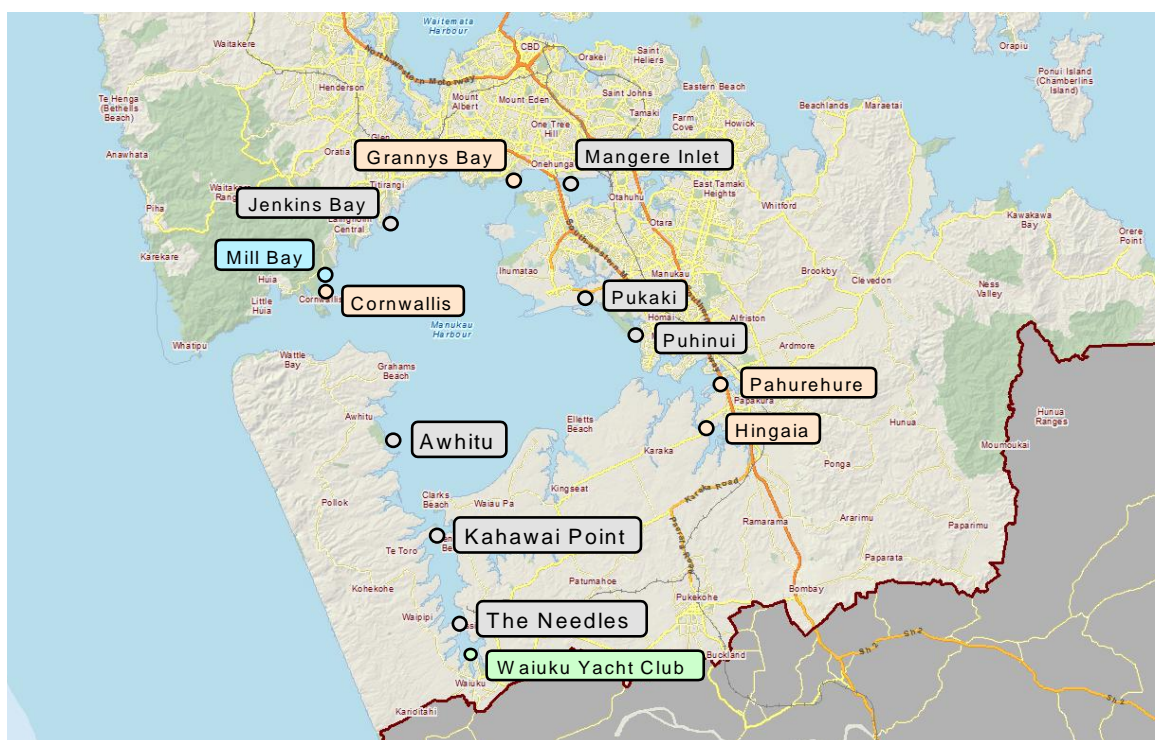
Figure 6-1 Location of regional shellfish (oyster) contaminant monitoring sites in the Manukau Harbour. Tan sites are those monitored for the entire programme (1987 to present), grey sites monitored in 1987–1991, Waiuku Yacht Club site monitored once in 1988. The Mill Bay site was first sampled in 2009.

Three sites in the Waiuku Estuary were monitored (Figure 6-1). In order of increasing distance down the estuary, these were:

- Waiuku Yacht Club, which according to ARWB (1990) was located on a large mud-flat between the camping ground and the point at the end of Racecourse Rd. Influences here are mainly stormwater runoff from Waiuku township. This site was only sampled once, in November 1988. Insufficient oysters were available for sampling after this.
- The Needles – this site is located downstream of the Waiuku WWTP discharge, and in the immediate vicinity of the NZ Steel Southside outfall (the site is essentially in the same location as the NZ Steel monitoring site “S5”).
- Kahawai Point, a popular recreational area, approximately 6 km downstream from the Needles site.

The closest Manukau Harbour site to the mouth of the Waiuku Estuary is Awhitu, located in the Regional Park approximately 4 km north of the estuary mouth. It is subject to rural runoff, but is remote from other contaminant sources.

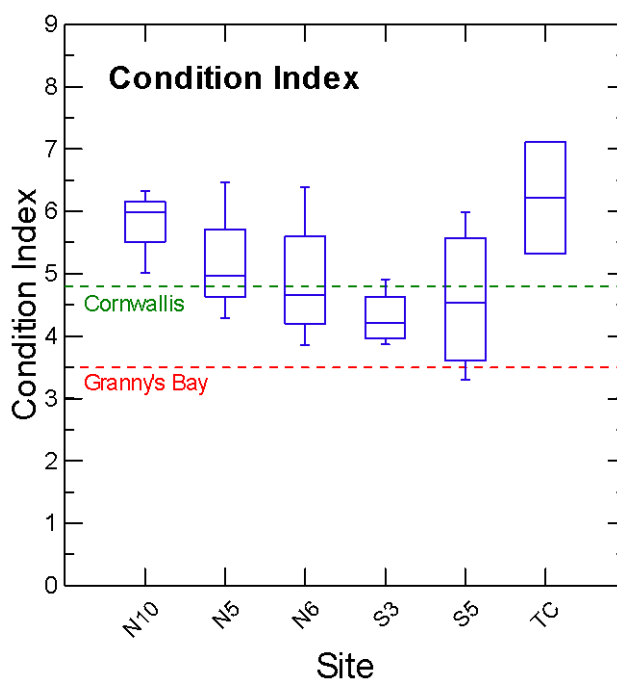
Figure 6-6 Oyster condition at NZ Steel monitoring sites compared with the worst (Granny’s Bay) and best (Cornwallis) sites in the AC Manukau Harbour shellfish contaminant monitoring programme (SCMP). Data are for the 2009–11 period. SCMP condition index values are estimates from visual inspection of Figure 4-1 of Stewart et al. (2013).

Compared with the Manukau Harbour SCMP sites, all NZ Steel sites are better than the “worst” Manukau site (Granny’s Bay), and apart from S3 are comparable or better than the “best” SCMP site (Cornwallis).

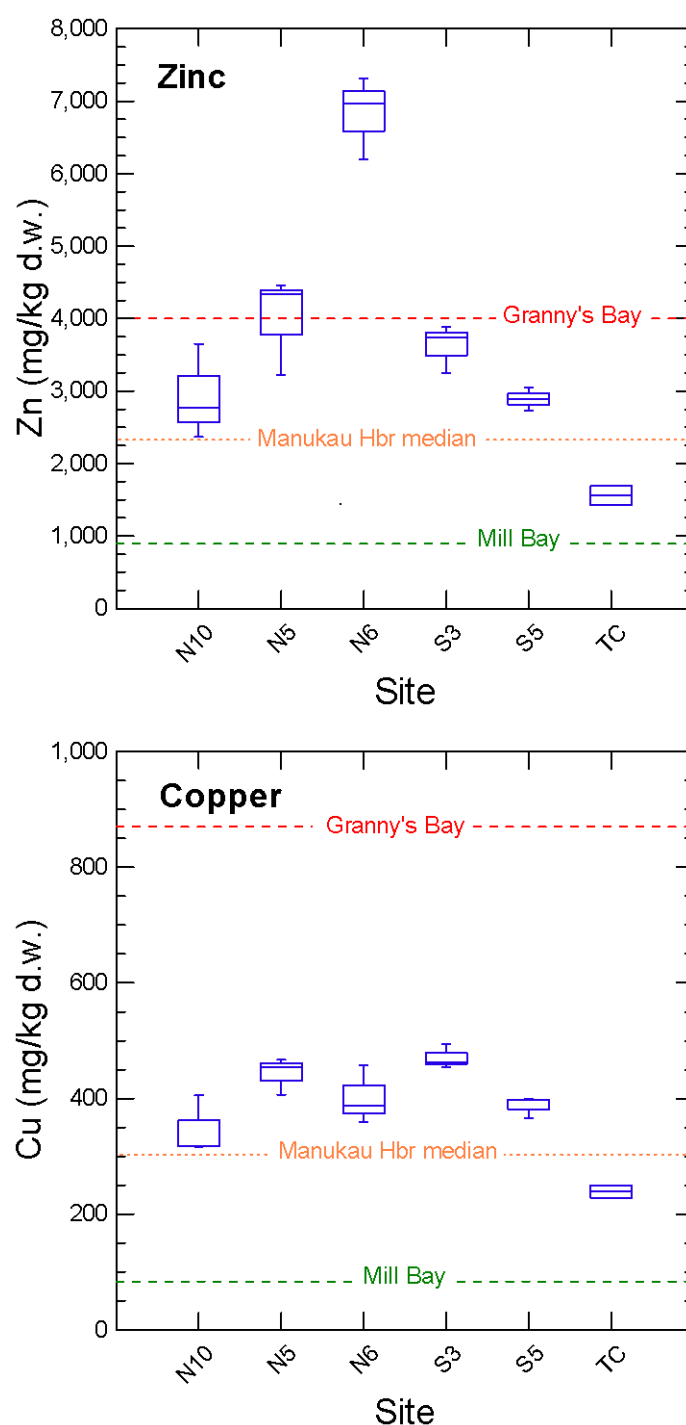
Figure 6-8 Copper and zinc concentrations in oysters at NZ Steel monitoring sites compared with the worst (Granny's Bay) and best (Mill Bay) sites in the AC Manukau Harbour shellfish contaminant monitoring programme (SCMP). Data are for the 2009–11 period. SCMP values are from Table 6-1 of Stewart et al. (2013).

Copper effects are not so great as those observed for Zn. Copper concentrations were generally similar at N5, N6, S3 (possibly the highest), and S5, which were all higher than at N10.

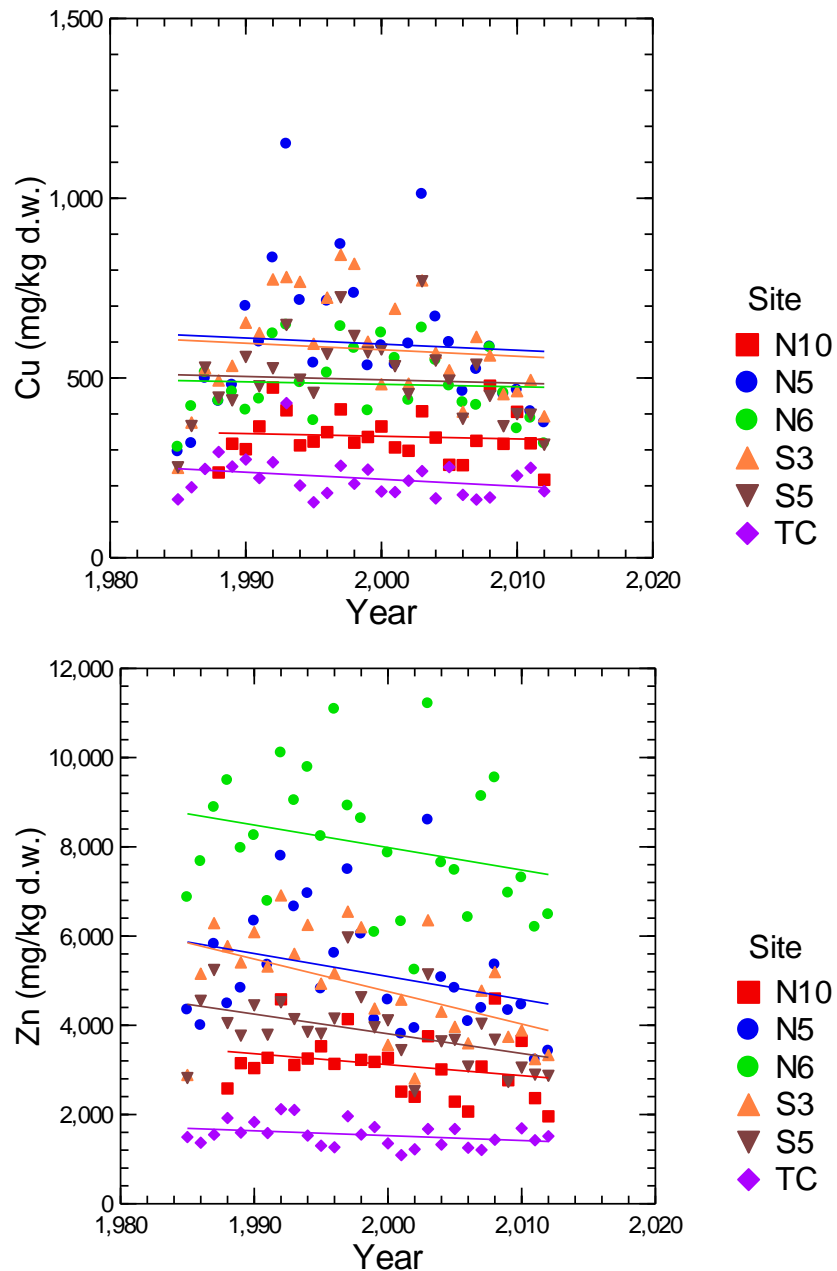
Figure 6-11 Trends in copper and zinc concentrations in oysters at NZ Steel monitoring sites between 1985 and 2011. Data are annual means, as tabulated in Bioresearches (2012).

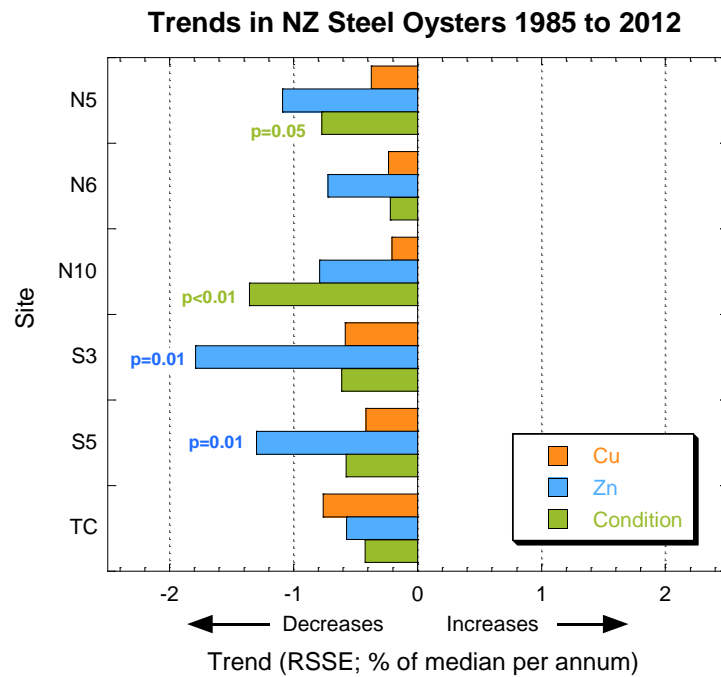
Figure 6-12 Trends, expressed as “Relative Sen Slope Estimators” (RSSE, % of median values per year), for Cu, Zn, and condition in oysters at NZ Steel monitoring sites. “TC” is Taihiki control site. Trend significance is shown above the bars (no values indicate trends are not significant;  $p > 0.05$ ).

Trend analysis (using the Mann Kendall trend test) showed that the overall trend in condition has been a decrease (between -0.2% and -1.4% per year), although these changes are only significant at sites N10 and N5 ( $p \leq 0.05$ ). Mann Kendall trend test results are shown Figure 6-12.
