# South Kaipara Head Hornwort Strategy

Technical Report 2014/027

Wells, R D S (2014). South Kaipara Head hornwort strategy. Prepared by the National Institute of Water and Atmospheric Research, NIWA for Auckland Council. Auckland Council technical report, TR2014/027

Project reference: HSJ14221. Report number: HAM2014-066

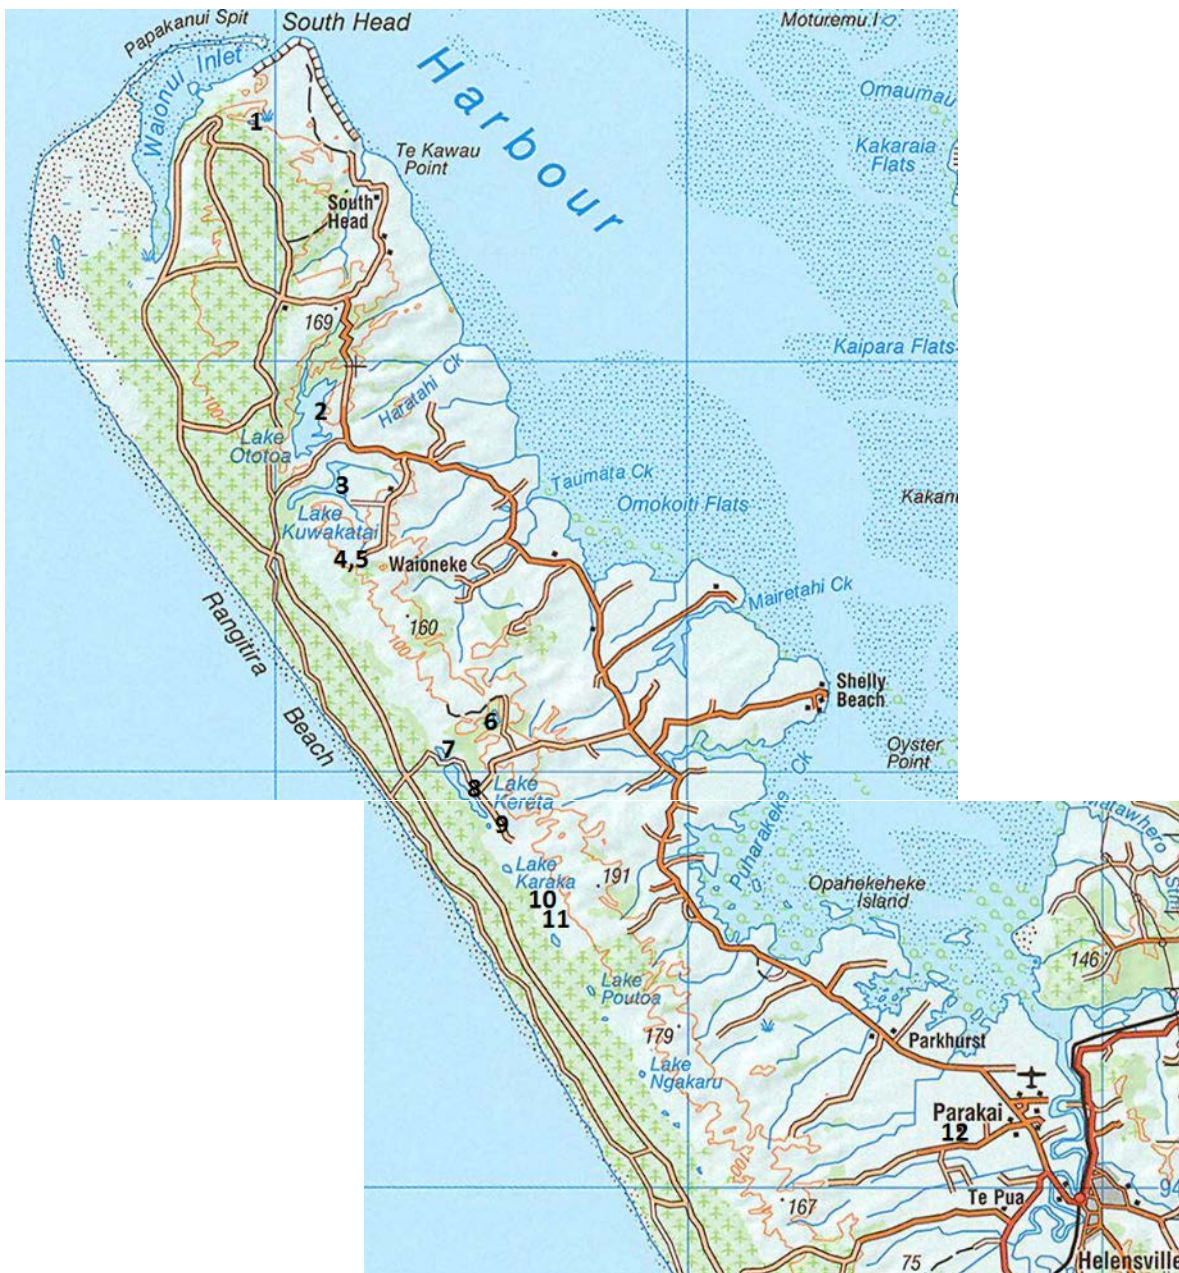
Figure 1 South Kaipara Head showing the location of the 12 sites with hornwort. 1. South Head Lake, 2. Lake Rototoa, 3. Kuwakatai, 4. Fuller Road Lake middle, 5. Fuller Road south, 6. Te Kanae, 7. North Kereta, 8. Kereta, 9. South Kereta, 10. Lake Karaka South One A 11. Lake Karaka South One B (Jenny Bright's front pond), 12. Fordyce Road, Nursery Pond.

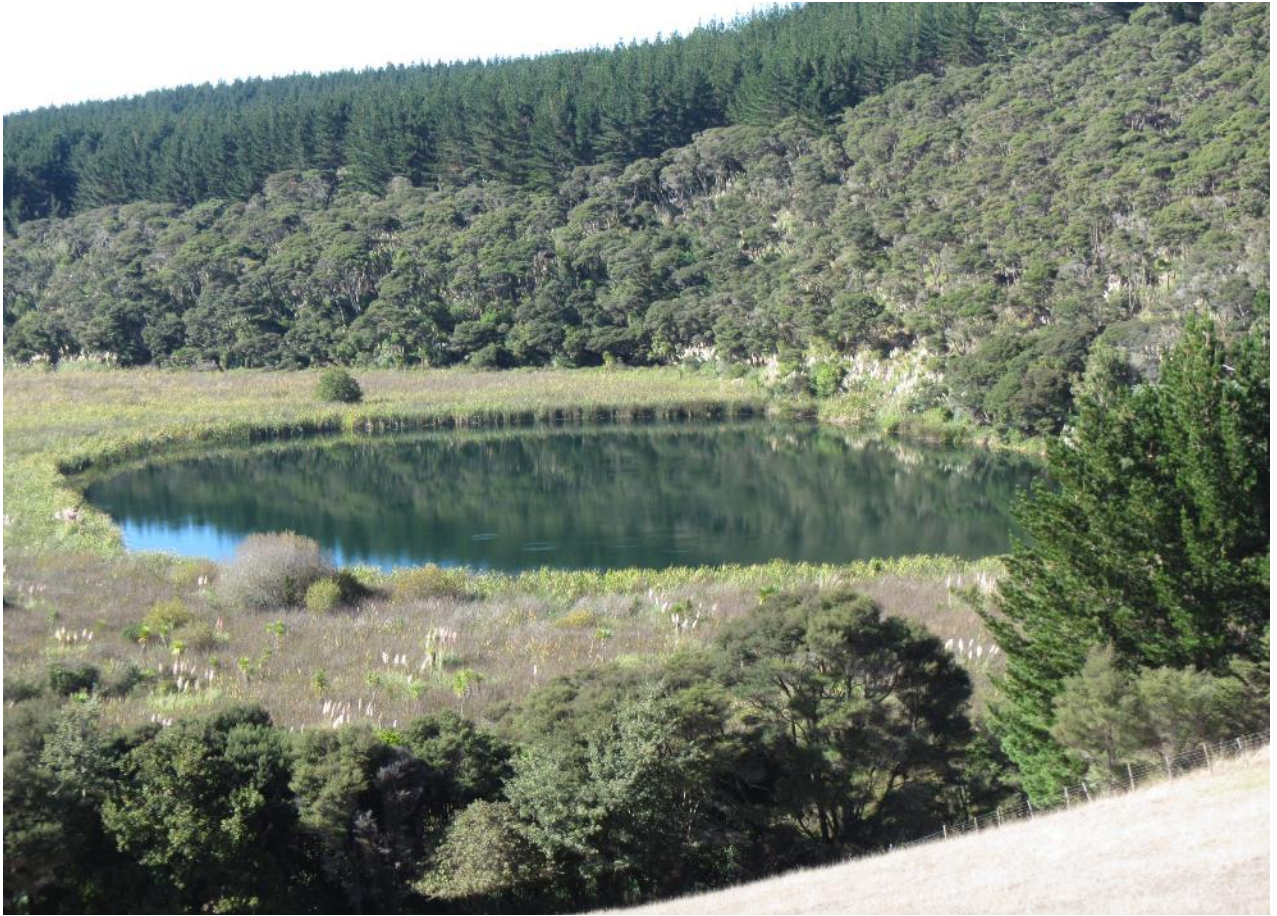
Figure 2 South Head Lake located at the top of the South Kaipara Head.

South Kaipara Head Lake is 157m by 108m (1.7ha). Lake access was through private land requiring 4WD and then wading through a raupo (*Typha orientalis*) swamp. The lake was dived and found to be dominated by hornwort up to 4m tall with 100% cover to 6m deep and 10 – 20 per cent cover across the middle of the lake to its maximum depth of 7.5m. No other submerged species were noted and water clarity was high with the in-water visibility about 5m. The lake was fringed with a wetland of mainly raupo.

Endothall would have a good chance of eradicating hornwort in this lake as the lake is relatively small (1.7 ha) and does not have any defined outlet or inflow. Endothall would be the preferred option but if it was not successful then grass carp would be.

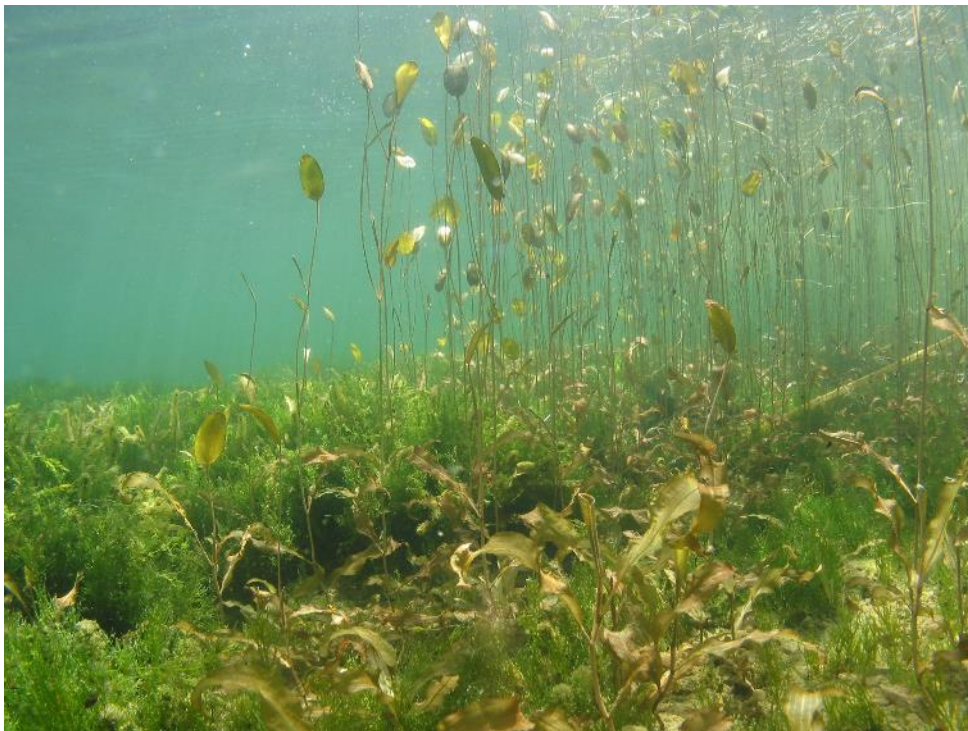
The native vegetation is well developed with a diverse range of species (Figure 3) and charophyte meadows recorded to 11.7m depth (Wells 2009). Emergents, native turf species and pondweeds are present. The invasive bladderwort, *Utricularia gibba* is also present, but is mostly restricted to shallow water ( $\leq 1.6$  m). Hornwort is present throughout the lake and may become the dominant plant.

Figure 3 Lake Rototoa (Ototoa) has a highly diverse native vegetation growing to in excess of 10m deep. Tall growing pondweed (*Potamogeton cheesemani*) is shown amongst a species rich charophyte meadow.

When hornwort was first found in the lake it was thought to be confined to the North Arm. The arm was netted off to contain the hornwort and attempts made to eradicate it with endothall. There were however difficulties in killing hornwort plants in an area influenced by a stream inflowing to the lake. It is thought the inflow diluted the endothall before the

target weed could receive a lethal dose. Later it became apparent that hornwort was present outside the arm and it has subsequently spread around the lake and threatens the highly diverse native plant communities in the lake. Eradication with endothall is not thought to be possible now. Grass carp could eradicate hornwort but would also remove the native species for as long as grass carp remained in the lake. However, the native species would be expected to re-establish (post grass carp) from seed or oospores present in the lake sediments. The decision to use grass carp would be more acceptable when hornwort has taken over and lake biodiversity is poor. In the meantime diquat could be used to slow down the hornwort invasion, but is not expected to eradicate the weed.

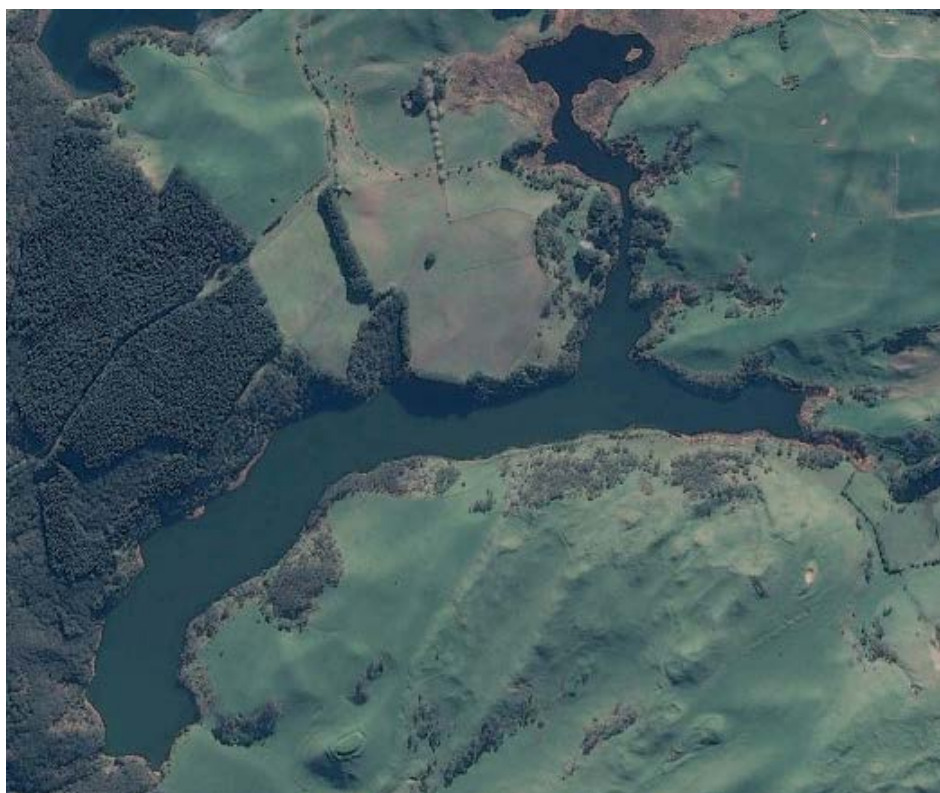
Figure 4 Lake Kuwakatai aerial photograph.

Lake Kuwakatai is reported to be from 28 to 36ha in size and has a maximum depth of 15m. Access is through private land and requires 4WD to launch a boat from the southern end. In 1950, native charophytes were recorded to 4m depth (Cunningham et al. 1953). Beds of hornwort now extend as complete cover from the lake edge down to between 5 and 7.5m depth. Weed bed heights are commonly 4.5m and are surface-reaching in

This lake is too large for endothall to be a practical option. Grass carp are recommended and will impact little on the native biodiversity as hornwort has almost completely taken over. The top of the northern arm (Figure 4) may need endothall if the grass carp avoid this shallow area. The inflows should also be checked for hornwort. Diquat should be used to reduce hornwort biomass prior to grass carp release.

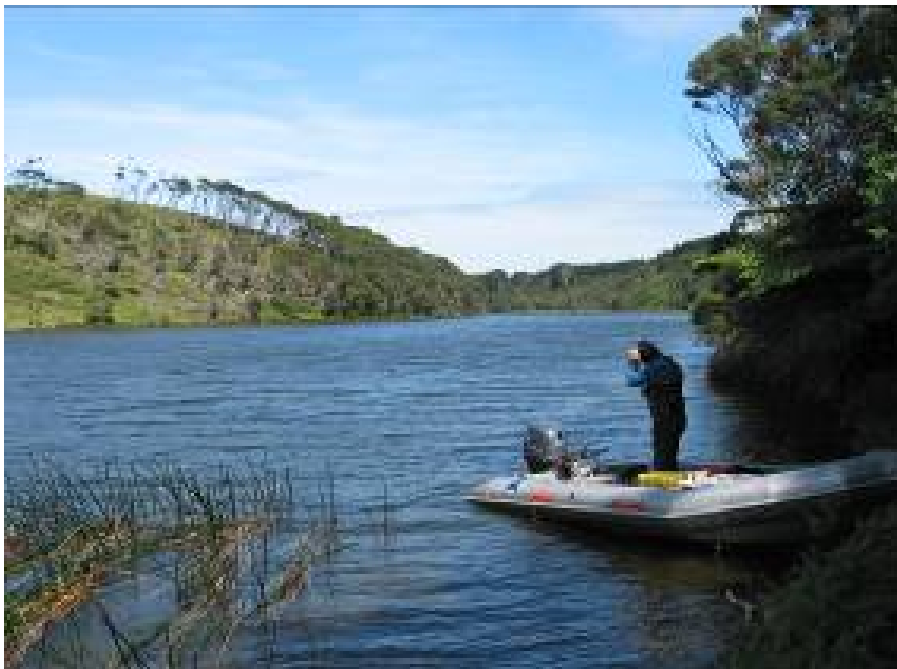
shallow areas. Only one native submerged plant, *Myriophyllum triphyllum* was recorded but was not common. Emergent marginal plants were well developed along the northern and eastern shorelines and scattered along the southern shoreline (Figure 5).

Figure 5 Lake Kuwakatai with some emergent *Eleocharis sphacelata* in the foreground.

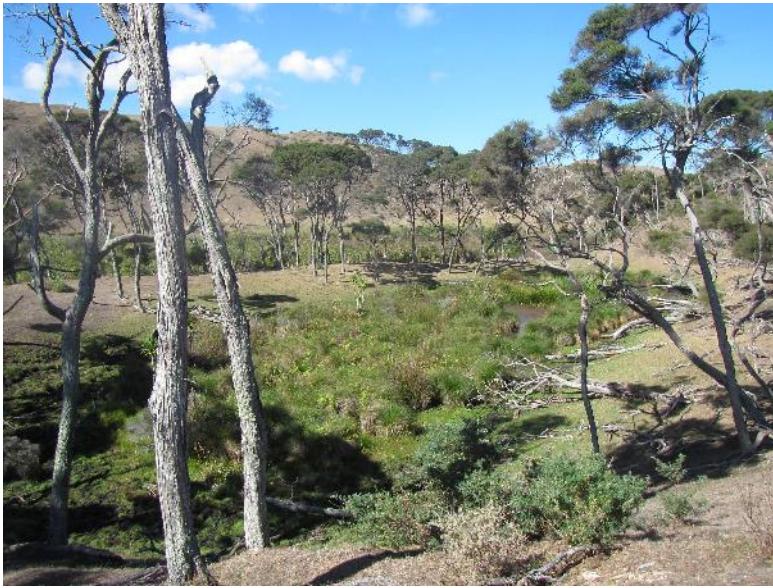
Figure 6 Fuller Road lake middle was mostly full of emergent *Carex secta*.

This is a small wetland about 0.03ha (300m<sup>2</sup>) in size (Figure 6) and is accessible across farmland with a 4 WD. It had little water in it and several patches of hornwort (the only submerged species present) in very shallow water or damp ground (Figure 7). Other species present were *Azolla pinnata*, *Persicaria decipiens*, *Ludwigia palustris*, duckweeds, *Typha orientalis*, *Eleocharis sphacelata*, *Myriophyllum propinquum* and *Baumea* spp.

This site would be unsuitable for grass carp as it is too shallow. It could be easily controlled with a small amount of endothall.

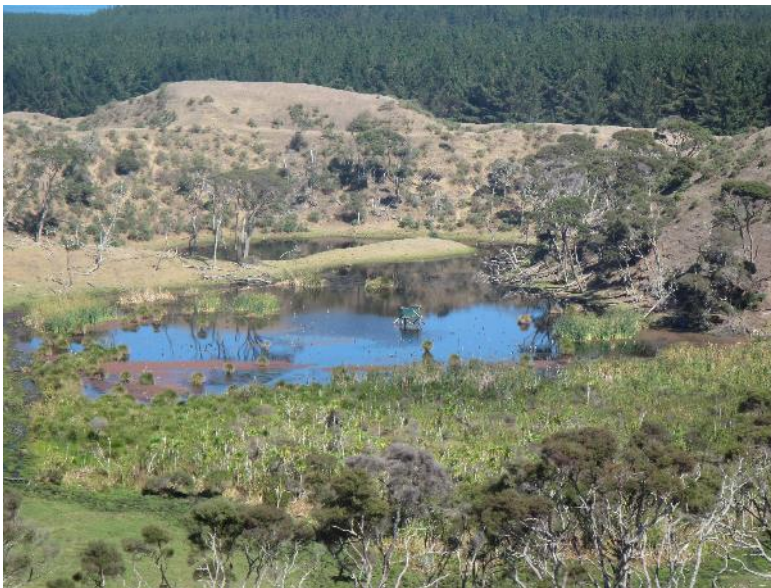
Figure 8 Fuller Road south lake with open water and a 0.6ha wetland in the foreground.

The open water area is about 0.7ha and there is about 0.6ha of wetland (Figure 8) that appeared not to have any hornwort. The lake is accessible across farmland with a 4 WD and is used for duck shooting. The lake appears to be very shallow about 1m deep. Hornwort was the only submerged plant seen from a walk around the margin and there was *Azolla pinnata* floating on the surface giving the red colour in Figure 8.

Endothall is the recommended control option for hornwort as this lake is too shallow for grass carp (much <0.5 m). A close examination of the wetland will be needed to locate any pools that might harbor hornwort.

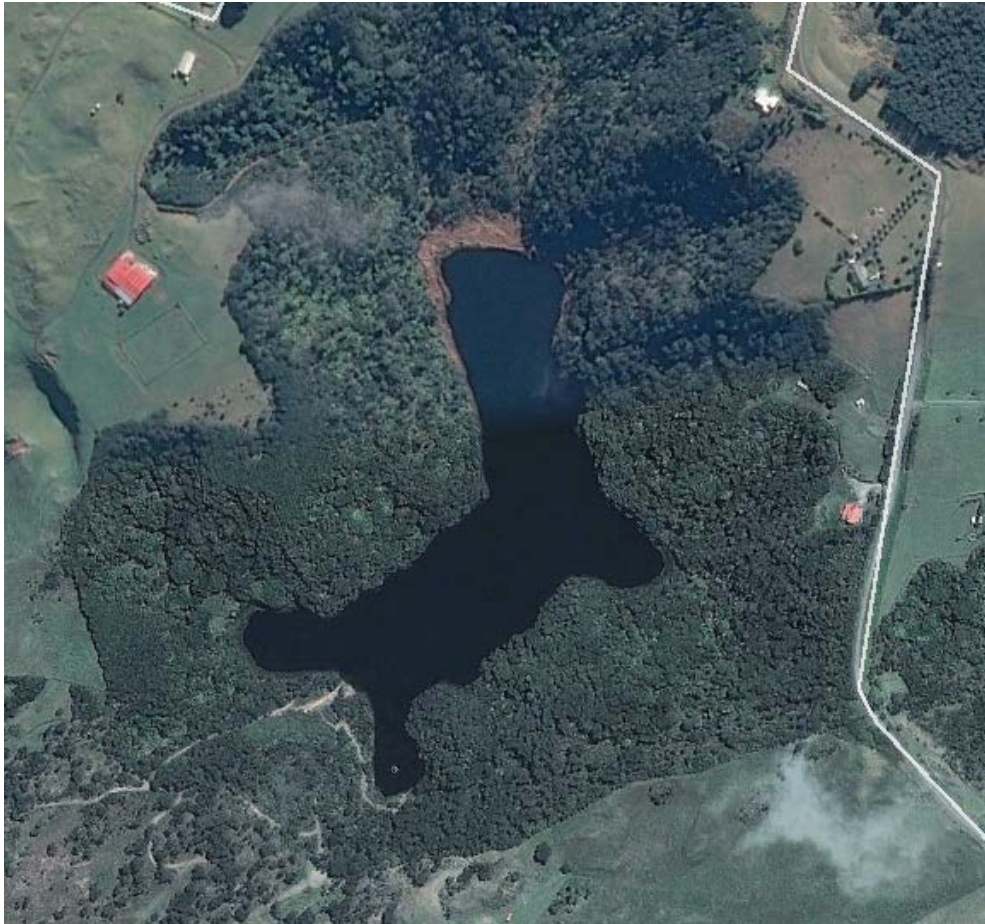
Figure 9 Lake Te Kanae is surrounded by trees but is accessible by a 4WD track visible at the south east end.

Lake Te Kanae is 5.6ha and is steep sided with a maximum depth of 18m. It is surrounded by trees but is accessible by a 4WD track at the south east end (Figure 9). Hornwort formed beds up to 3m in height extending from the margin of emergent plants to a maximum of 6.6m depth. The only other submerged plants seen were a native milfoil and fragments of the invasive bladderwort *Utricularia gibba* at one of five dive locations. Koi, rudd and tench (*Tinca tinca*) have been liberated to the lake (Grant Leighton, landowner,

It might be possible to eradicate hornwort with endothall in this lake but that would be uncertain and would be expensive. There is a large volume of water in the lake and fragments were seen to 12m deep. Grass carp are recommended as they would eradicate the hornwort and the lake is of low biodiversity value in its present condition.

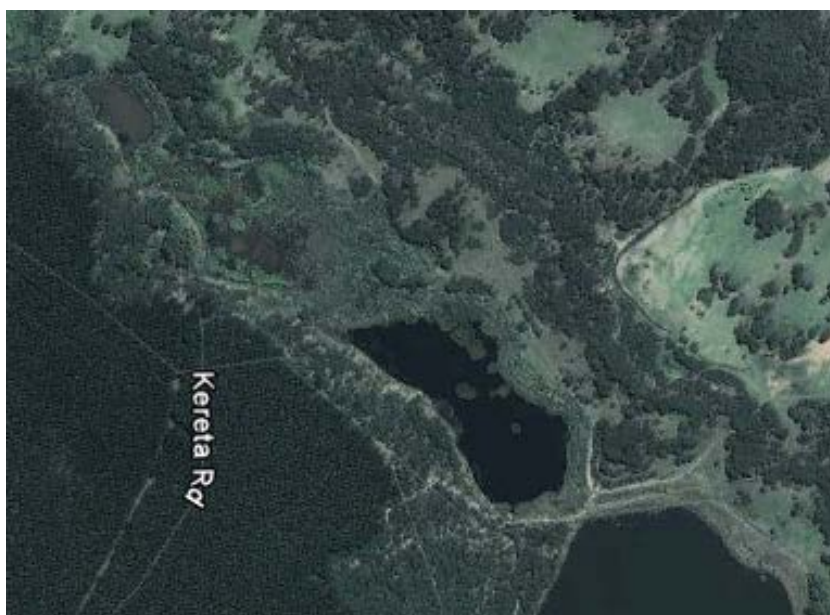
Figure 10 North Kereta.

There is a lake north of Lake Kereta (Figure 10 and Figure 13). North Kereta is about 2.8ha and is likely to be < 2m deep if it is similar to Lake Kereta. It is fringed with a wetland and access was difficult. We walked to the south end of the lake from Lake Kereta in 2012 and confirmed it had dense hornwort and relatively clear water.

North Kereta needs to be looked at more closely but it is likely hornwort could be eradicated with either endothall or grass carp. The endothall option is recommended first.

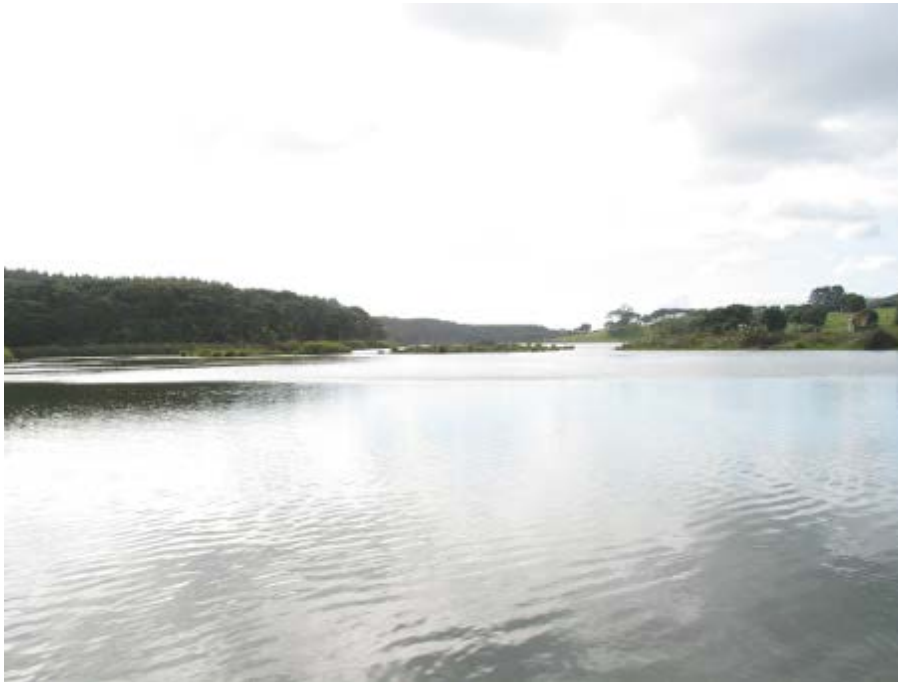
Figure 12 Lake Kereta.

Lake Kereta is a narrow lake (Figure 12) 1.66km long and 23.6ha in area. It has a maximum depth of 2.3m. The lake is easily accessible with the road running alongside its southern basin (Figure 13), however the only boat ramp is on private land in the north basin which is used for water skiing.

Grass carp (*Ctenopharyngodon idella*) were stocked in Lake Kereta in 2008 and 2009 to improve amenity values of the lake. By the 2012, nearly all the hornwort was gone with only a few plants found amongst dense stems of marginal emergent beds of *Zizania latifolia*.

Grass carp have already been introduced to the lake and may have eradicated the hornwort already. The fish may be left in the lake to maintain its amenity value for skiing and prevention of re-establishment.

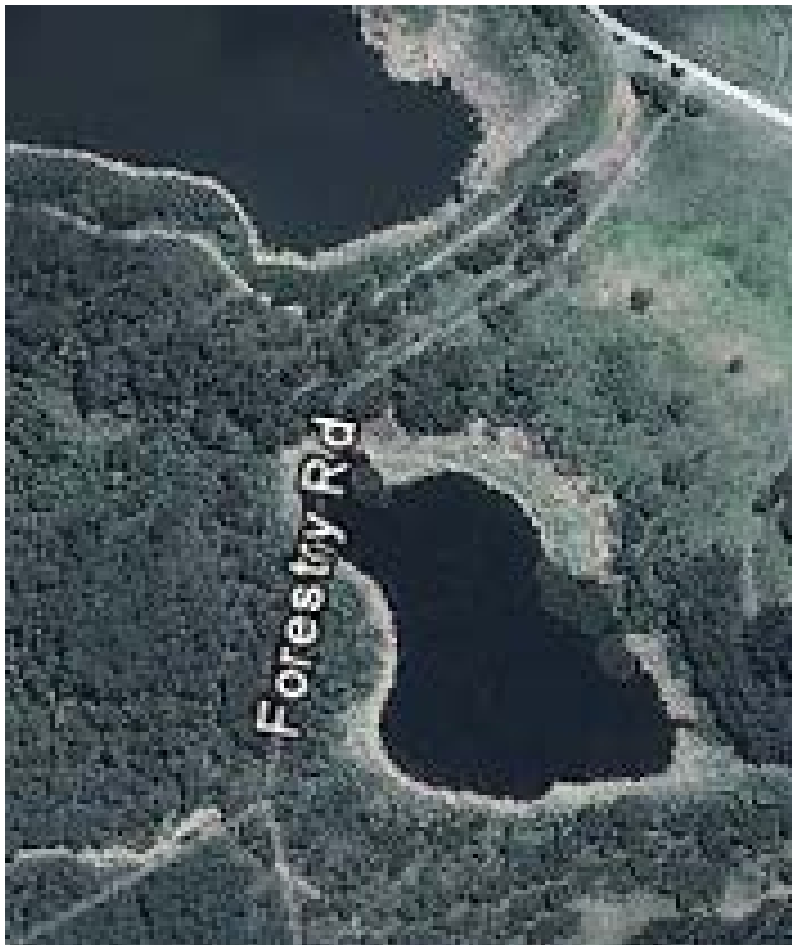
Figure 14 South Kereta aerial view.

South Kereta is an unnamed water body south of Lake Kereta (Figure 13 and Figure 14). It is about 0.7ha and shallow (<1 m). Hornwort was growing in patches in the lake with an overall cover of about 10% and no other submerged species other than the invasive bladderwort *Utricularia gibba* were noted. The lake was surrounded by the invasive tall grass Manchurian wild rice (*Zizania latifolia*) and some *Eleocharis sphacelata*. As in Lake Kereta the Manchurian wild rice is the target of an eradication program.

Endothall would be the most suitable option in this lake.

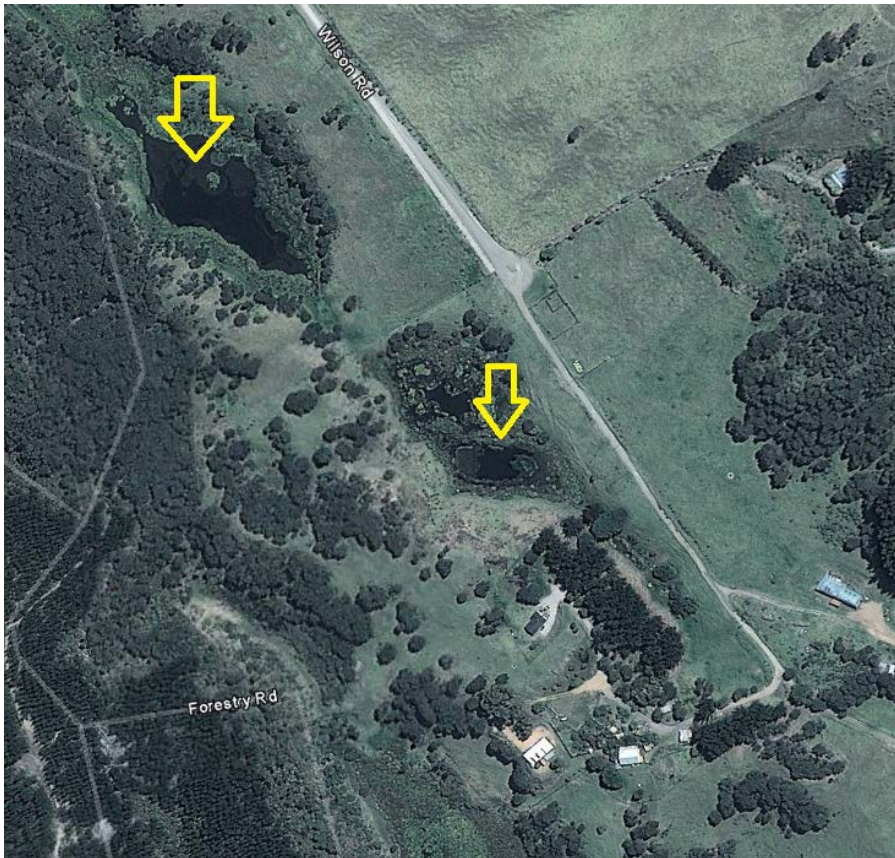
Figure 15 Lake Karaka South One A (TOP arrow) and Lake Karaka South One B (LOWER arrow).

The lake is 176m x 67m (at its longest and widest) and has an estimated area of 0.47ha and an average depth <2m. The lake was accessed by walking across farmland from Wilson Road (Figure 15). Hornwort was the only submerged plant recorded. *Azolla pinnata* was also prominent covering about 30% of the lake and there was a clearly defined margin to the lake fringed with abundant *Isolepis prolifera* and *Eleocharis sphacelata*.

Endothall would be the most suitable option for this lake with large areas too shallow for grass carp.

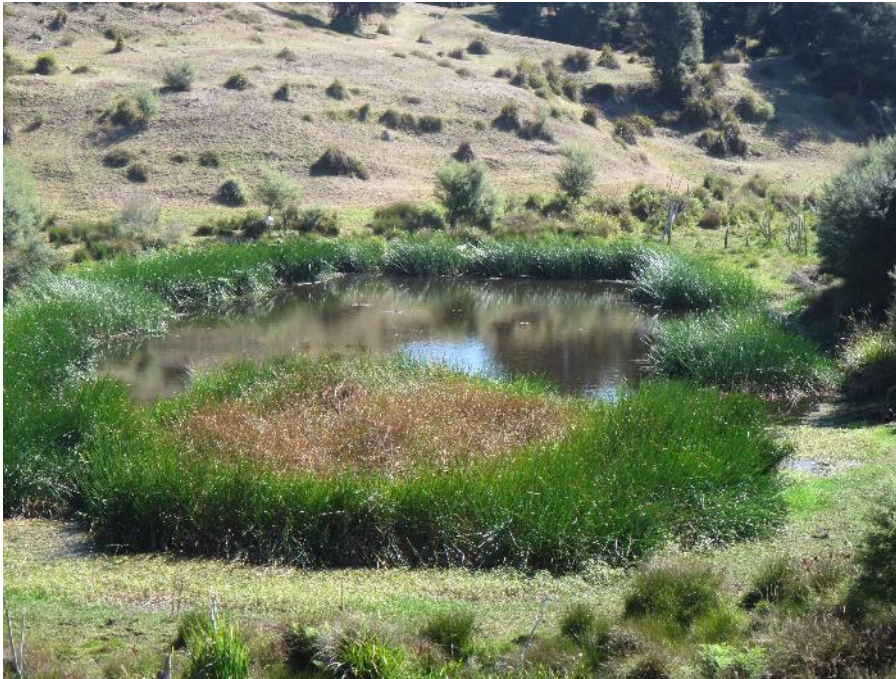
Figure 16 Lake Karaka South One B (Jenny Bright's front pond).

The lake / pond is about 55m x 25m or 0.14ha in size. The pond is located close to Wilson Road and was reached on foot. Hornwort was prevalent in the pond. The native emergent *Eleocharis sphacelata* mostly encircled the pond and also present was the invasive *Ludwigia peploides*.

Endothall or grass carp would eradicate the hornwort in the pond. Endothall would be the preferred option but the pond is used as a water supply, so more details would need to be considered in consultation with the landowner.

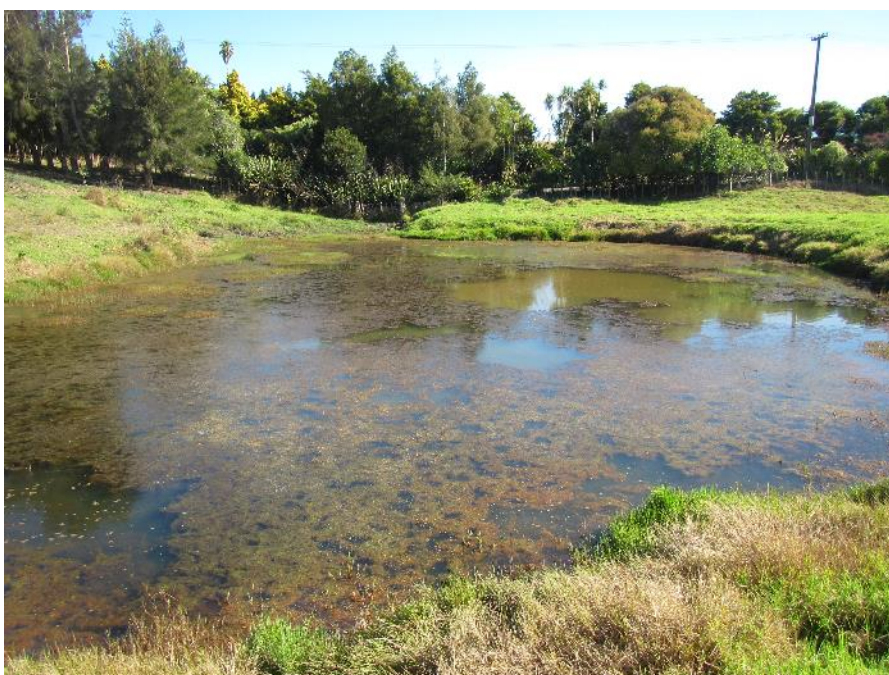
Figure 17 Aerial view of Fordyce Road nursery pond. Yellow arrow locates the pond.

Figure 18 Fordyce Road nursery pond, ground view.

The pond (Figure 17 and Figure 18) is 35m long x 21m wide or about 0.0735ha (735m<sup>2</sup>) in area and about 1m – 2m deep. Hornwort was the only submerged plant seen and grew to the surface over about 90% of the area.

Endothall would be the preferred option in such a small water body.

The Fordyce Road nursery pond is also considered a priority as it is relatively close to an access way and is easily eradicated being a small pond.
