Assessment of Auckland Lakes using LakeSPI

October 2012 Technical Report 2012/034

Auckland Council
Technical Report 2012/034, October 2012

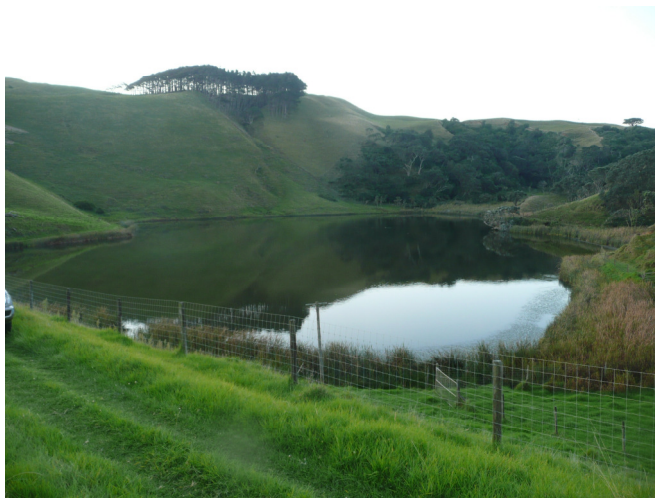
3.6.4 Lake Pehiakura (Big)

Latest assessment:	2012
Lake condition:	Poor
Stability:	Stable
Lake Max Depth (m):	10.7
Lake type:	Dune

LakeSPI scores for the larger Pehiakura Lake were poor, with values of 10% and 14% obtained from surveys in 2012 and 2005 respectively. During both surveys egeria (*Egeria densa*) was the only submerged plant recorded (Invasive Impact Index 89-91%), forming large beds down to around 4 m depth in 2012 and 5 m depth in 2005, and extending from the almost continuous band of emergent plant species around the lake margin.

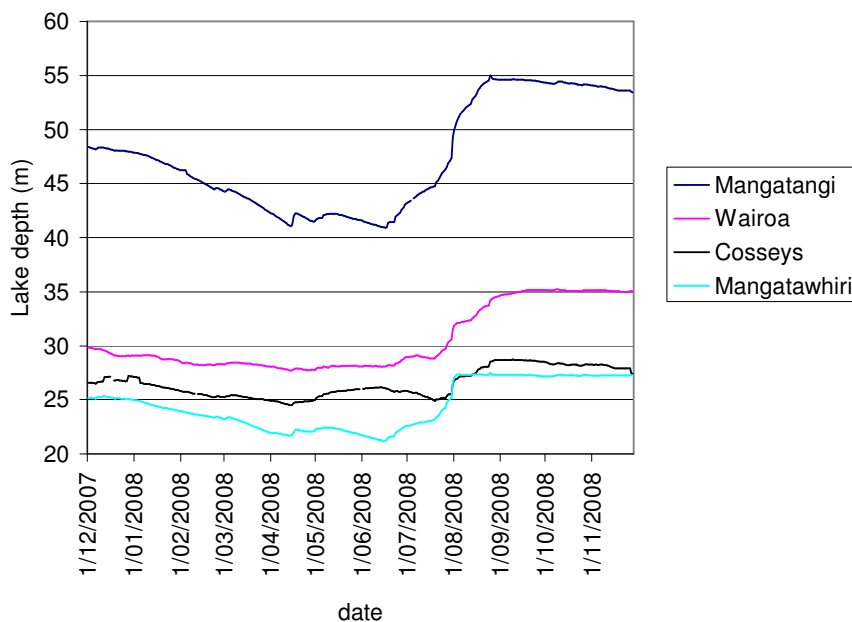
Amplitude of water level fluctuations (m) for the Hunua reservoirs in relation to their depth over the period from 01/12/2007 to 28/11/2008 (Watercare Services Limited data). The LakeSPI survey was in late October 2008.

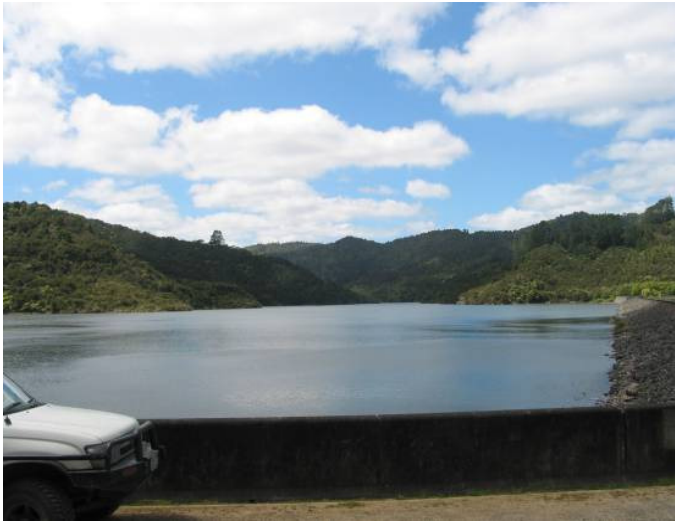
3.7.1 Mangatawhiri Reservoir

Latest assessment:	2008
Lake condition:	Excellent
Stability:	Improving
Lake Max Depth (m):	35.6
Lake type:	Reservoir

The upper Mangatawhiri Reservoir had the highest LakeSPI ranking of the Auckland Region (76%) on account of the depth extent of native charophytes that formed high cover meadows down to 10.4 m depth (Table 28). The shallow edge of these meadows began at 6 m depth, corresponding with the water level rise of 6.3 m recorded prior to the survey. Native milfoils and pondweeds were a minor vegetation component found in shallower depths than the charophyte meadows and no invasive submerged weeds were recorded.

Mangatawhiri Reservoir (Hunua Ranges) was the only lake in the Auckland Region that currently qualifies as having an excellent ecological condition (Table 32). However, it is noted that the LakeSPI indices for this reservoir may be slightly inflated because vegetation might not yet have compensated for water level increases prior to the lake survey. Nevertheless, Mangatawhiri Reservoir would still rank the highest out of all the Auckland lakes assessed with scores only likely to change by $<10\%$ if meaningful adjustments could be made based on the water level change.

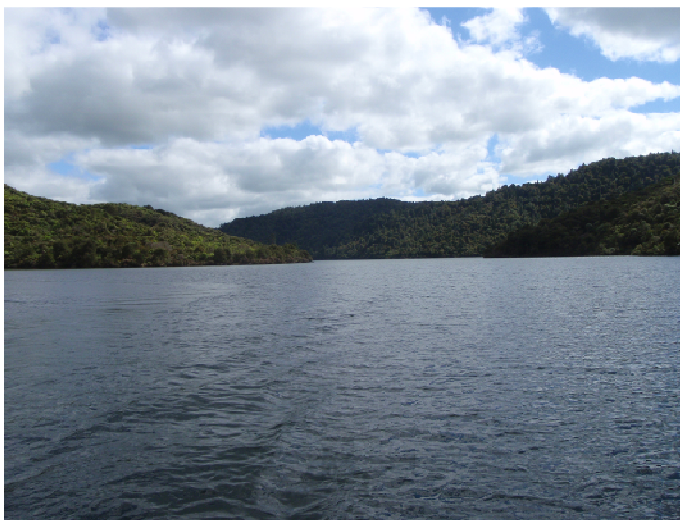
3.7.2 Wairoa Reservoir

Latest assessment:	2008
Lake condition:	High
Stability:	Stable
Lake Max Depth (m):	40.3
Lake type:	Reservoir

A high LakeSPI Index of 66% (Table 29) resulted from the presence of native plant communities growing down to a moderate depth in the absence of any invasive plant species. Beds of native charophytes began at 6.3 to 7.1 m and extended to 8.6 m depth, with occasional plants recorded as deep as 11.7 m. Native milfoils and pondweeds were sometimes present in mid-depths of 3 to 8.2 m and terrestrial vegetation was noted to 4.4 m depth. An increase in water level of 7.5 m prior to the survey would account for the transition from terrestrial to obligatory submerged plants seen between 4.4 and around 7 m depth.

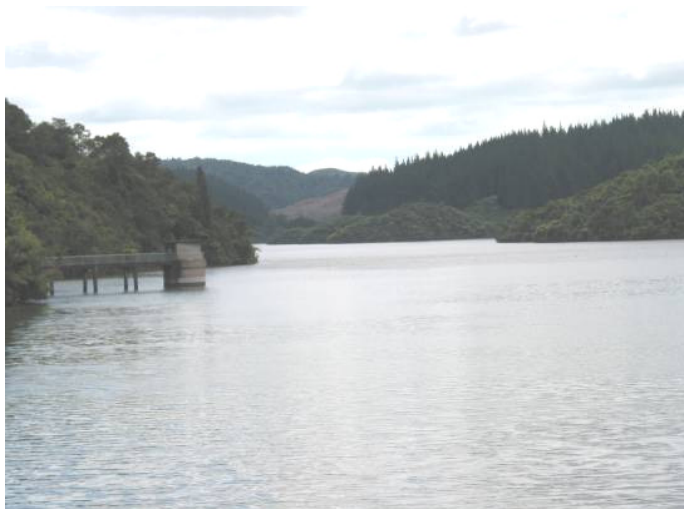
3.7.3 Cossey's Reservoir

Latest assessment:	2008
Lake condition:	Moderate
Stability:	Declining
Lake Max Depth (m):	35.1
Lake type:	Reservoir

The LakeSPI Index of 49% (Table 30) reflected the largely native vegetation character in Cossey's Reservoir that, although it was low in cover and depth extent, had only minimal impact by invasive *Juncus bulbosus*. The sparse submerged vegetation comprised of native charophytes and milfoils while *J. bulbosus* was present at some of the sites. Submerged plants were recorded to 5.6 m depth although most growth was less than 3.3 m, and inundated terrestrial plants were noted to 2.6 m. The water level increase of 4.2 m prior to the 2008 survey was not clearly reflected in the depth distribution of the submerged vegetation.

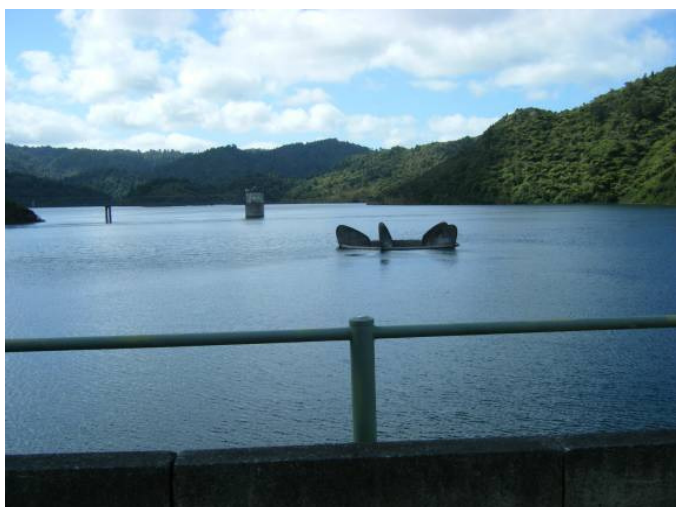
3.7.4 Mangatangi Reservoir

Latest assessment:	2008
Lake condition:	Non-vegetated
Stability:	Declined
Lake Max Depth (m):	54.6
Lake type:	Reservoir

In 2008 small patches of native charophytes were recorded between 13.1 and 15.4 m depth and native milfoils from 6 to 8.5 m. However, these plants were considered to be remnants of previous vegetation after inundation by a 14.1 m rise in water level prior to the 2008 survey, as it is doubtful these patches would survive the maintenance of high levels recorded over the subsequent three or more months (Figure 7). This together with the sparse nature of plant growth ($\geq 10\%$ cover at only one of three sites investigated) results in a LakeSPI Index of 0% (Table 31).

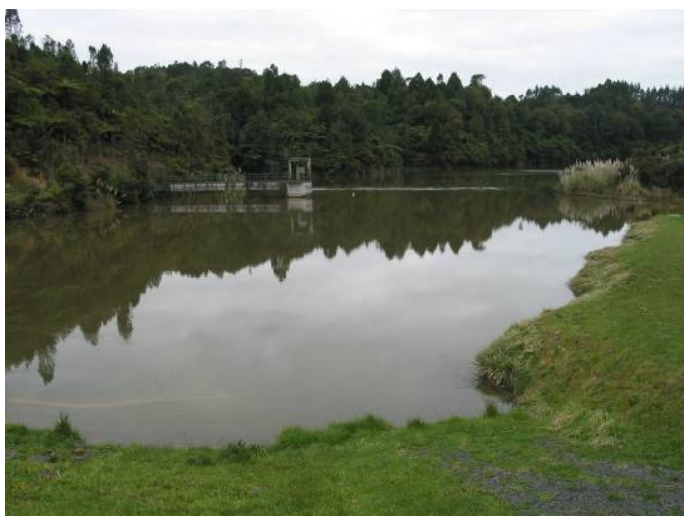
3.7.5 Hays Creek Reservoir

Latest assessment:	2008
Lake condition:	Non-vegetated
Stability:	-
Lake Max Depth (m):	20.7
Lake type:	Reservoir

Hays Creek Reservoir received a LakeSPI Index of 0% (Table 32) on account of the low presence of submerged vegetation. Only occasional charophyte plants were encountered at $\leq 10\%$ cover; below the threshold for generating LakeSPI scores. The low water clarity, with a turbid, 'milky' appearance, suggests light availability restricted submerged vegetation development. However, the presence of koi carp known from the reservoir is implicated both for impacts on water clarity (Rowe 2007) and direct impacts on submerged plants (e.g., Crivelli 1983). In contrast to the other Hunua Reservoirs, Hays Creek had a stable water level (Figure 7).
