**Auckland Lake Assessments**

**2024**

| <b>Document title:</b> | Auckland Lake Assessments 2024 |
| <b>Prepared for:</b> | Auckland Council |

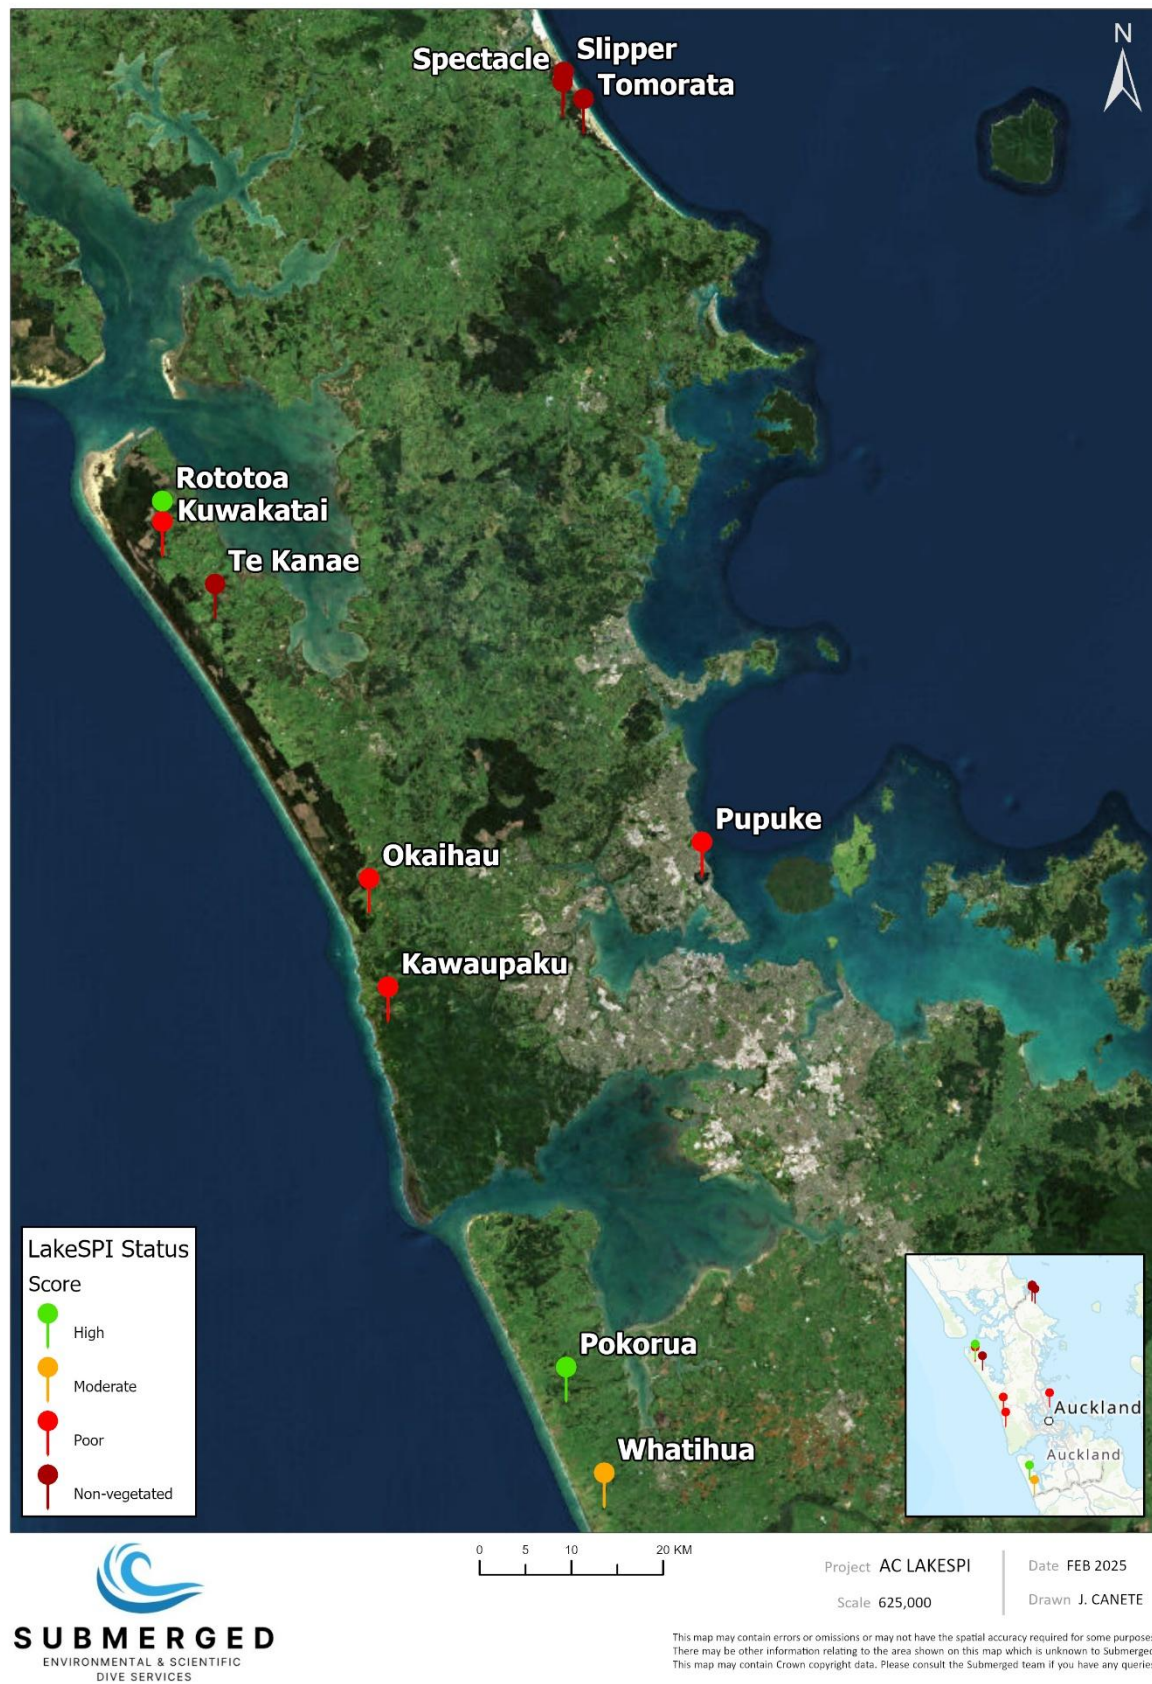
**Figure 2:** Location of the 11 surveyed lakes and their most recent LakeSPI status.

The lakes are grouped under five geographical groupings (Figure 2). The Te Arai Lakes (Ngāroto Lakes) (Tomorata, Spectacle and Slipper), the South Kaipara Lakes (Rototoa, Kuwakatai and Te Kanae), the Muriwai Lakes (Ōkaihau and Kawaupaku), the Auckland City Lakes (Pupuke) and the Āwhitu Lakes (Pokorua and Whatihua).

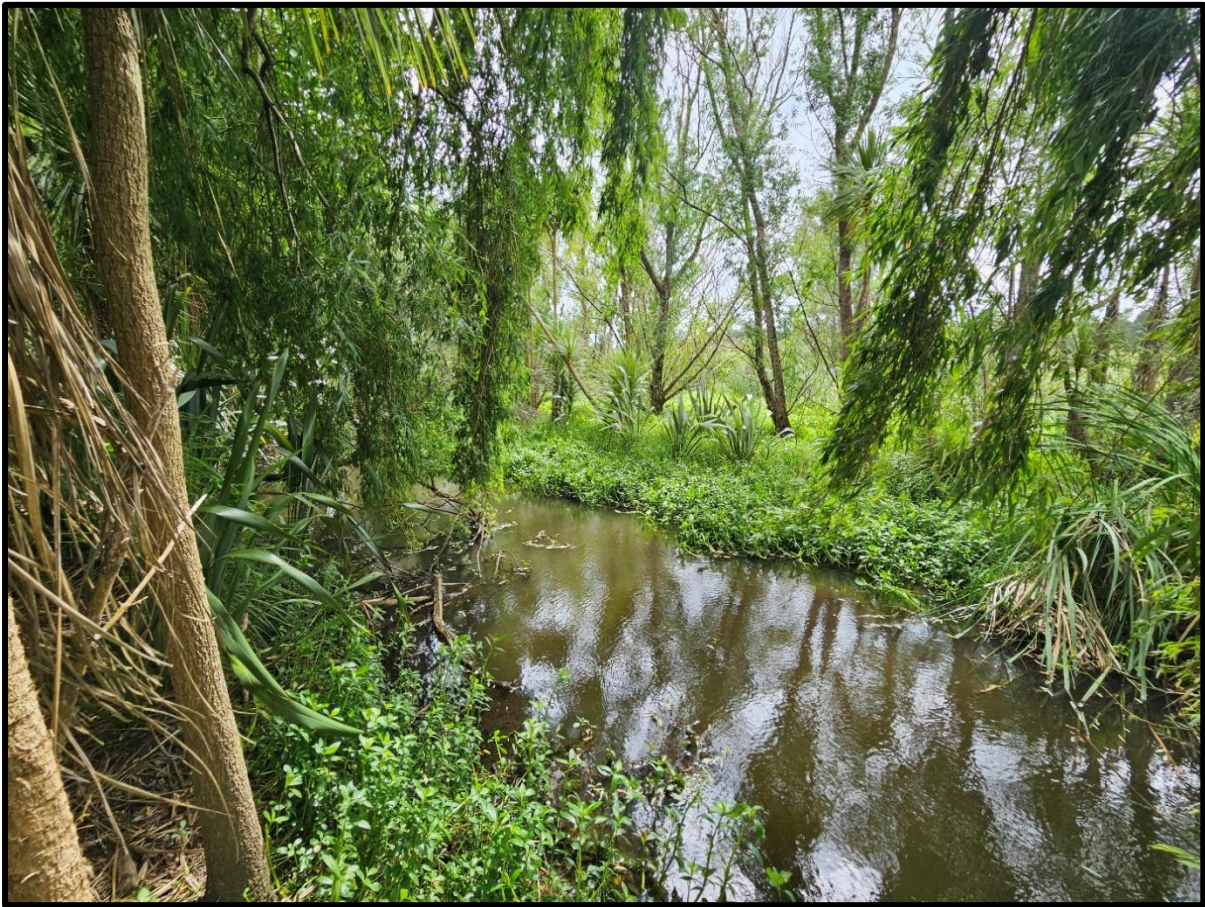
m deep and the base was lined with a thick layer of silt and organic debris. No submerged macrophytes were found in the channel.

**Photo plate 2:** Channel that links Lake Spectacle to Lake Slipper.

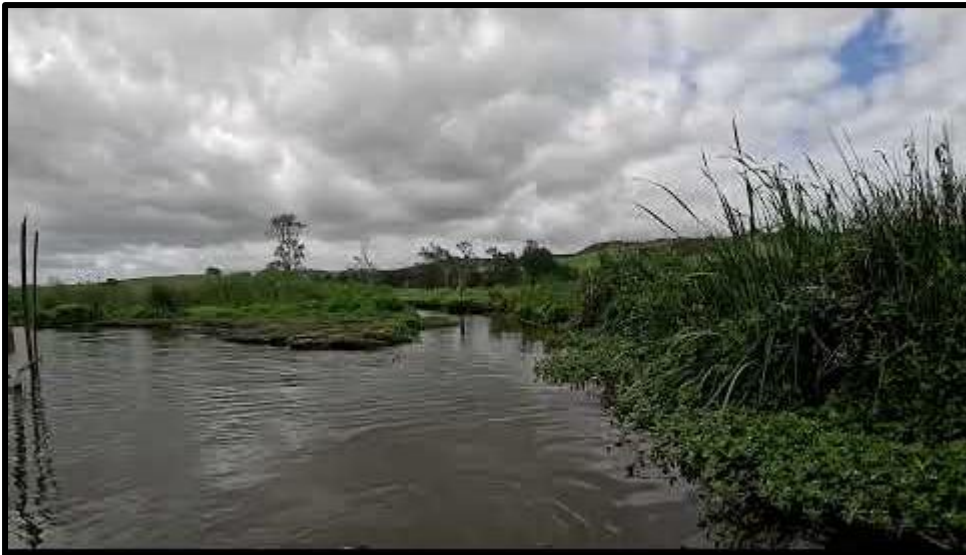
A series of farm drains were noted along areas of the lake with poor riparian vegetation (Video 1). Aerial imagery shows several drain-like features entering the riparian margin and it is likely that these drains carry a notable portion of the catchment derived contaminant load.

**Video 1:** Farm drain entering the lake from the adjacent paddock.

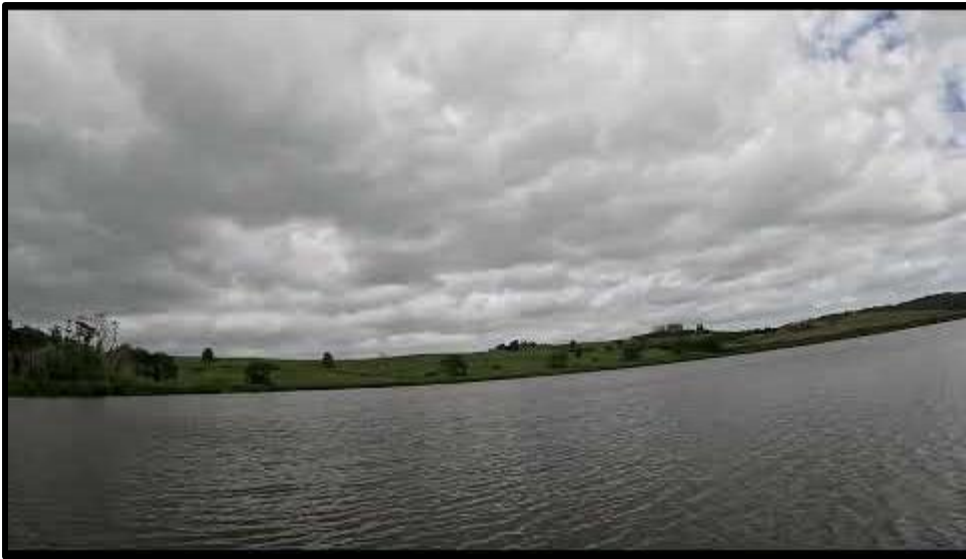
**Video 2:** Surrounding pastoral land use on steep sloped hills.

The 662.47-hectare catchment area surrounding Lake Spectacle is almost entirely pastoral grazing land (high producing exotic pasture), some of which is on steep sloped paddocks draining directly to the lake (Video 2). The outer edge of the catchment along the eastern boundary consists of production forestry and a newly constructed quarry operation. This combination of high impact land use activities on highly permeable soils contributes to the nutrient enrichment and sedimentation of the lake.

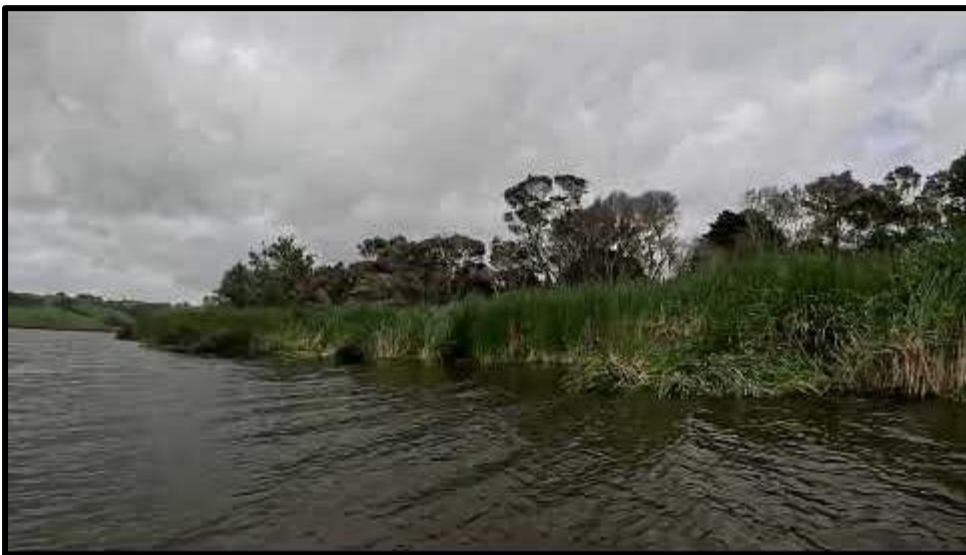
**Video 3:** Intact riparian margin with dense emergent vegetation.

The riparian vegetation is predominantly raupō reedland that backs onto manuka/kanuka scrub, it forms an almost contiguous band around the lake (Video 3). The average width of this emergent vegetation is 10 -15 m, with some areas along the eastern bank being as wide as 30 m and others as narrow as 2 m.

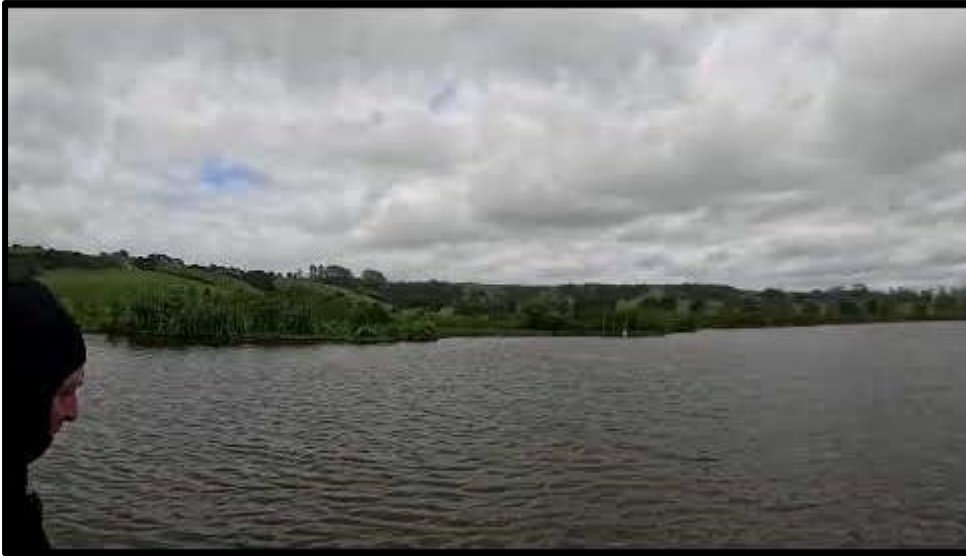
intensively grazed and slope directly toward the lake (Video 4). Several sections of the riparian margin were in poor condition with limited vegetation and signs of stock access to the water (Video 4).

**Video 4:** Steep grazed paddock draining to an impacted riparian margin with limited vegetation and signs of stock access.

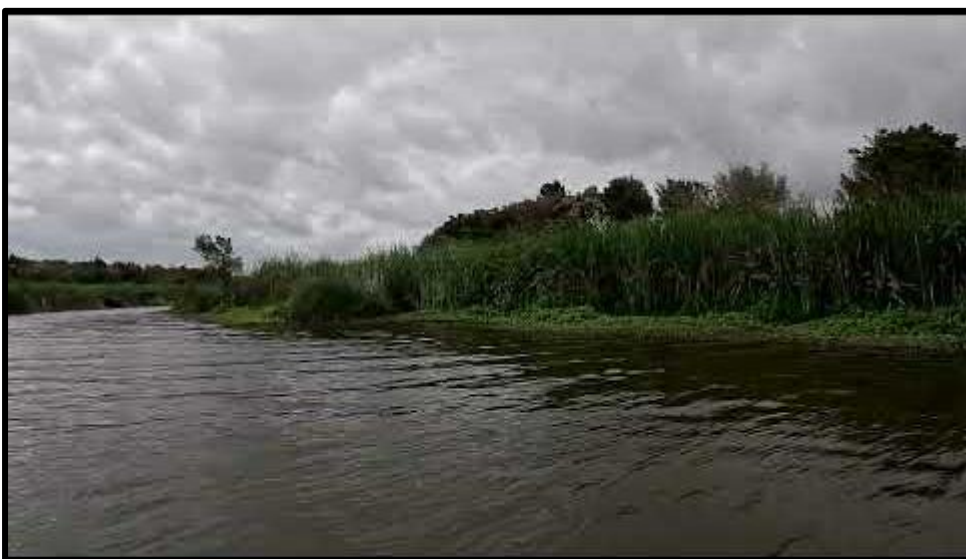
Invasive alligator weed (*Alternanthera philoxeroides*) was found across ~30% of the lake perimeter. It formed a 1 – 2 m wide band along the outer edge of the emergent vegetation with a concentration across the northern and eastern banks (Video 5).

**Video 5:** Alligator weed (*Alternanthera philoxeroides*) along the outer edge of the emergent vegetation.

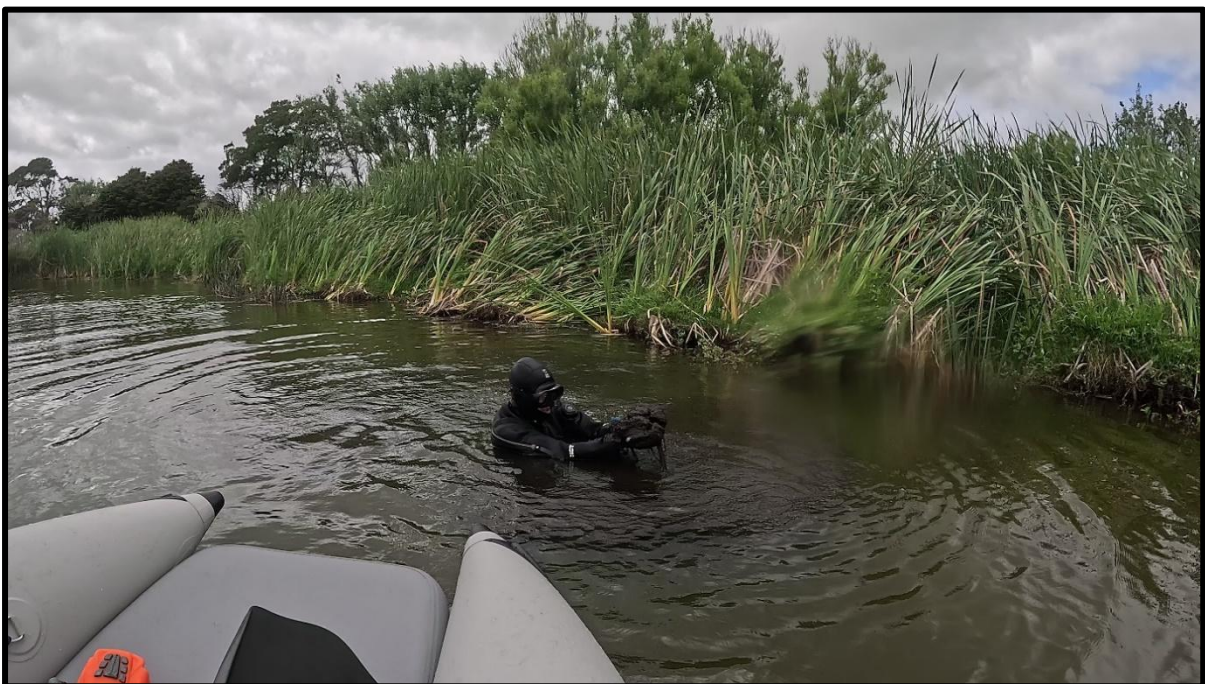
There is a lot of decomposing organic matter along the edge of the emergent vegetation. The remainder of the substrate consisted of a > 1 m thick layer of organic floc and silt on top of a deep mud base (Photo plate 3). A consolidated sandy base was found near the access point and areas with limited emergent vegetation.

**Photo plate 3:** Diver retrieving black anoxic sediment with high organic content.

The high concentration of suspended organic matter, poor water clarity and inappropriate substrate conditions have prevented submerged vegetation from establishing.

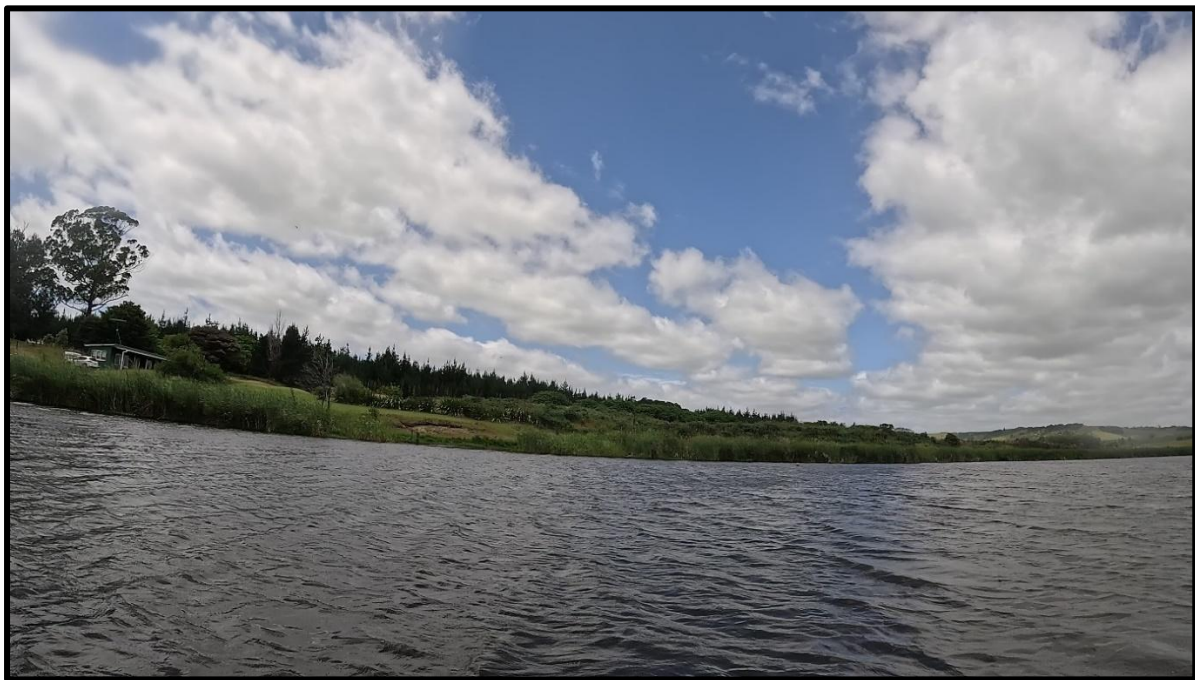
**Photo plate 5:** Representative area of the Northeast bank indicating poorly vegetated riparian margins, fragmented reed beds and exotic grassland.

The riparian vegetation is predominantly raupō reedland and forms an almost contiguous band around the lake (~75%), however the width and quality of this vegetation is variable. The northeastern tip of the lake has the least intact riparian margins and largely consists of exotic grass, a fragmented 0.5 - 1 m wide strip of emergent reeds and an average vegetated riparian width of 0.5 - 4 m (Photo plate 5). The quality of this vegetation is moderate to poor and offers limited buffering capacity (Video 8).

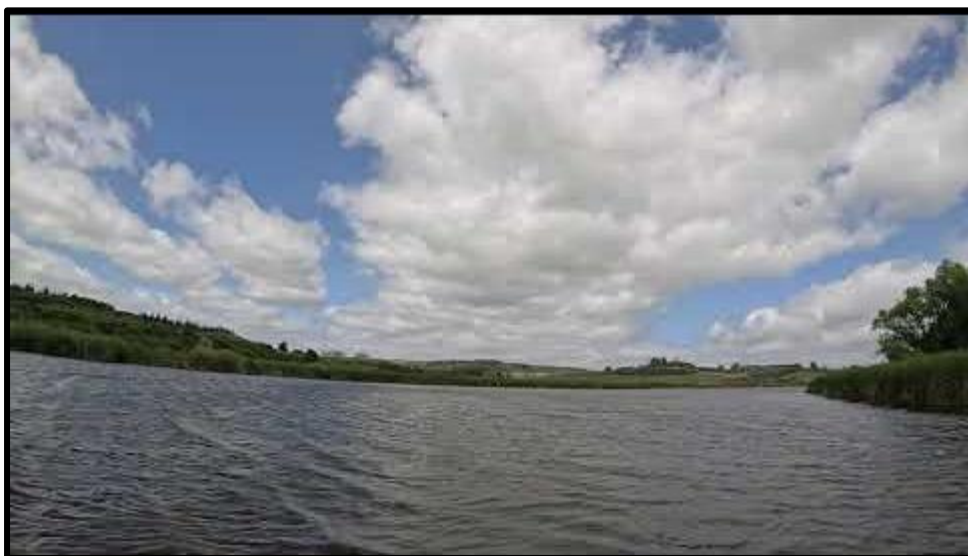
**Video 9:** Southwestern view of the lake indicating the intact southern riparian margin.

The western and southwestern riparian margins are of better quality and are bordered by 20 m of native scrub. The southern bank is bordered by a 30 m wide wetland complex that transitions into native scrub and exotic pasture (Video 9). This area provides the highest buffering capacity that attenuates contaminants from the adjacent pasture. The southeastern banks have intact riparian margins that extend into wetland features with a maximum width of 30 m (Video 9). The average width of emergent reeds is 5 m. This vegetation provides some nutrient attenuation however, the adjacent slopes have noticeable farm drains and appear to be heavily grazed, so it is likely that this area contributes elevated levels of nutrient runoff to the lake.

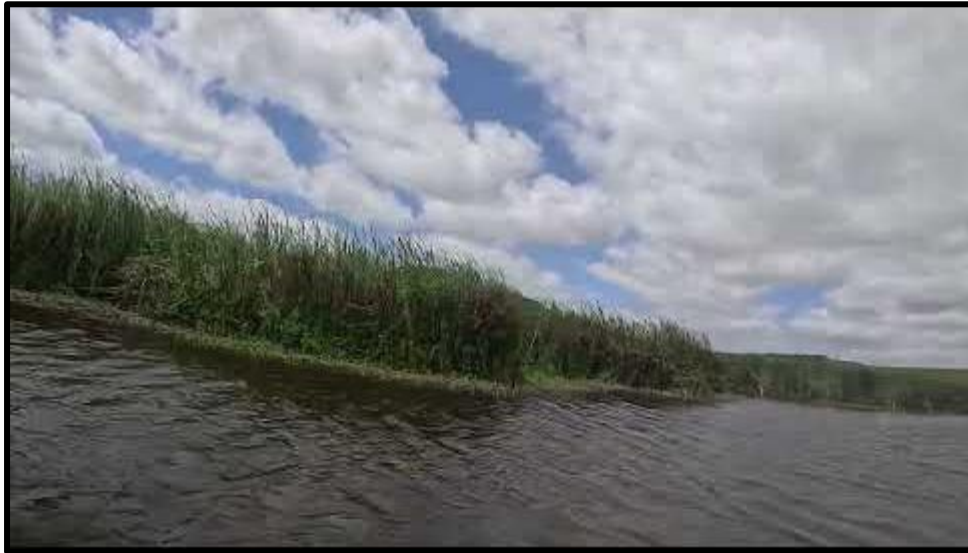
**Video 10:** Continuous Alligator weed band along the outer edge of the emergent vegetation.

Alligator weed (*Alternanthera philoxeroides*) has spread prolifically across the lake and forms an almost continuous 1 – 2 m wide band along ~75 % of the lake perimeter (Video 10). This encroachment shades out large sections of the littoral zone, further preventing macrophyte establishment.

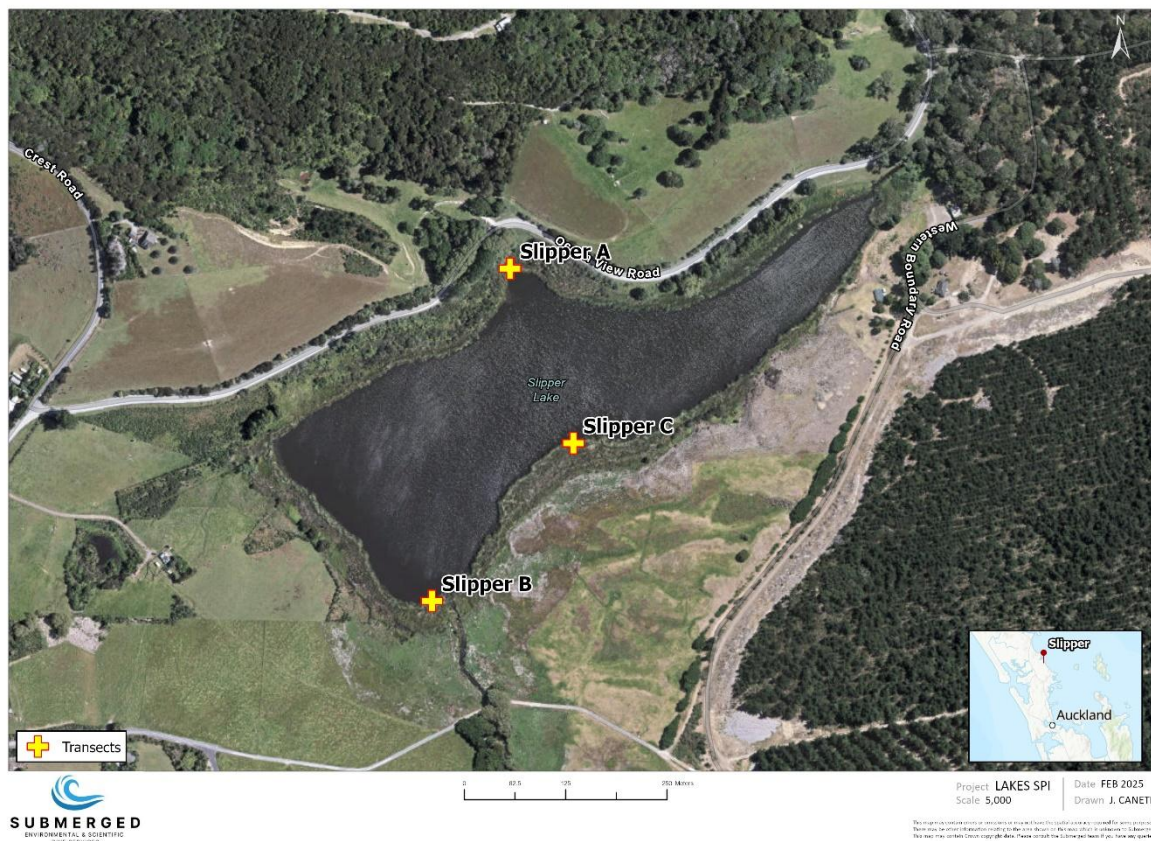
**Figure 5:** Lake Slipper LakeSPI survey transects.

LakeSPI assessments were done along three survey transects in Lake Slipper (Figure 5). Additional areas were dived to confirm substrate characteristics, emergent vegetated depth extent and general lake health.

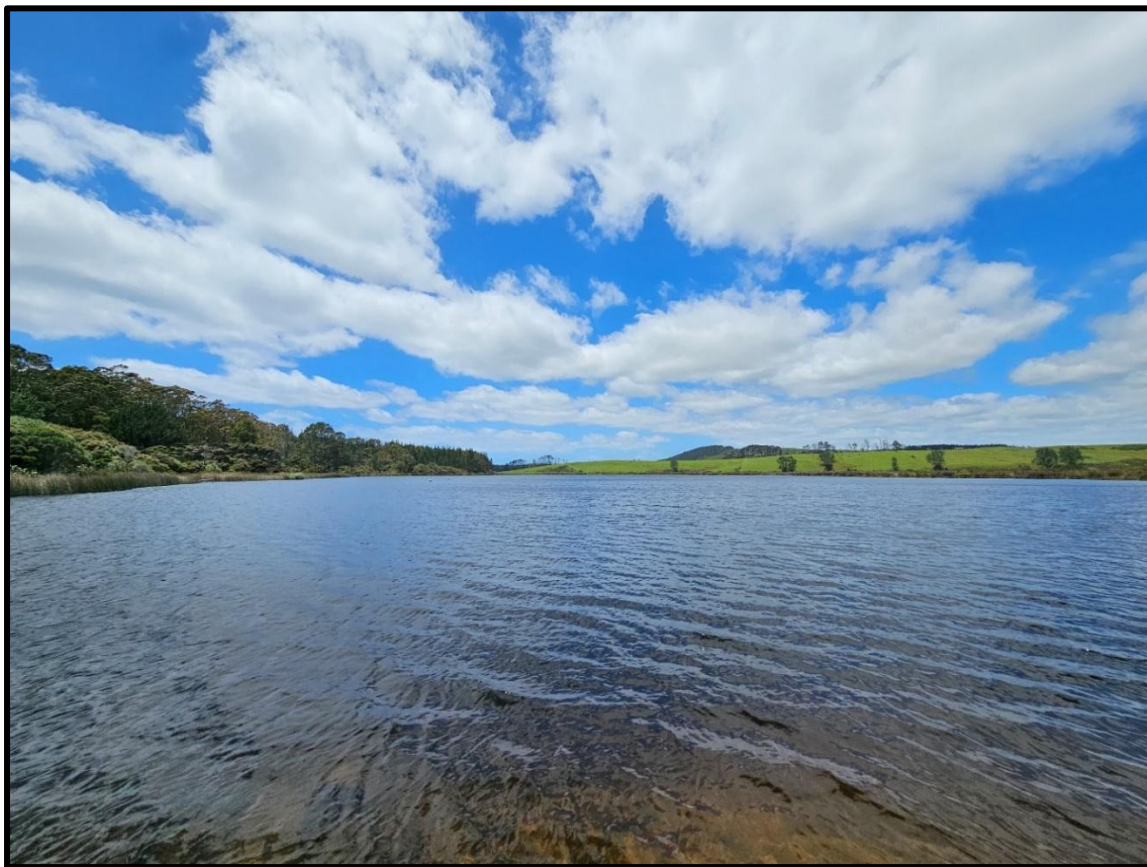
**Photo plate 7:** Southern view across Lake Tomorata indicating the dominant land cover (pasture along the east and a mix of native scrub and exotic forestry along the west).

The 103.34-hectare catchment surrounding Lake Tomorata differs from the other Te Arai lakes and is primarily utilised for production forestry however, the 83-hectare sub-catchment is predominantly high producing exotic grassland (Photo plate 7). As a result, the lake is subject to pressures from land use activities, including nutrient runoff, sedimentation, and altered hydrological patterns. The underlying geology of the sub-catchment consists of sandy soils typical of coastal dune systems, with anthropogenic variations in permeability leading to relatively high surface runoff into the lake during rainfall events. This catchment typology is a primary contributor to the elevated trophic state of the lake, as nutrient rich runoff from agricultural and forestry can accelerate eutrophication.

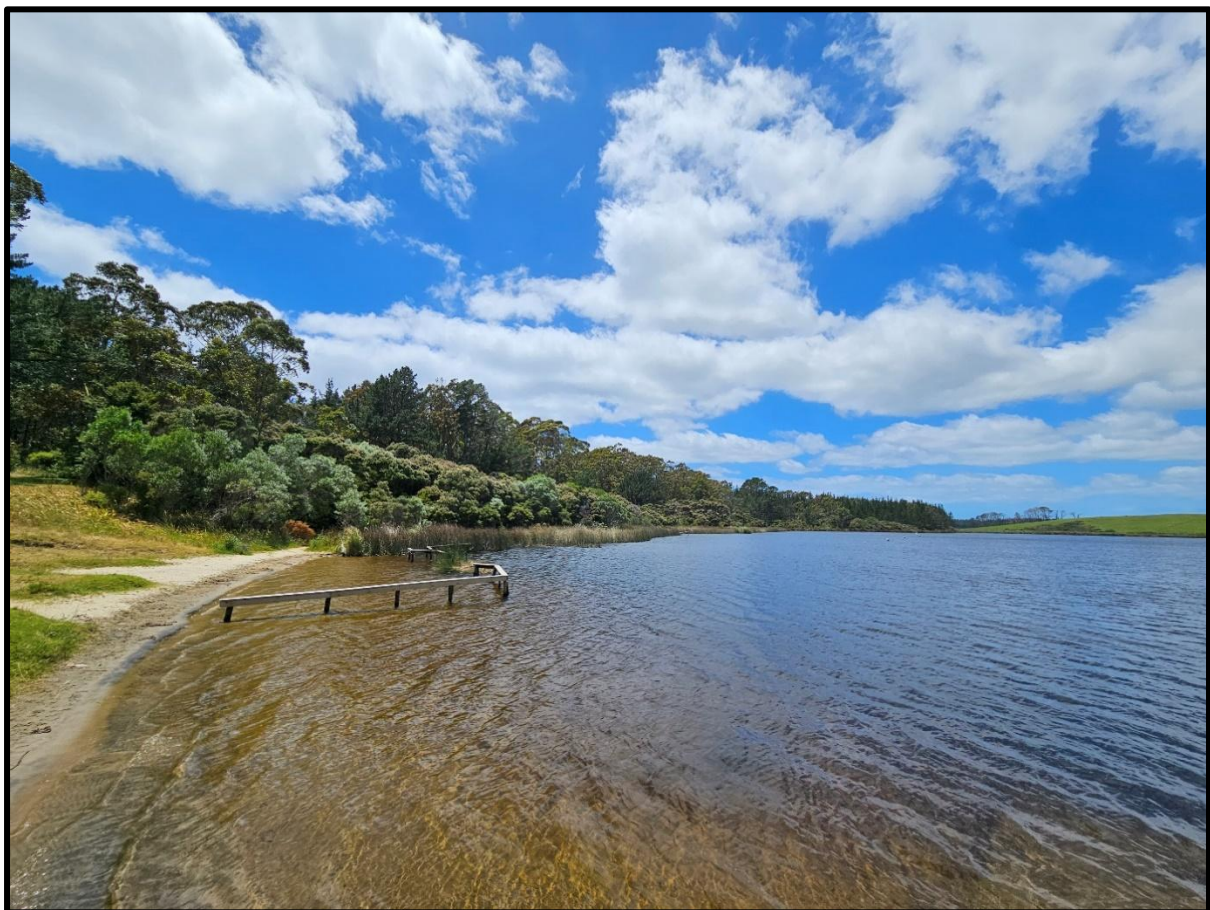
**Photo plate 8:** Northern & eastern banks indicating the transition from bare beach to vegetated riparian margins.

The riparian vegetation is sparse along most of the northern margin and the area around the public access/boat ramp is primarily a sandy beach (Photo plate 8). The eastern bank is fringed with a narrow 2 - 5 m non-contiguous band of emergent reeds that backs onto manuka/kanuka scrub and exotic forestry (Photo plate 8). A large lacustrine wetland creates an extensive buffer along the western and southern banks (Photo plate 9). The width of this wetland buffer varies from 67 m at its narrowest point, near the boat ramp, to 578 m at the widest point midway along the western bank. The wetland along the southern bank is connected to a wider wetland feature that includes a smaller lake, the width of this entire complex is 257 m at its widest point. The remaining sections of the western and southern banks have an average width of 115 m.

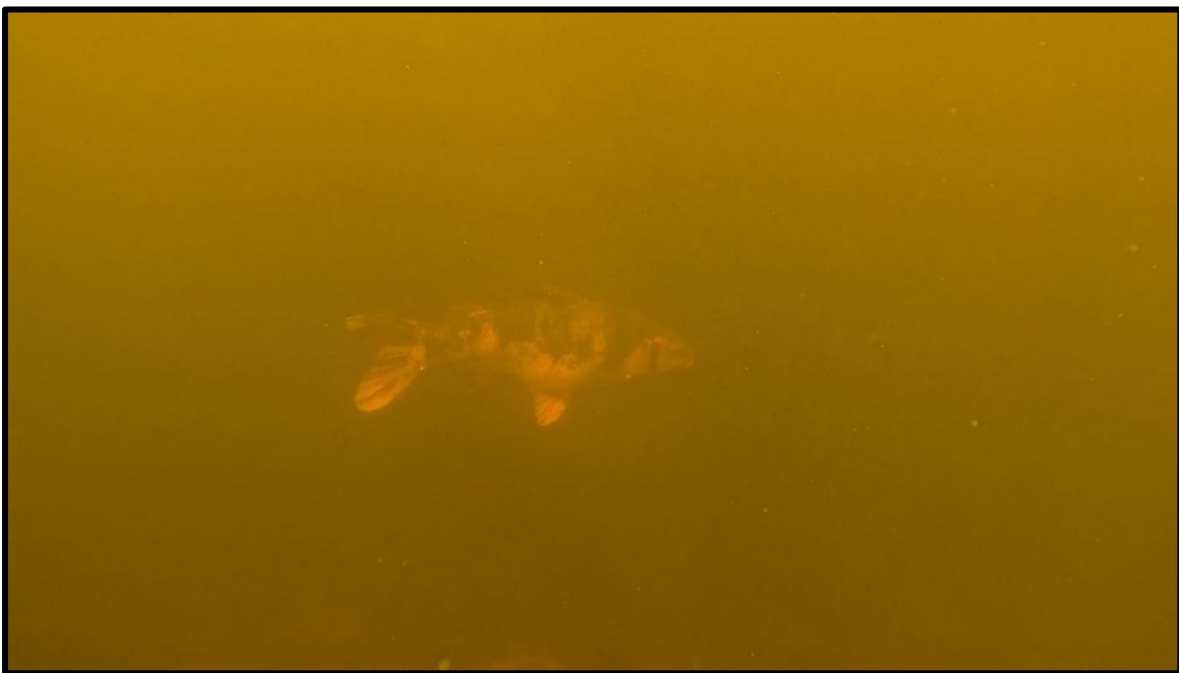
The invasive coarse fish Rudd (*Scardinius erythrophthalmus*) and Tench (*Tinca tinca*) were present in high numbers prior to the sustained control programme implemented by the council. Koi carp (*Cyprinus carpio*) (Photo plate 10) have also been confirmed in low numbers in the lake (a large adult was sighted during the survey). These invasive fish species disrupt natural food webs, cause excessive bioturbation and exert predatory pressure on native macroinvertebrates and macrophytes. As a result, these exotic fish have impacted the biodiversity and water quality of the lake which contributed significantly to a decline in overall lake health.

**Photo plate 10:** Koi carp at 1.8 m deep along the eastern lake edge.

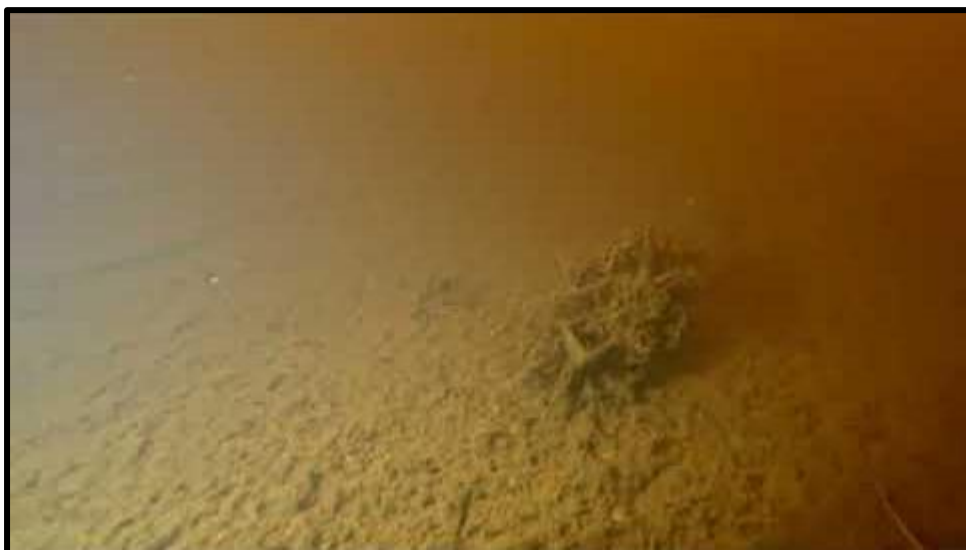
**Video 13:** Substrate along the deep central bowl.

The substrate in the deeper sections of the lake (> 2.4 m) was soft and silty with a thick (> 45 cm) layer of organic silt (Video 13). In some places consolidated sediments were found more than a metre below the loose surface sediments. A thick layer of clay and peat was found below the loose surface sediment in several locations along the lakebed, which suggests that the lake may be perched or capped in the deeper bowl.

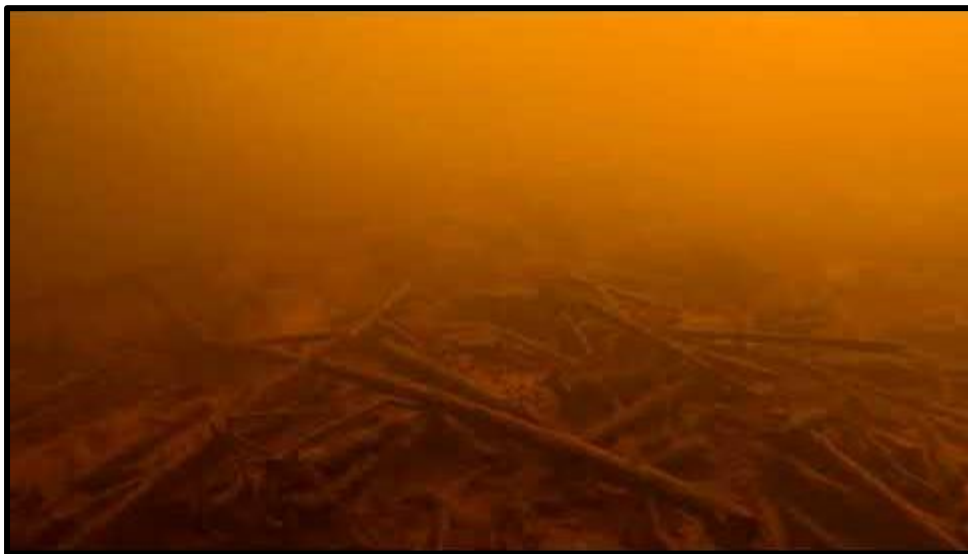
**Video 14:** Representative transect through the eastern littoral margin.

The shallow (0 – 2 m) areas along the northern and eastern portions of the lake largely consisted of a consolidated sandy base with a thin layer of organic floc, fine silt and detritus. The northern littoral margin has limited accumulation of organic debris, which can be explained by the lack of riparian vegetation and extent of recreational activities that can cause anthropogenic dispersal of accumulated organic matter. The eastern lake margin is steeply sloped and had large deposits of riparian derived detritus/organic debris at the base of the sloping lakebed between 3 – 4 m deep (Video 14).

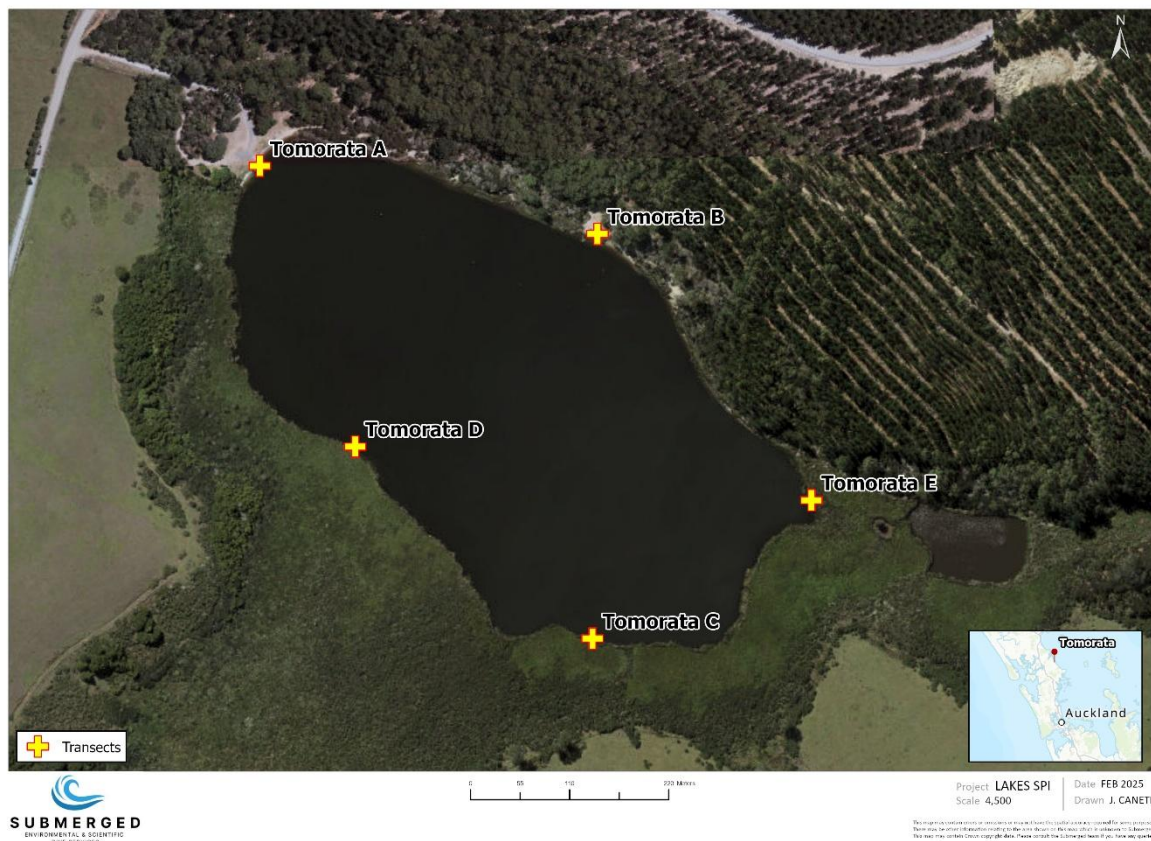
**Figure 7:** Lake Tomorata LakeSPI survey transects.

LakeSPI assessments were done along five survey transects in Lake Tomorata (Figure 7). Additional investigations were conducted along representative sections of the lake to assess macrophyte recovery post coarse fish control as well as general lake health and the influences of various riparian and sub-catchment typologies.

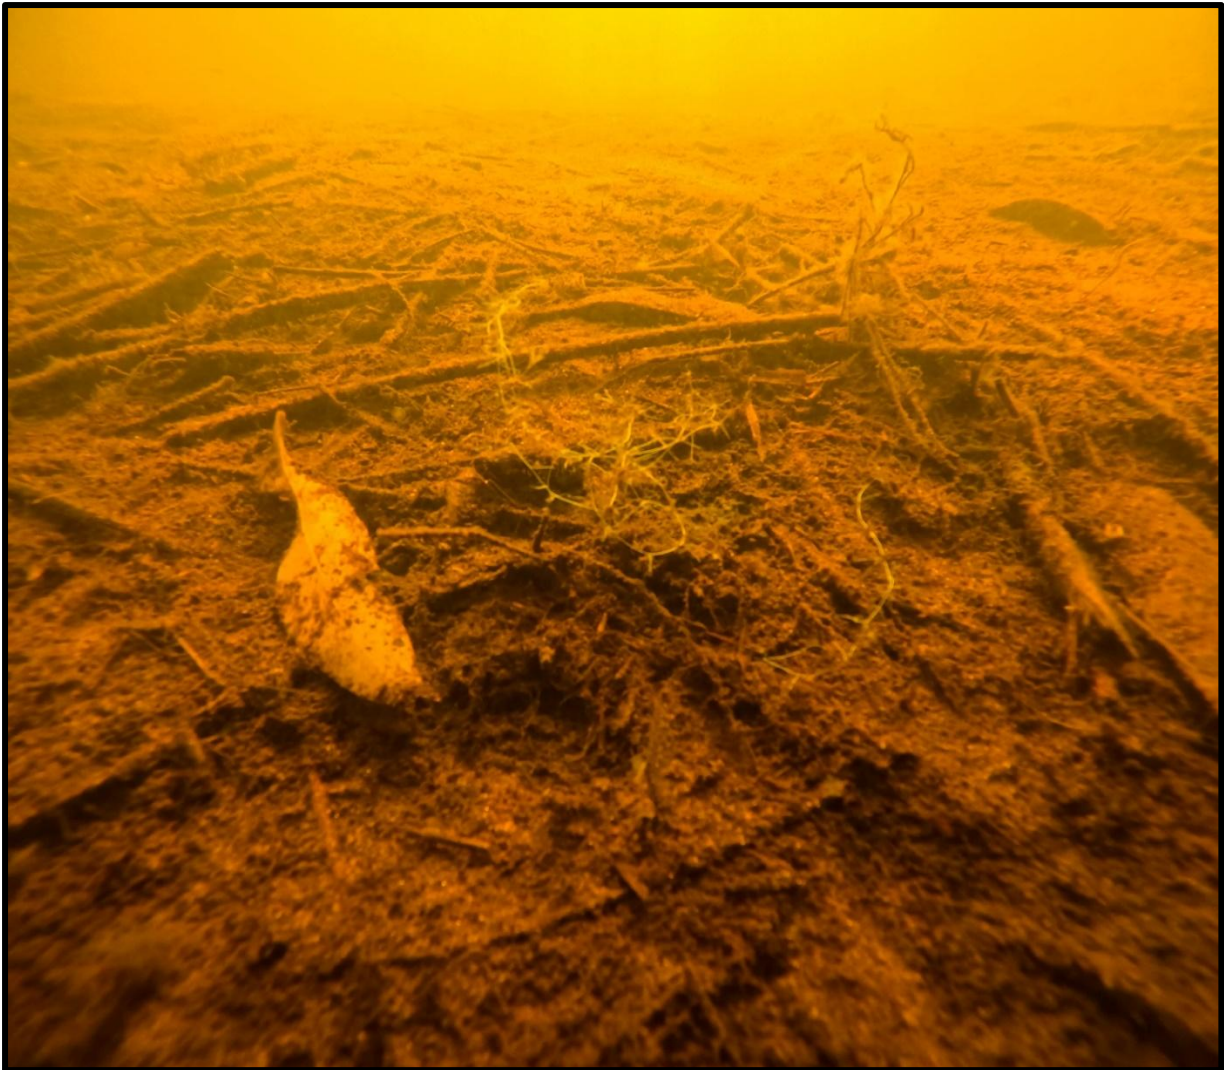
**Photo plate 11:** *Utricularia gibba* amongst the organic debris in the shallow littoral zone.

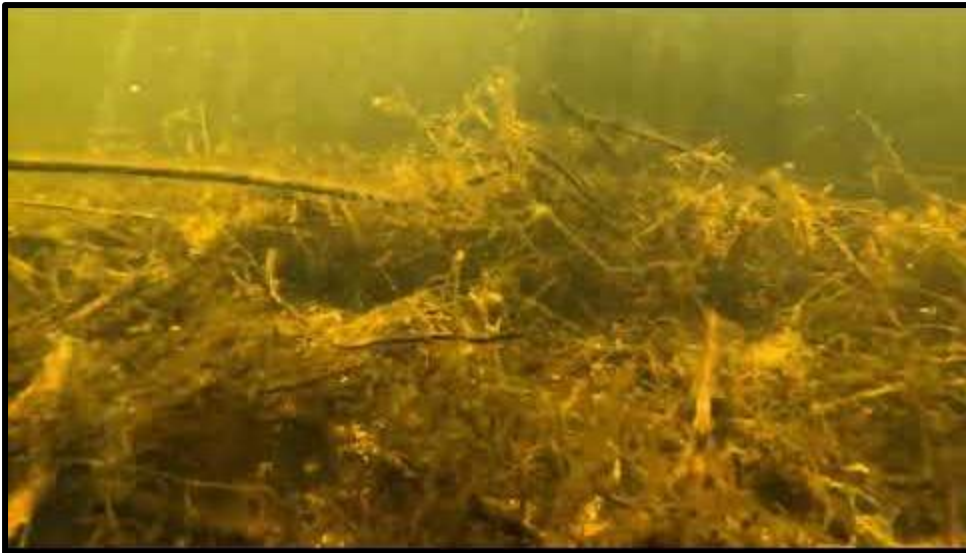
The eastern lake margin has a flat sandy plateau that leads to a steep slope extending to 4 m deep. Both the eastern transects (E & B) were devoid of macrophytes however the wider area between these transects had sparse macrophyte growth in the form of single stems and small clumps. Three larger clumps/beds of *Nitella* sp. aff. *Cristata* were seen along the southeastern end of the lake (near transect E) and ranged in size from 2 - 9 m<sup>2</sup> with covers exceeding 10% in two of the beds larger than 4 m<sup>2</sup> (Video 16).

**Video 16:** Large *Nitella* bed growing amongst the detritus in southeastern end of the lake.

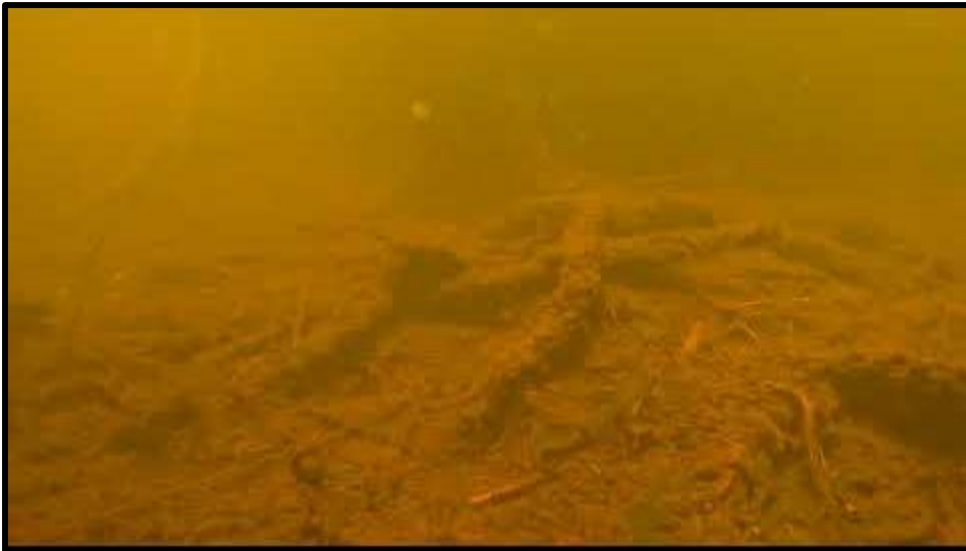
The southern lake margin (between transects C & E) had the lowest macrophyte cover observed during the survey. This is likely a result of the emergent vegetation forming floating rafts that shade the shallow lake margin from 0.5 – 2.1 m (Video 17). The large deposits of organic debris in this zone also limit the establishment of macrophytes (Video 17). A few small clumps of *Nitella sp. aff. Cristata* with 3 – 5 short stems each were the only macrophytes seen in this zone, the plant condition was poor, and majority of the growth was blackened and brittle.

**Video 17:** Emergent vegetation encroaching into the upper littoral zone.

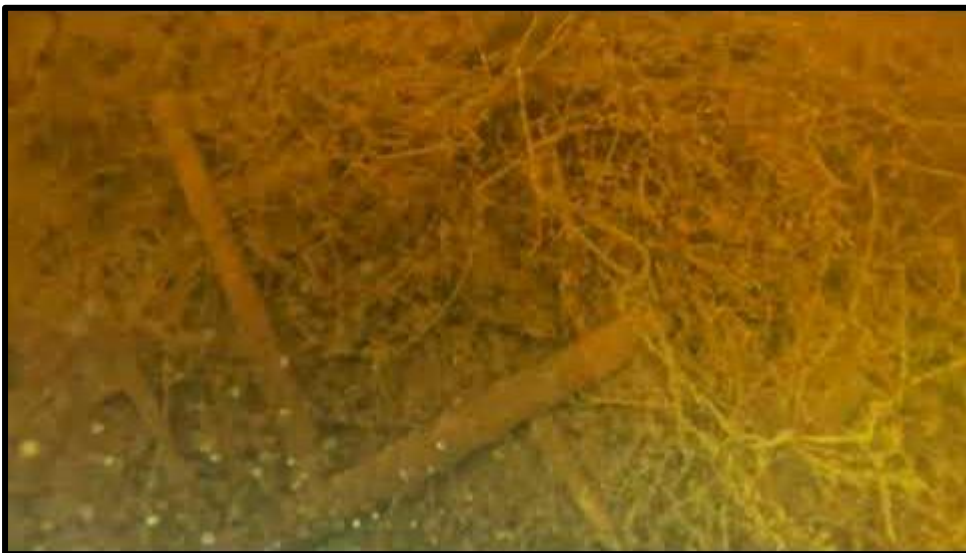
The western lake margin (transect A - C) had the highest macrophyte cover and widest distribution, transects D and C where the only survey transects that had macrophyte growth along the survey line. The average cover across both these transects was 5%. However, vegetated areas larger than 4 m<sup>2</sup> and covers exceeding 10% were observed in the area between transect D and C (Video 18).

**Video 18:** Mature *Nitella* bed along the western littoral margin.

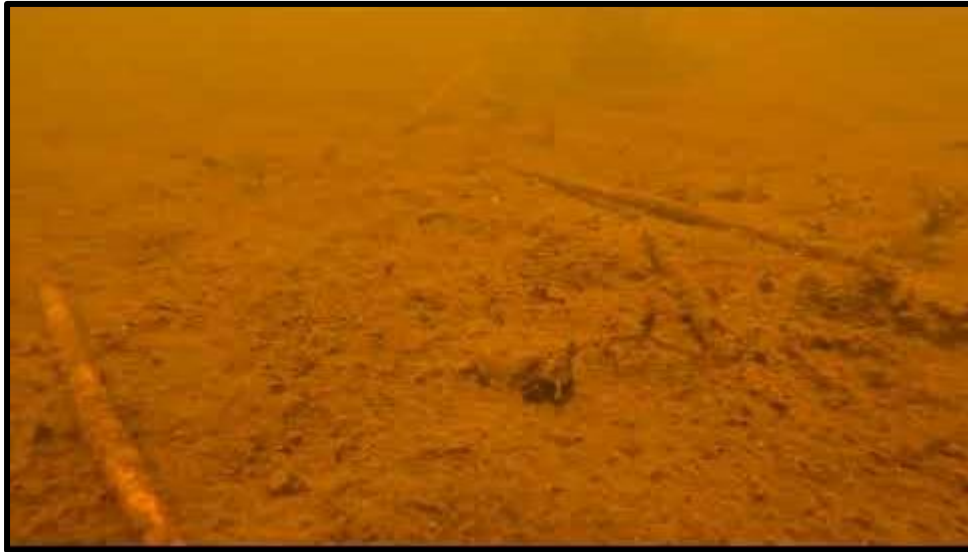
The general growth across the lake consisted of sparsely distributed single stems, small clumps and germlings (Video 19). As a result, the overall lake-wide macrophyte cover remains less than 10%, which under the LakeSPI assessment criteria places Lake Tomorata in the non-vegetated category. The general macrophyte condition was moderate to poor with epiphytic growth seen on most macrophytes. There were no signs of grazing damage from herbivorous coarse fish which is an indication that the intensive pest fish removal activities are having a positive impact.

**Video 19:** Single stems and small clumps of *Nitella* in the shallow littoral zone.

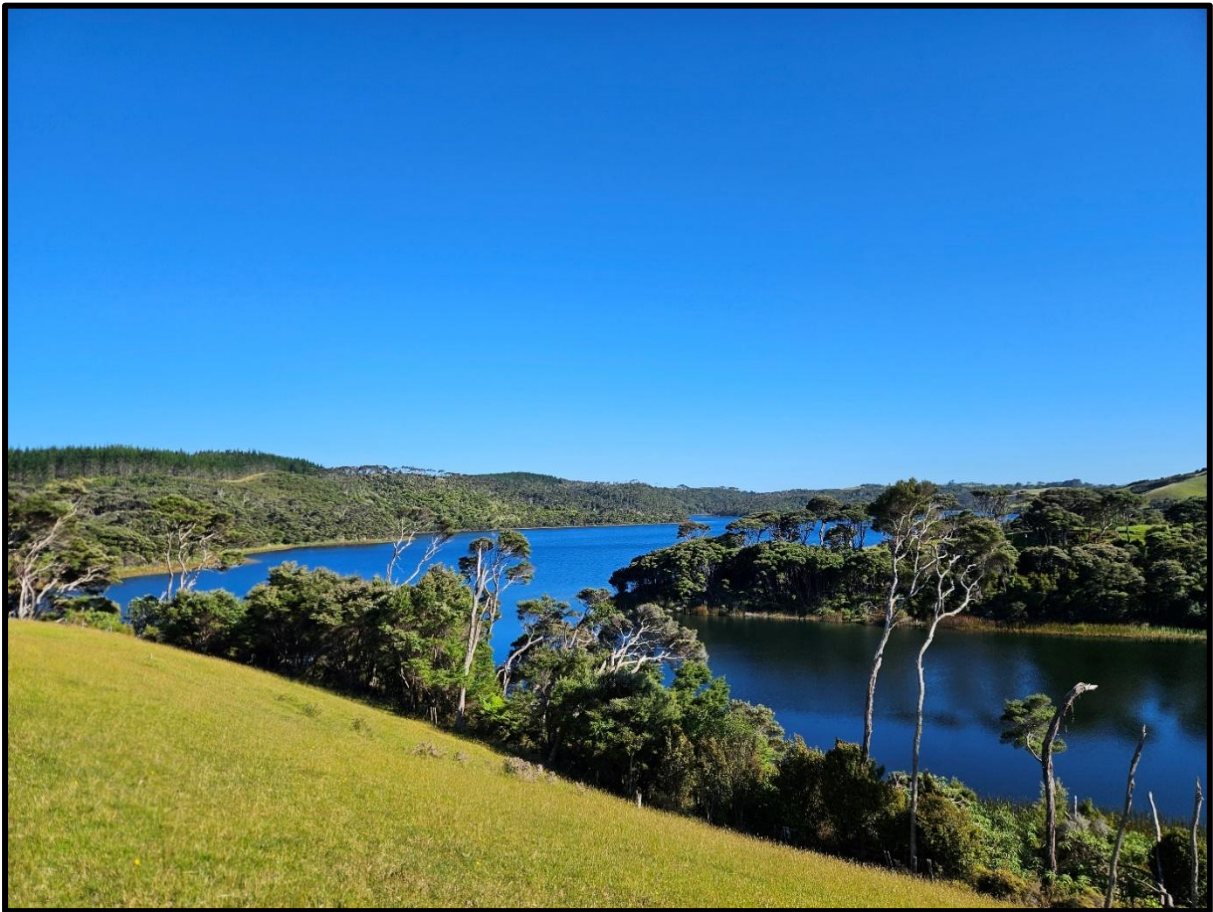
**Photo plate 12:** North facing view across lake Rototoa indicating the sub-catchment land cover (pasture along the east and native bush along the west).

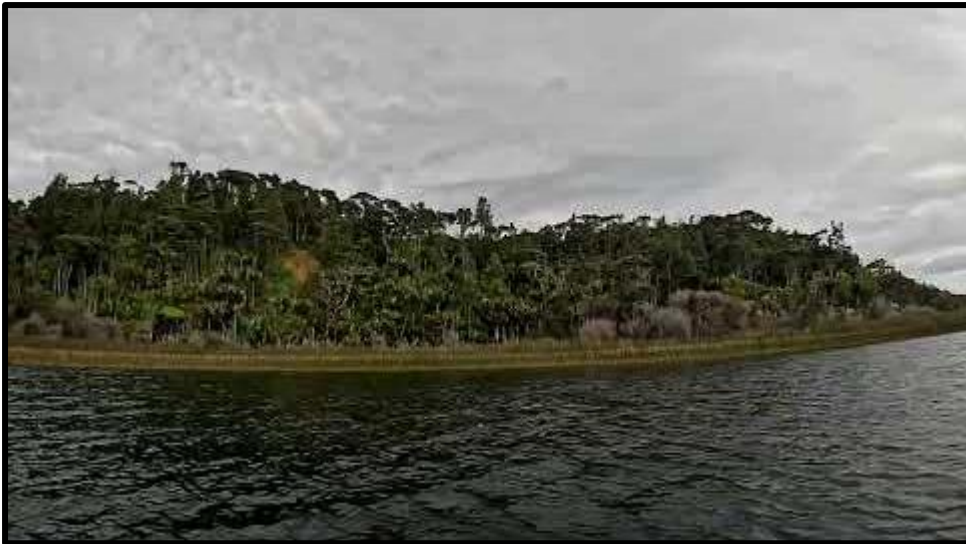
The terrestrial vegetation assemblage has been impacted by Cyclone Gabrielle (February 2023). Several land slips and large sections of buried vegetation were noted. The taller canopy of manuka/kanuka has fallen and in some areas made way for a canopy dominated by nikau palms, this is particularly evident in the northern arm and along parts of the western bank (Video 20).

**Video 20:** Western bank with cyclone induced land slip & altered vegetation assemblage.
