**Auckland Lake Assessments**

**2024**

| <b>Document title:</b> | Auckland Lake Assessments 2024 |
| <b>Prepared for:</b> | Auckland Council |

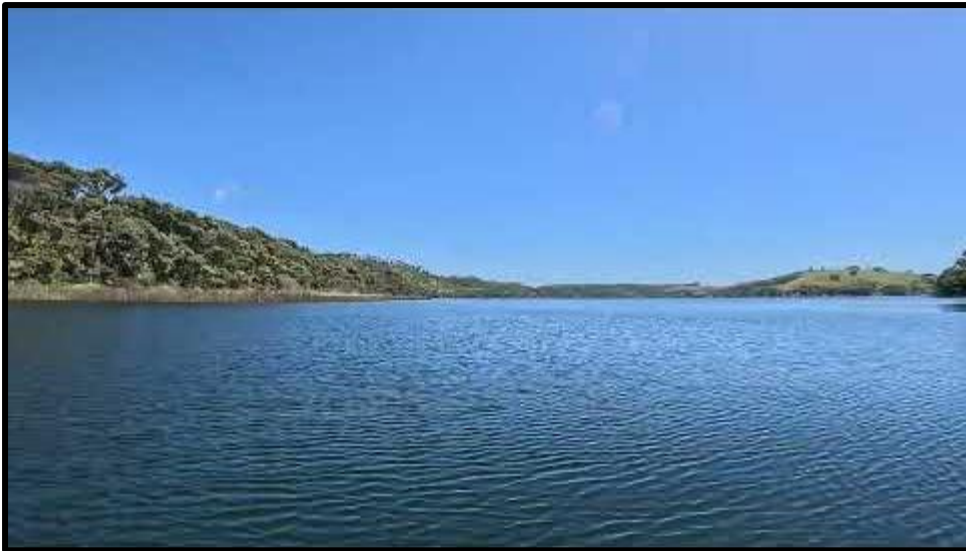
The terrestrial vegetation within the riparian margin, including species like raupō, mānuka, flax and sedges (Video 21), provides buffering against nutrient and sediment inputs from the surrounding catchment however, significant impacts were noted during the 2024 survey. The understory throughout most of the native bush is poor and has been heavily impacted by feral deer browsing (Video 21). The depauperate understory and cyclone induced erosion allows organic rich soil and detritus to flow into the lake during rainfall events. This is exacerbated by the steep nature of the surrounding sub-catchment.

**Video 21:** Sub-catchment & riparian margin with sparse understory.

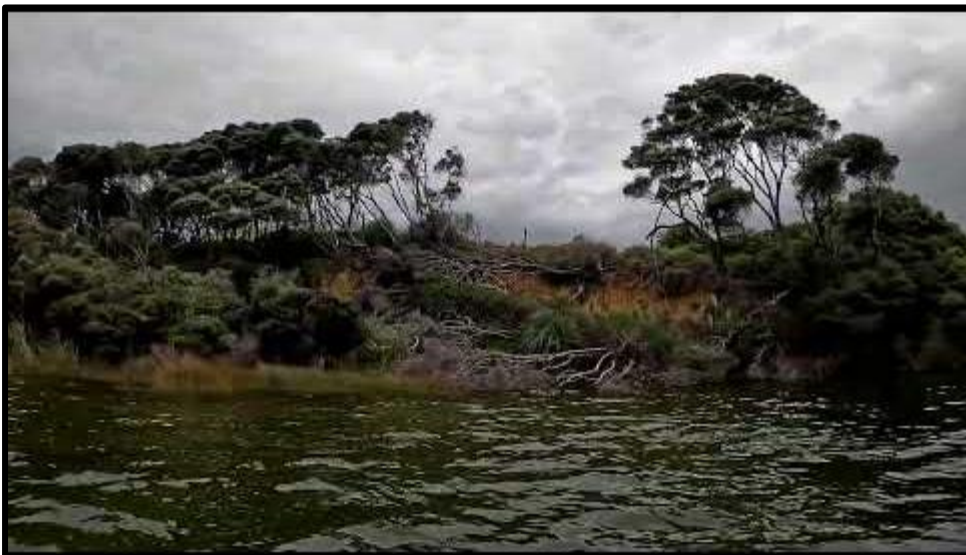
The emergent vegetation largely consists of *Eleocharis sphacelate*, *Machaerina articulata* and *Machaerina arthropphylla* with an average width of 10 - 15 m. This reed line borders approximately 70% of the lake and forms wetland features in some areas, particularly along the northern and eastern shores. This riparian buffer contributes significantly to the lake's water quality, helping to filter contaminants and stabilise the shoreline, reducing erosion. Cyclone Gabrielle (February 2023) has caused localised breaches in this contiguous reed line and has buried large section that are open to colonisation by exotic terrestrial species (Video 22).

**Video 22:** Cyclone induced slip & bank erosion along the eastern shore.

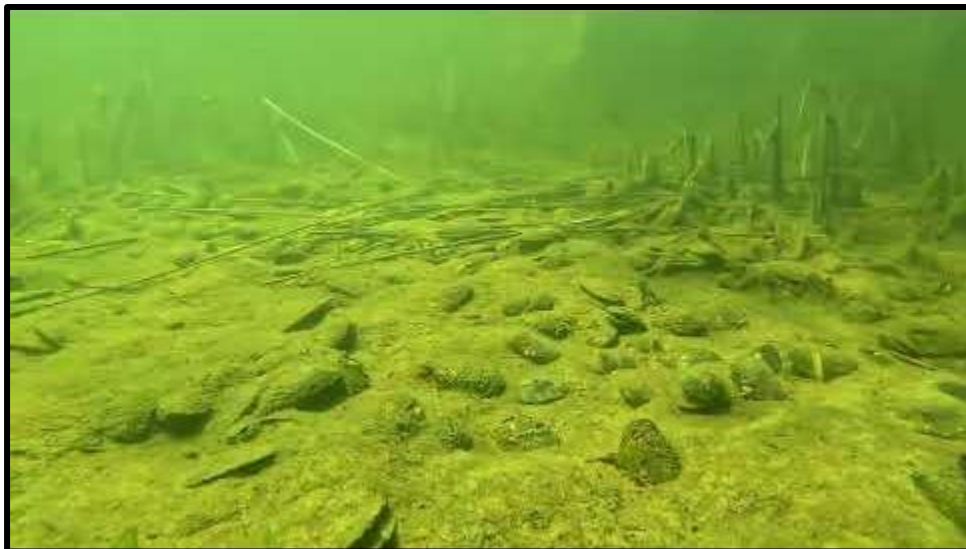
Rototoa is one of two known lake bound population of kākahi (*Echyridella menziesii*) in the region that still has live mussels across multiple areas. During the 2024 survey several historic kākahi beds were found and estimated to have a density of 40 – 50 per m<sup>2</sup> (Video 23). Where live kākahi were found the average densities were only 1 – 5 mussels per m<sup>2</sup> or less.

**Video 23:** Historic freshwater mussel (kākahi) bed with dead adult size shells.

pers. comms, 2024). All kākahi (dead & alive) found during the survey were mature adults with majority being in the 51 – 60 mm size class and the remainder in >61 mm size classes. There appears to have been a mass kākahi mortality event within the past couple of decades as most of the dead shells are intact and of the same size class. The assumption is that these mussels are largely from the same cohort and that several failed spawning events lead to limited recruitment resulting in the adult population eventually dying of old age.

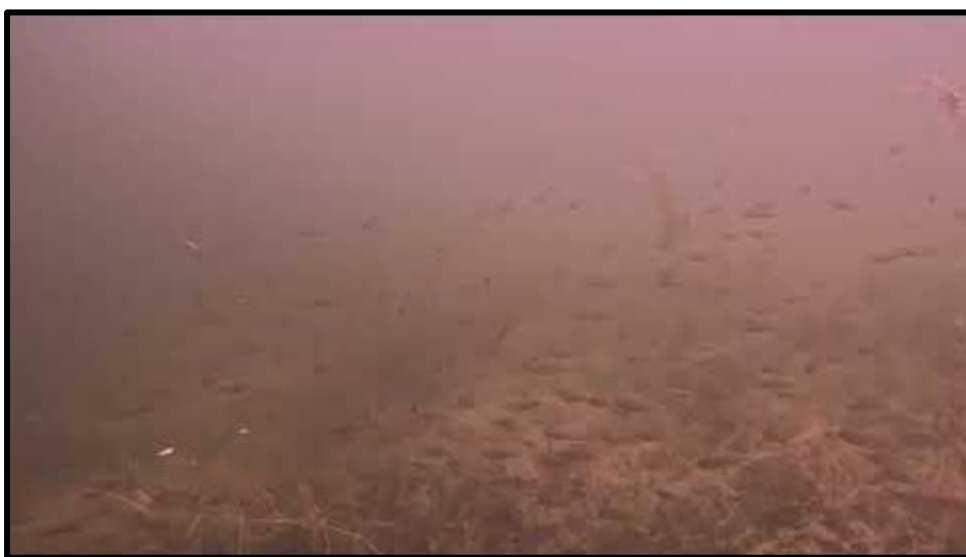
Coarse fish, such as perch (*Perca fluviatilis*) and tench (*Tinca tinca*) as well as mosquitofish (*Gambusia affinis*) have established large populations within the lake. Several schools of juvenile perch were sighted during the 2024 assessment which indicates active recruitment is occurring (Video 24), and benthic feeding pits were common on the lakebed indicating a high degree of benthivorous feeding from tench. Rudd (*Scardinius erythrophthalmus*), goldfish (*Carassius auratus*) and koi carp (*Cyprinus carpio*) are also present but in lower numbers than the perch and tench. These exotic fish displace native species and exert excessive grazing pressure on the submerged macrophytes which results in ecosystem health degradation and reduced environmental resilience (de Winton et al. 2002 & Dugdale et al. 2006).

**Video 24:** School of juvenile perch.

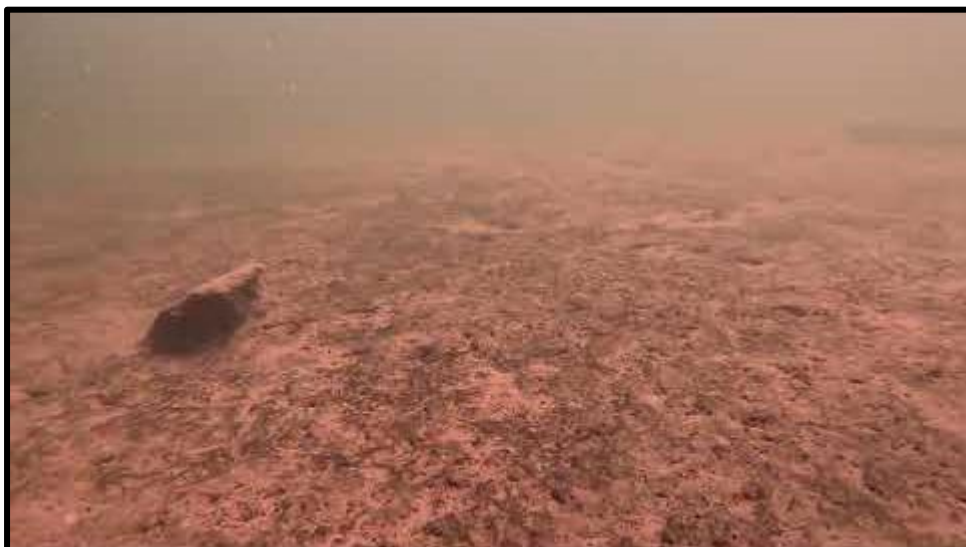
Limited benthic algal growth was seen during the 2024 survey. The upper littoral margin had epiphyton covering sections of shallow macrophytes, in particular pondweed and hornwort. Benthic mats were observed in parts of the shallow littoral margin, but the bulk of the growth was seen below 5 m deep (Video 25).

**Video 25:** Benthic algal mats & coarse fish feeding pits along the lakebed.

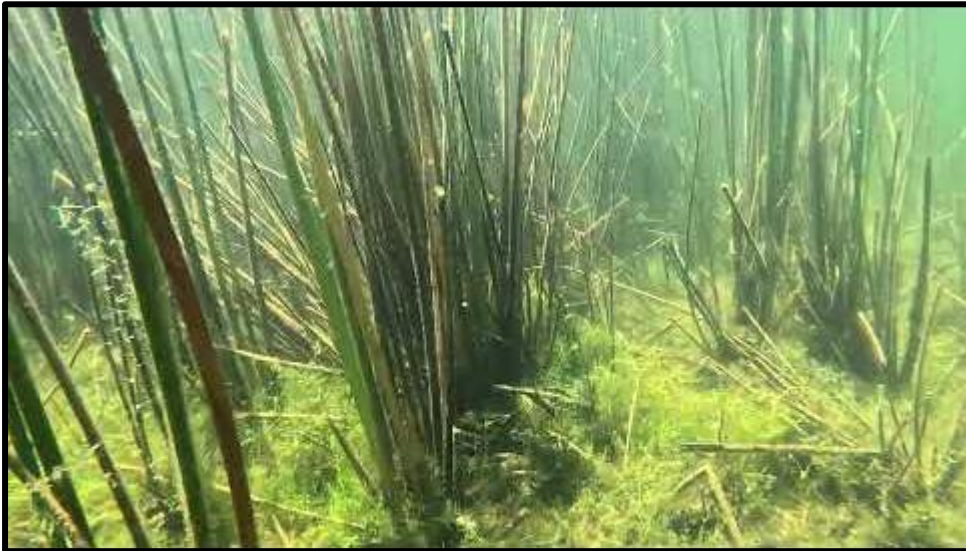
The general vegetation assemblage pattern consists of emergent reeds from 0.2 – 2.5 m deep with *Chara australis*, *Chara fibrosa*, *Chara globularis*, *Nitella hyaline*, *Nitella pseudoflabellata* and *Nitella leonhardii* growing amongst the emergent reeds (Video 26). *Utricularia gibba* was common amongst the emergent reeds (Video 26).

**Video 26:** Native macrophytes growing amongst the emergent reeds.

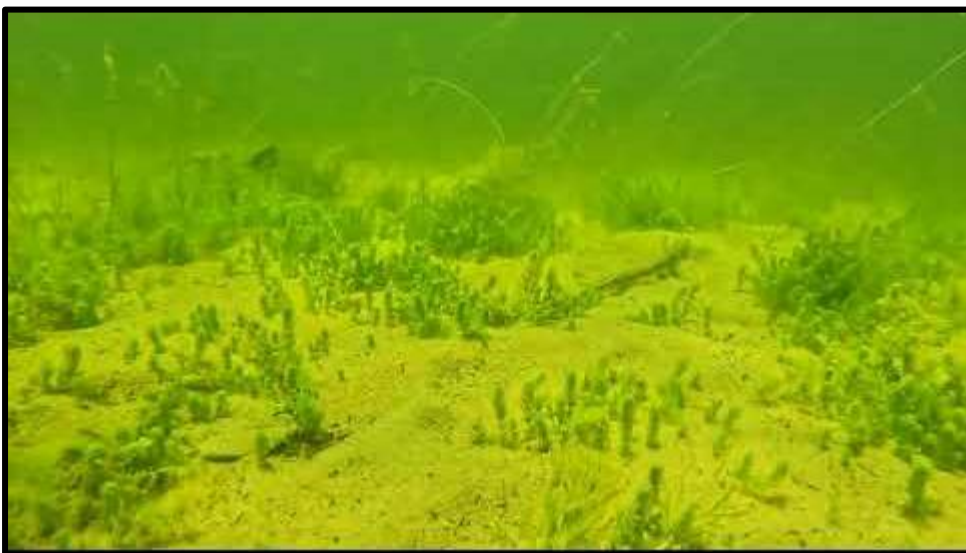
Low to moderate covers of *Chara australis*, *Chara fibrosa* and *Chara globularis* with short stems of *Potamogeton ochreatus* forming a sparse canopy extended from the edge of the emergent reeds (0.5 m) to 3 m deep (Video 27).

**Video 27:** Representative shallow macrophyte assemblage.

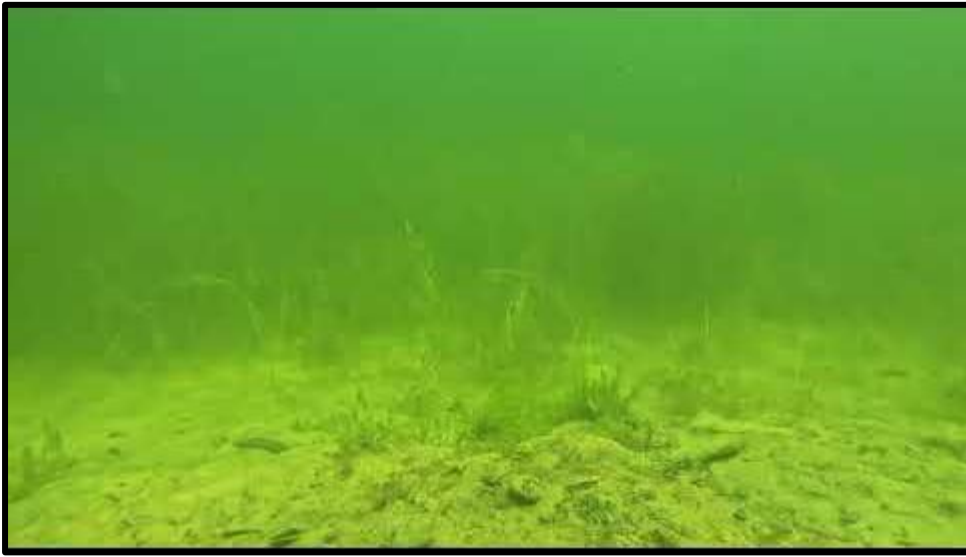
A ~50 m wide band of bare lakebed, occasionally with sparse charophyte cover, was commonly seen separating the shallow charophytes from the pondweeds

(*Potamogeton ochreatus* & *Potamogeton cheesemanii*) that formed a distinct band from 3 – 5 m deep (Video 28).

**Video 28:** Transition from bare lakebed with sparse charophyte cover to the pondweed belt at 3 m deep.

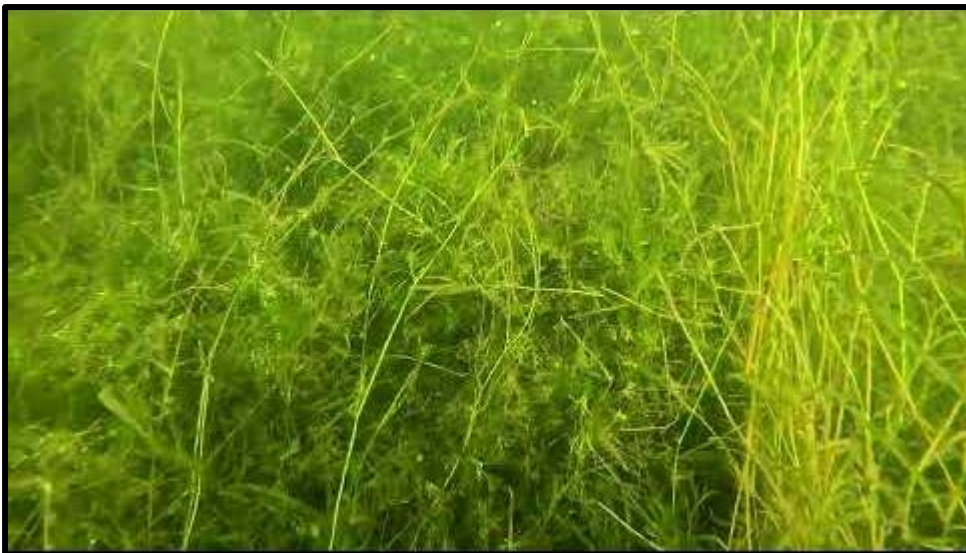
*Chara australis* dominated the deeper macrophyte extent from 5 – 8 m with some beds extending to 9 m. The shallower sections of the charophyte meadows (5 – 6 m) often had tall stems of pondweed (*Potamogeton ochreatus* & *Potamogeton cheesemanii*) with gradually decreasing cover toward the maximum vegetated depth (Video 29).

**Video 29:** Dense charophyte meadow with tall stems of pondweed.

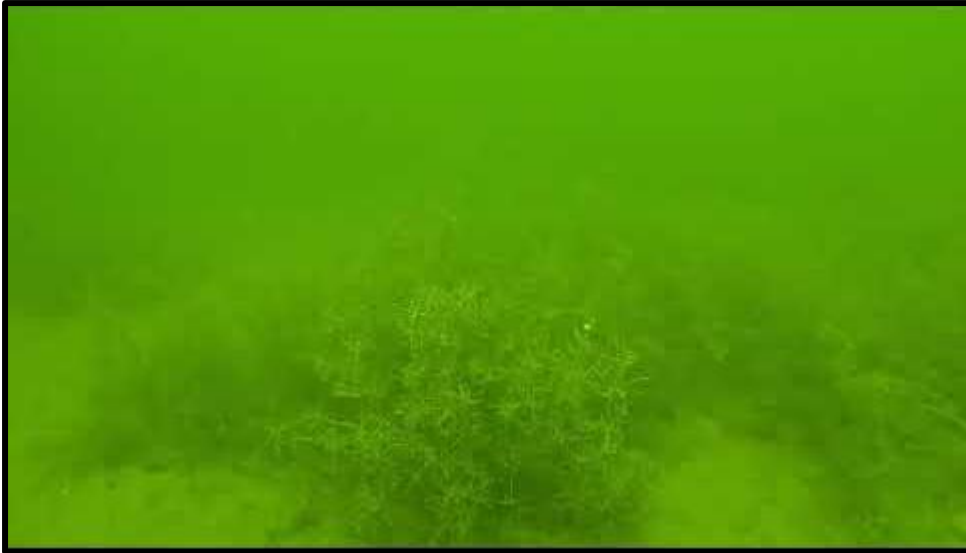
*Chara australis* was the only macrophyte that formed significant covers along the maximum vegetated depth extent (7 – 9 m) (Video 30). The charophyte meadows seen

between 5 – 6 m began to thin out and fragment into small to medium sized beds along the outer edge of the maximum vegetation extent (7 – 9 m) (Video 30). Below 9 m the lakebed was completely bare and devoid of macrophyte growth.

**Video 30:** Lower macrophyte depth extent with fragmented charophyte meadows.

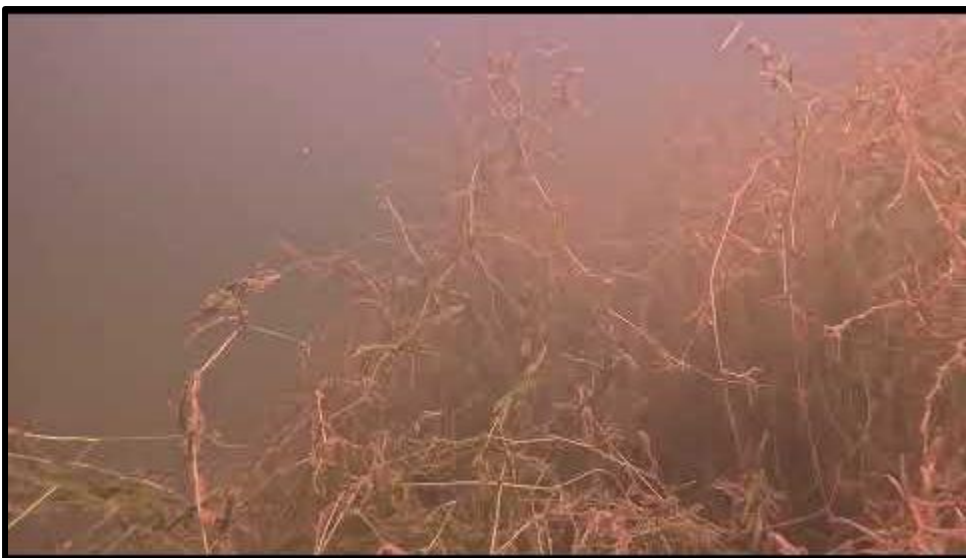
Macrophyte condition was good overall. There were sections of the upper littoral zone (0.5 – 3 m) where the macrophytes were coated with epiphyton and the deeper sections (> 6 m) had larger clumps of charophytes covered with benthic algal mats. The mid depth macrophyte growth had a light dusting of organic floc/epiphyton but no algal mats. The pondweed in several of the shallow bays were bleached which is a likely result of light intensity and temperature (Video 31).

**Video 31:** Shallow pondweed with epiphyton & bleaching.

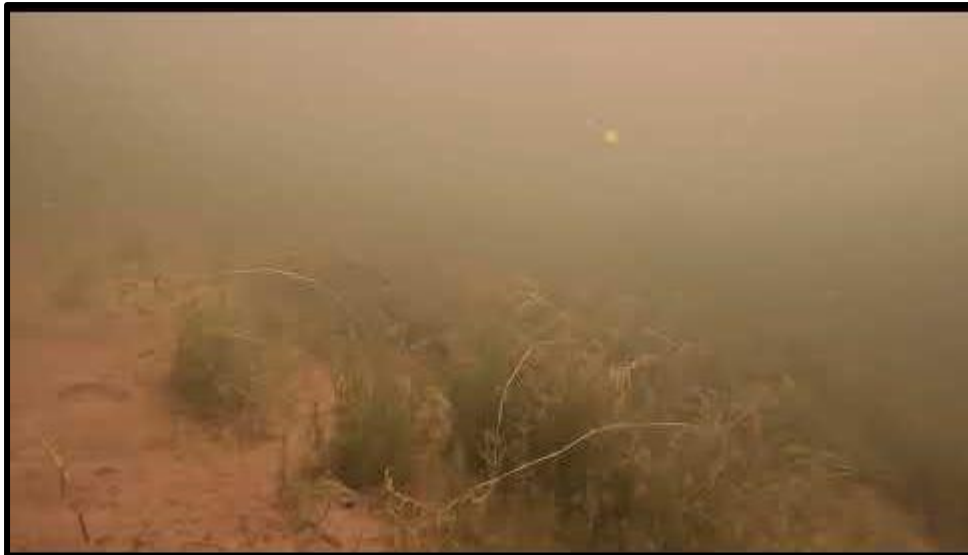
The in-lake stressors have confined most of the vegetation to a band along the mid-depth contours. The upper macrophyte extent appears to be driven by water level, encroaching emergent vegetation, turbulence and heat/light intensity (Video 32). The lower macrophyte extent is primarily governed by photic depth and anoxic conditions in the hypolimnion below 6.5 m deep (Video 32).

**Video 32:** Representative transect across the macrophyte extent indicating the concentration of growth along the mid-depth contours.

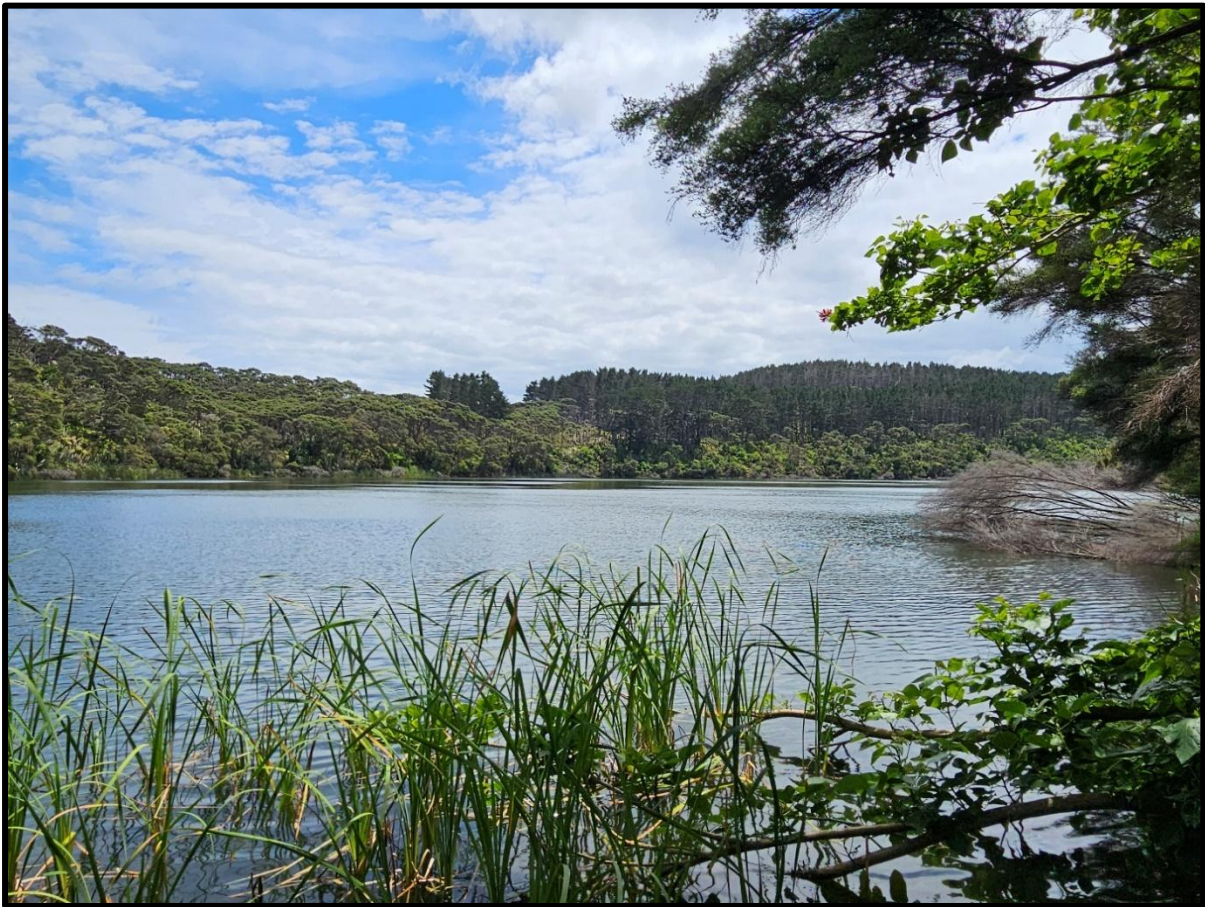
**Photo plate 13:** North facing view across lake Kuwakatai.

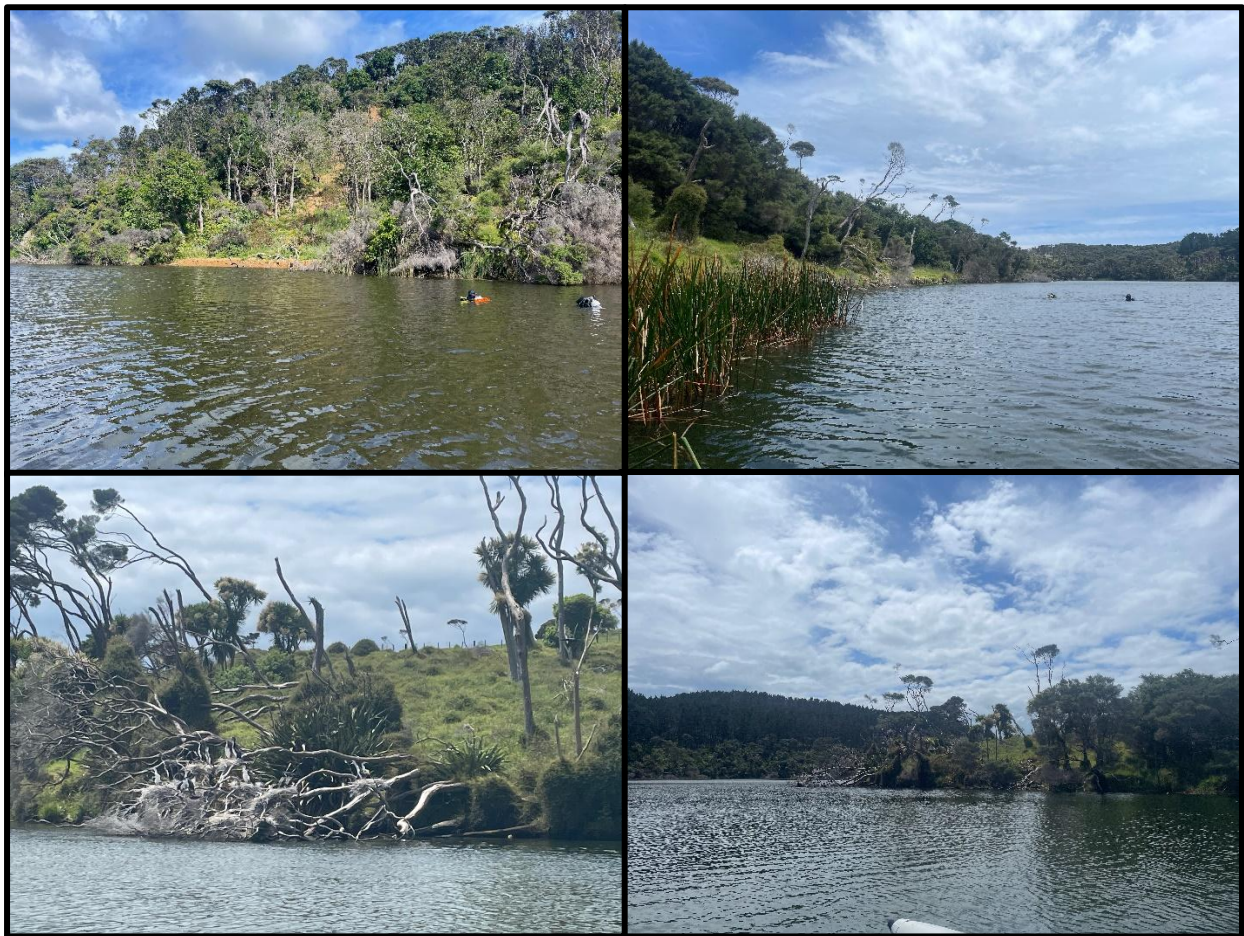
Several landslides were visible along the steep sloped northern bank, the pastoral southern sub-catchment exhibited no signs of recent erosional issues (Photo plate 14). The lake is entirely fenced along the southern boundary which excludes stock from the adjacent paddocks, however, the northern boundary is unfenced and backs onto native scrub and forestry which support a sizable feral deer population.

**Photo plate 14:** Depauperate riparian margin – *Top row:* Land slips, damaged understory & narrow fragmented riparian margin; *Bottom row:* Fallen trees & exotic grass in the riparian margins.

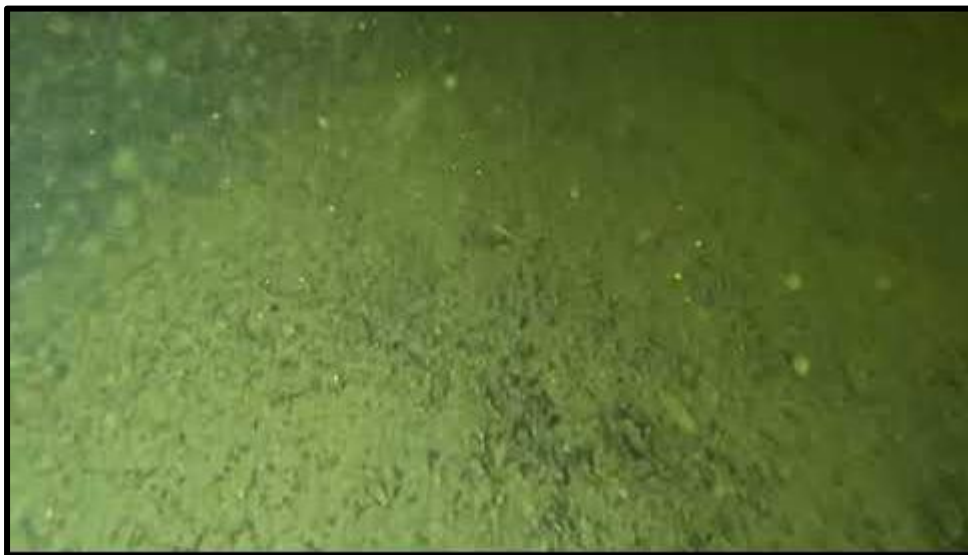
These invasive species have significantly altered the lake and are primary contributors to the deteriorating water quality and ecological health.

**Video 33:** Benthic feeding pits on the lakebed created by coarse fish.

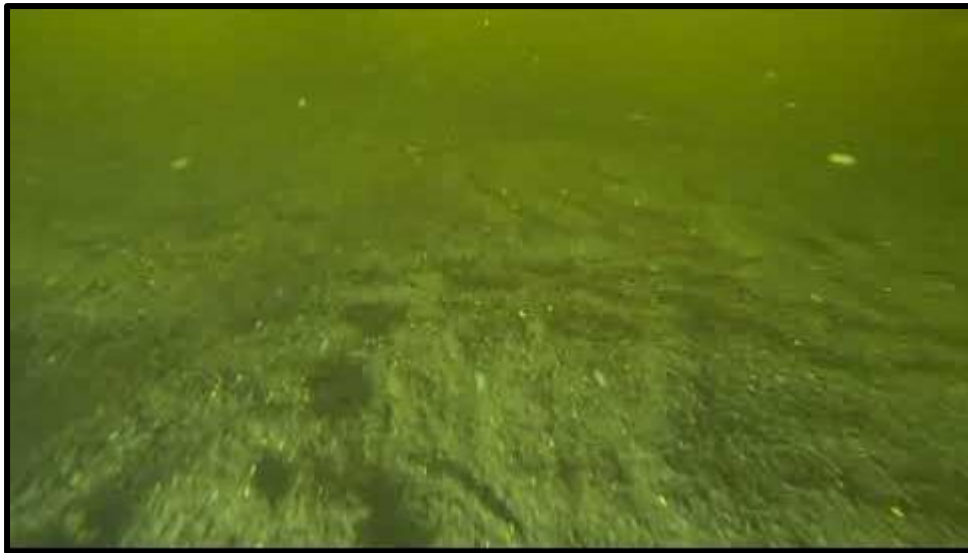
Visibility was approximately 2 m in the epilimnion and 4 m in the hypolimnion. The epilimnion had high concentrations of suspended particulate matter and clusters of algae. The hypolimnion was dark and notably clearer but still had suspended aggregates of algae (Video 34).

**Video 34:** Suspended algae in the hypolimnion.

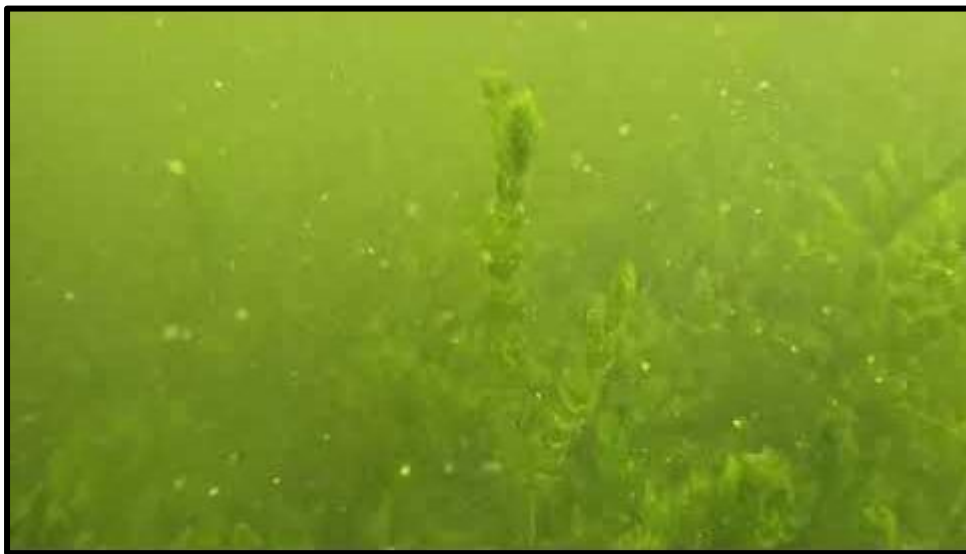
Hornwort formed a wide, almost continuous, band around the entire lake that extends up to 100 m from shore in some areas, the average width across the lake was assessed as 50 m wide. This band created a dense closed canopy (85 - 100% cover) from 0.2 m to a maximum of 6.5 m deep (Video 36). The growth was almost surface reaching in all locations with some stands measuring 5.2 m tall. Signs of persistent anoxia were noted along the underlying substrate below the hornwort beds.

**Video 36:** Dense hornwort growth in the upper littoral zone.

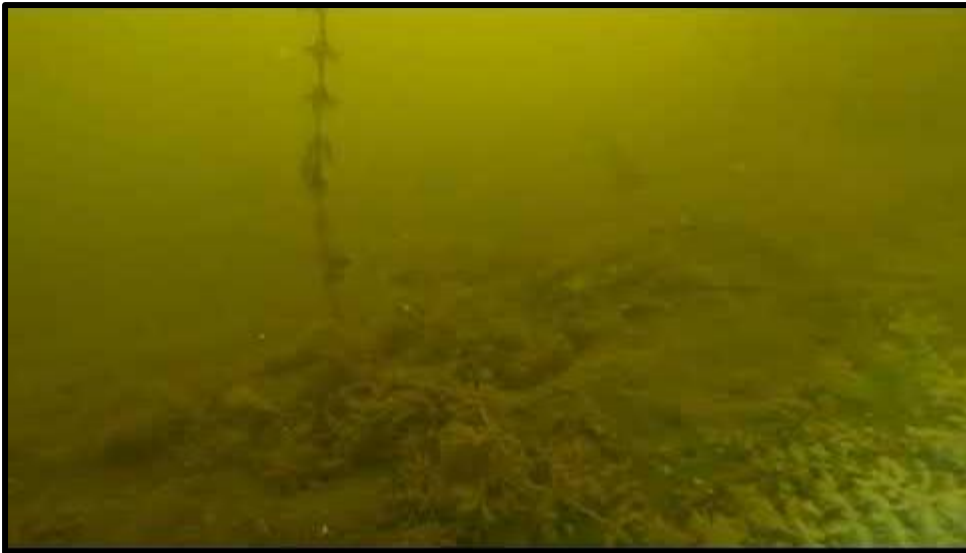
There was a defined line along the 5 m depth contour where the dense hornwort band ended. Past 5 m, hornwort formed fragmented beds that eventually dispersed into small clumps and isolated stems past 6 m (Video 37).

**Video 37:** Lower hornwort extent with sparse cover and poor macrophyte condition.

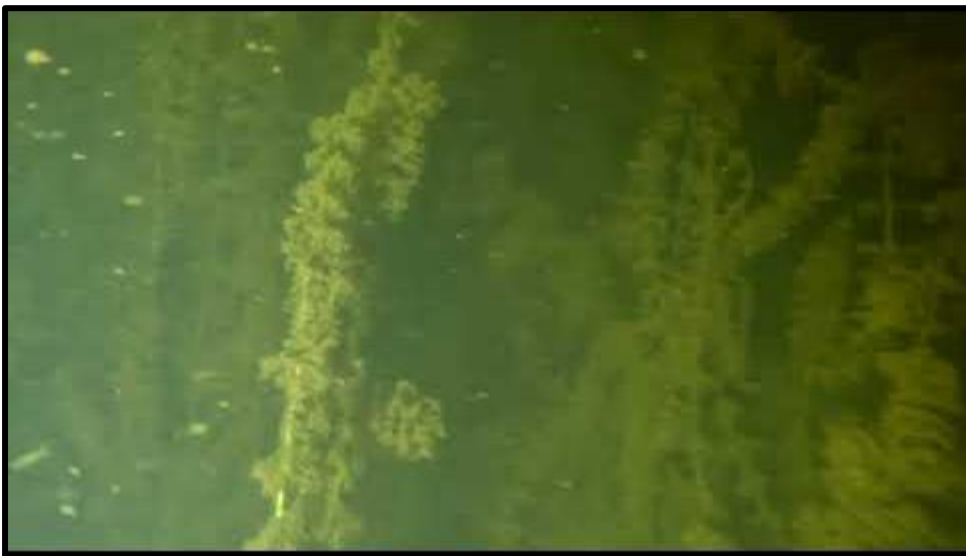
**Video 38:** Etiolated hornwort below the thermocline.

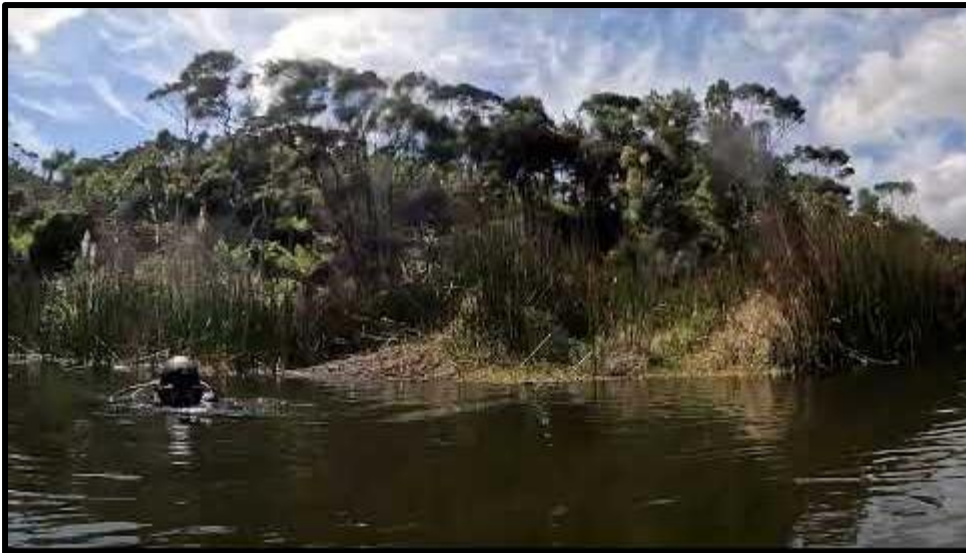
The riparian zone around Lake Te Kanae is relatively intact, with a well-established band of native emergent vegetation along 80% the lake's perimeter. Raupō reedland, flax, and sedges form an almost continuous band averaging 3 - 5 m in width. The emergent reed line is broken in some parts by bare areas, collapsed banks and areas where the manuka/kanuka scrub extends into the lake (Photo plate 16). The northern arm of the lake has a 10 - 15 m wide lacustrine wetland that stretches along the outer edge of the northern bay (Video 39).

**Video 39:** Lacustrine wetland along the outer edge of the northern bay.

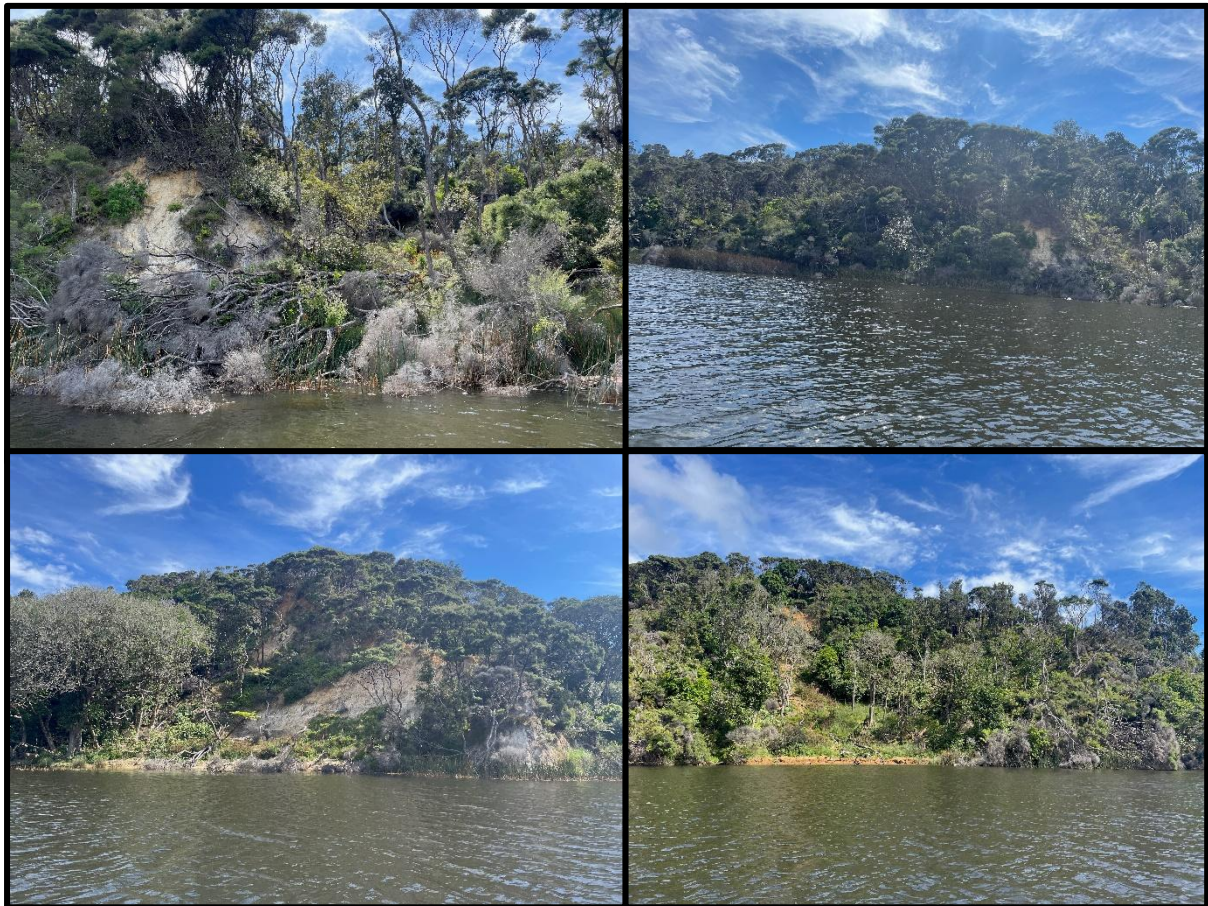
**Photo plate 16:** Cyclone induced damage in the riparian margin – Top row: Fallen trees & damaged riparian vegetation entering the lake; Bottom row: Land slips & bare earth on the steep slopes adjacent to the riparian margin.

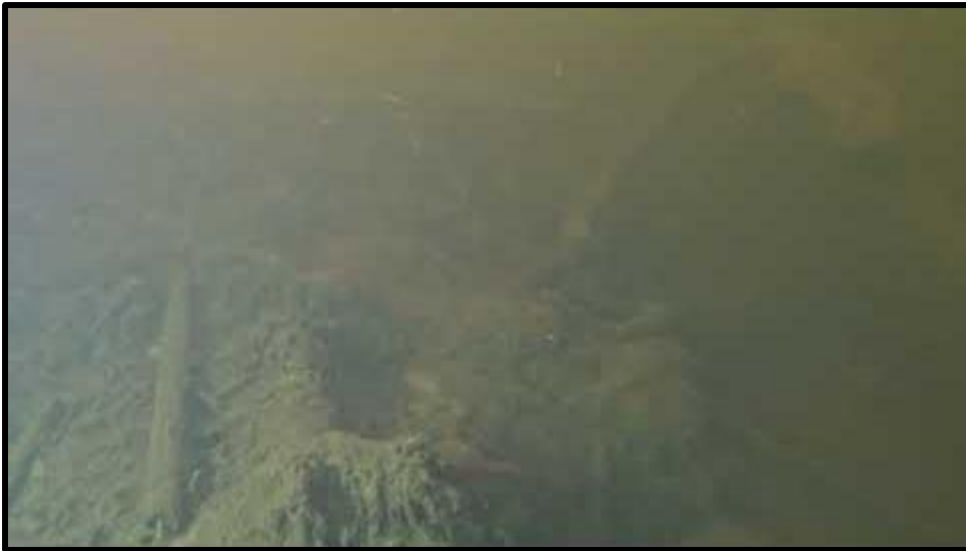
The lake was stratified during the survey and had a distinct thermocline at 4.4 m. A sulphide haze extended from 0.5 m to 4 m and is likely a result of the decomposition of organic matter along the base of the emergent vegetation (Video 41). The shallow lake margin (0 - 3 m) had large deposits of woody debris, detritus and fallen manuka/kanuka trees.

**Video 41:** Woody debris, decomposing organic material & sulphide precipitate in the upper littoral zone.

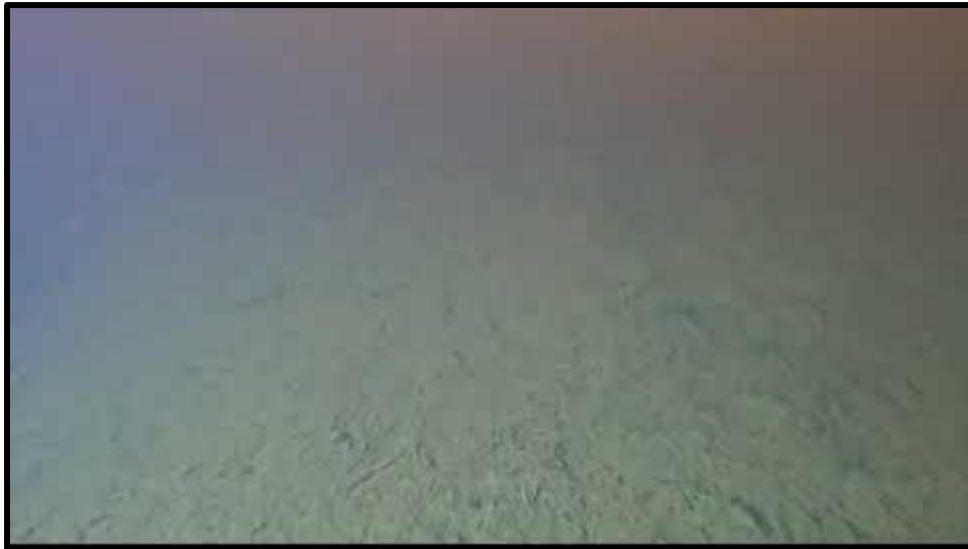
The majority of the lakebed slopes steeply from the base of the emergent vegetation (2.8 m) at a constant gradient until 4 m deep where the gradient becomes less steep but continues to slope past 7 m. The deep in-lake deposition zone is likely deeper than the maximum dive depth of 8.5 m recorded during the survey. The northern end of the lake has a gentler bathymetric gradient and significantly more organic matter deposition because of the bordering wetland. The substrate in this area had a 0.8 - 1 m thick layer of soft silt and organic floc. This area also had higher covers of benthic algal mats (Video 42) which in places reached more than 25% cover with an average of 15% cover across the entire northern arm. This is indicative of possible localised nutrient enrichment.

**Video 42:** Benthic algal mats along the deeper contours of the northern bay.

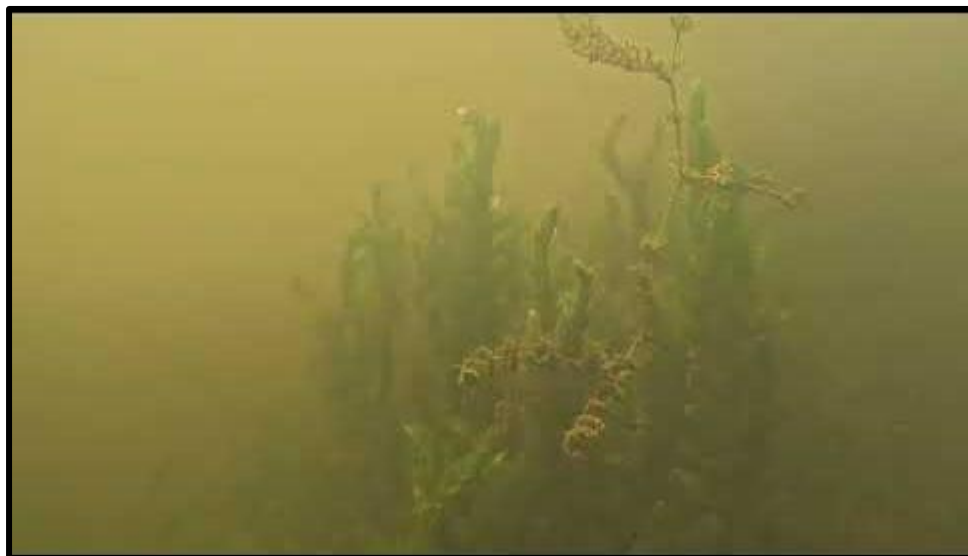
The non-vegetated classification, resulting from the low macrophyte cover, places the lake in a D band for the Native Condition Index National Objectives Framework attribute (Figure 16). The Invasive Impact attribute is not applicable to non-vegetated lakes however, significant hornwort (*Ceratophyllum demersum*) growth was found in discrete locations outside of the survey transects (Video 43).

Single stems and small isolated clumps of hornwort (*Ceratophyllum demersum*) were seen in parts of the littoral zone but did not achieve covers higher than 10% along any of the survey transects. The southern bay (not on a transect) had an extensive bed of short growing hornwort along the edge of the emergent vegetation, this was the largest and densest bed observed during the survey (Video 43). This bed decreased in density as it extended into the shallow sandy areas on the sides of the bay.

**Video 43:** Hornwort bed along the southern bay.

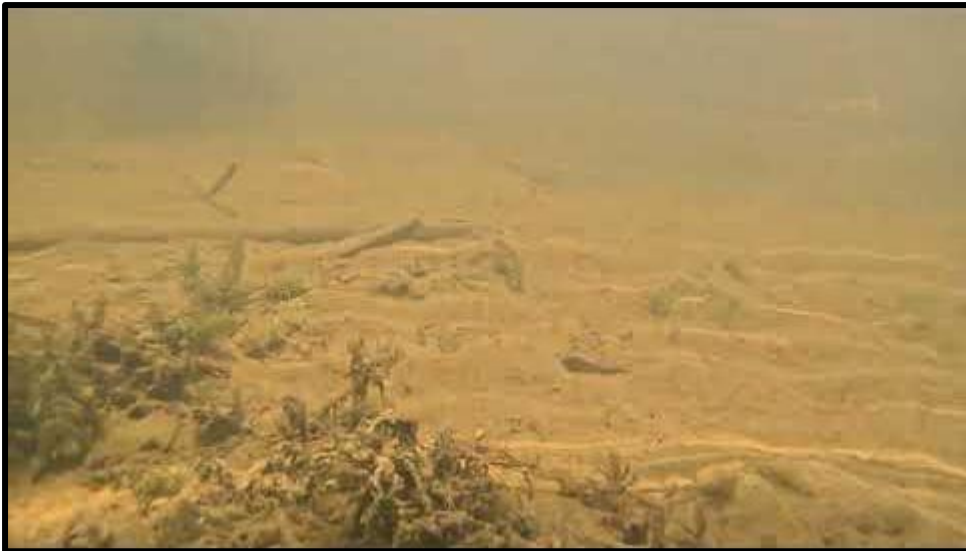
Small clumps of hornwort were seen amongst the sparse emergent vegetation in these exposed sandy areas, the lack of riparian vegetation along this bay has led to increased sediment deposition and the burial of hornwort patches (Video 44).

**Video 44:** Hornwort in the shallows along the southern bay with sections of burial from recent sedimentation.

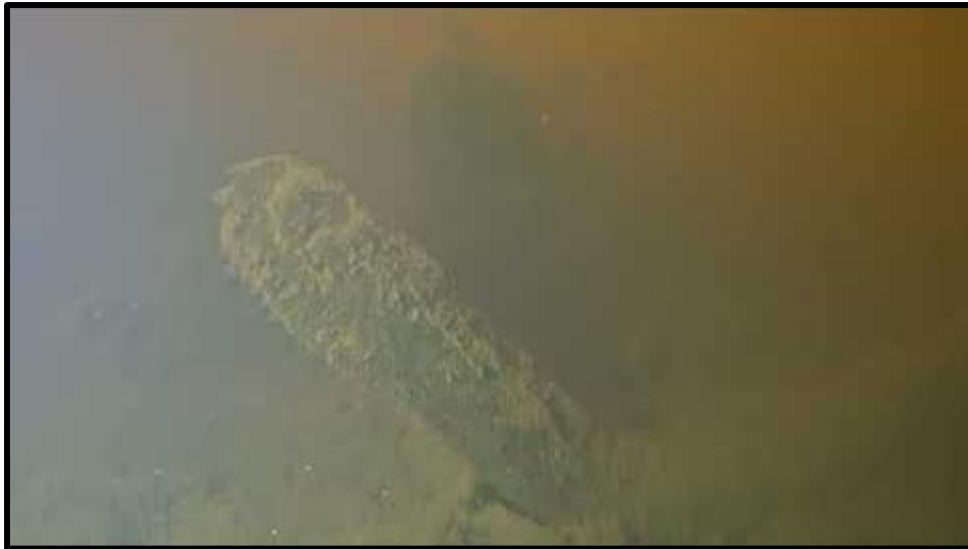
Video 45 is a representative transect extending from a depth of 8.5 m to 0.5 m, this video illustrates the non-vegetated nature of the majority of lake as well as the substrate characteristics and delineation between the hypolimnion and epilimnion.

**Video 45:** Representative transect from 8.5 m to 0.5 m indicating the non-vegetated nature of the lake & substrate characteristics.

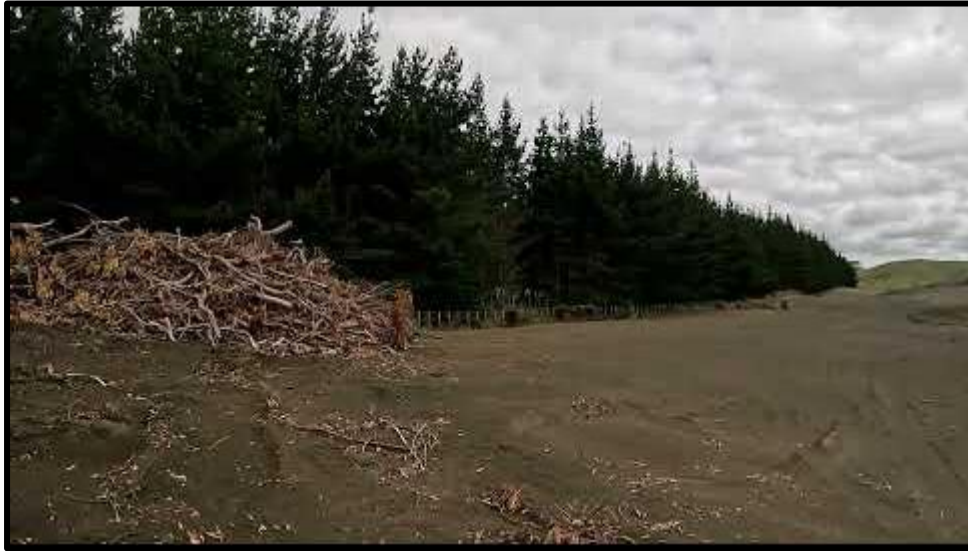
The recent development of a new golf course is currently underway and has created large areas of bare earth (Video 46). The site is in the early stages of earthworks and will change significantly over the upcoming year. It is likely that the bare earth will be converted to golf greens, sand bunkers and natural features which could return habitat value and buffering to portions of the lake edge.

**Video 46:** Alterations to the riparian margin resulting from the golf course development.

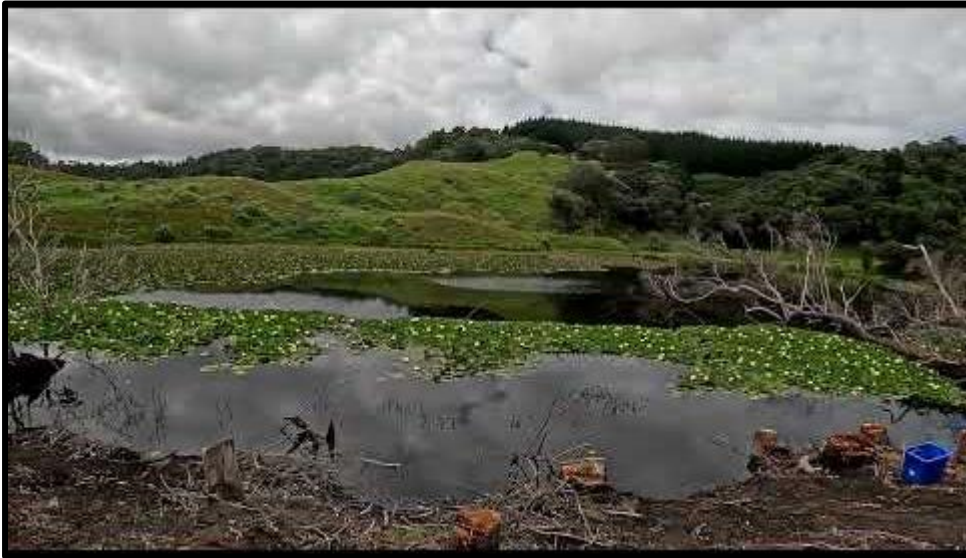
**Video 47:** Riparian impacts resulting from the golf course development.

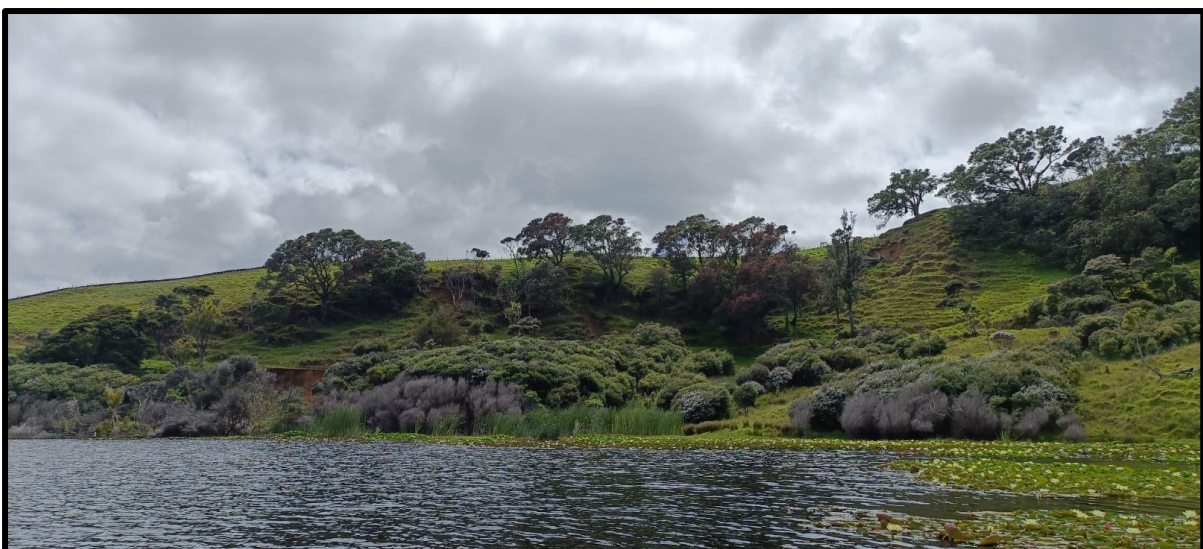
The eastern section of the lake has a narrow-fragmented band of raupō reedland and patches of native sedges that provide buffering against runoff (Photo plate 18). The average width of this riparian zone is less than 1 m however, the southeast section has more established riparian vegetation (Photo plate 18).

**Photo plate 18:** Section of the southeastern riparian margin with emergent reed beds that back onto native scrub.

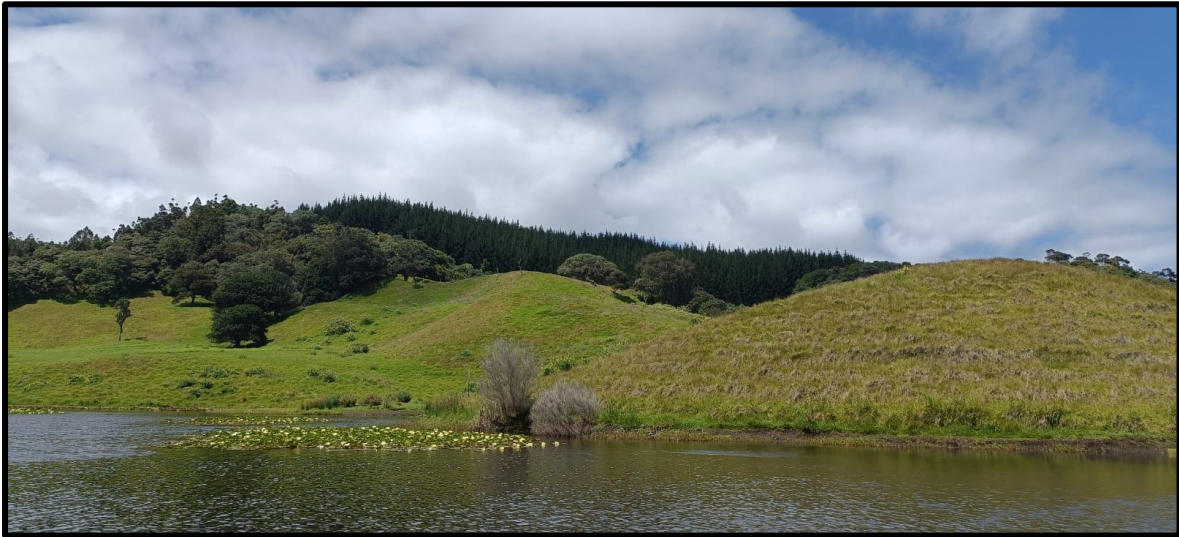
The western and southern banks are largely bordered by short homogenous exotic pasture with little other emergent vegetation and areas of bare soil resulting in less buffering capacity. This bank has limited to no emergent vegetation and often had undercut banks and bank collapses (Photo plate 19).

**Photo plate 19:** Representative section of the western and southern riparian margins indicating limited emergent vegetation, exotic grass cover and bank erosion.

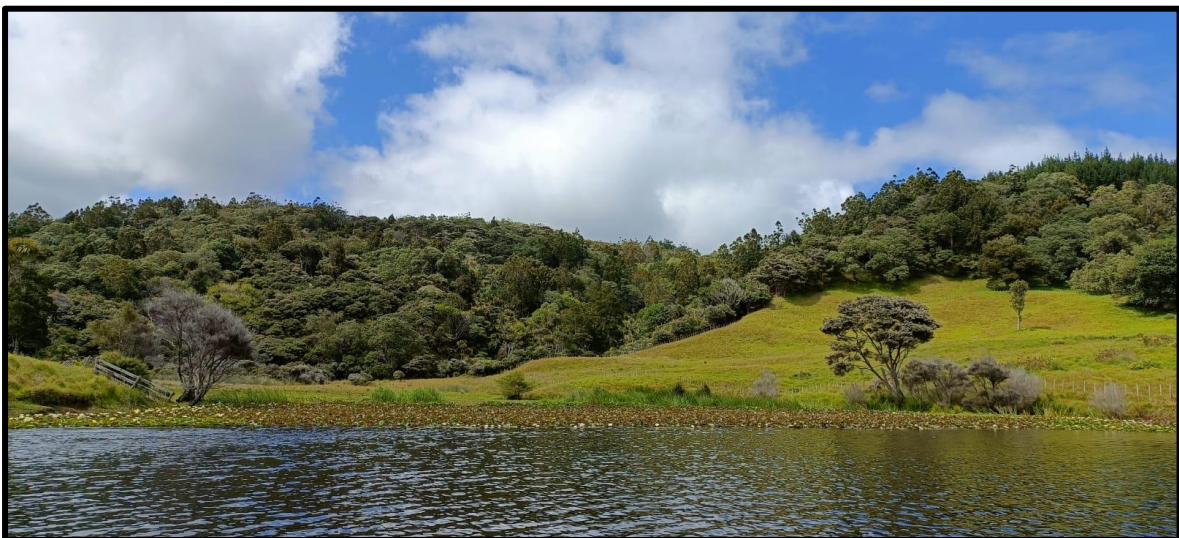
The southern tip of the lake is bordered by a small wetland feature, extending about 15 m from the shore however, this feature is still dominated by exotic pasture and provides limited buffering capacity (Photo plate 20). The fragmented emergent vegetation is surrounded by exotic lilies that form a large surface aggregation across the entire bay (Photo plate 20).

**Photo plate 20:** Southern tip of the lake with the exotic lilies in the foreground, fragmented emergent vegetation in the midground and the exotic pasture dominant wetland feature in the background.
