**Auckland Lake Assessments**

**2024**

| <b>Document title:</b> | Auckland Lake Assessments 2024 |
| <b>Prepared for:</b> | Auckland Council |

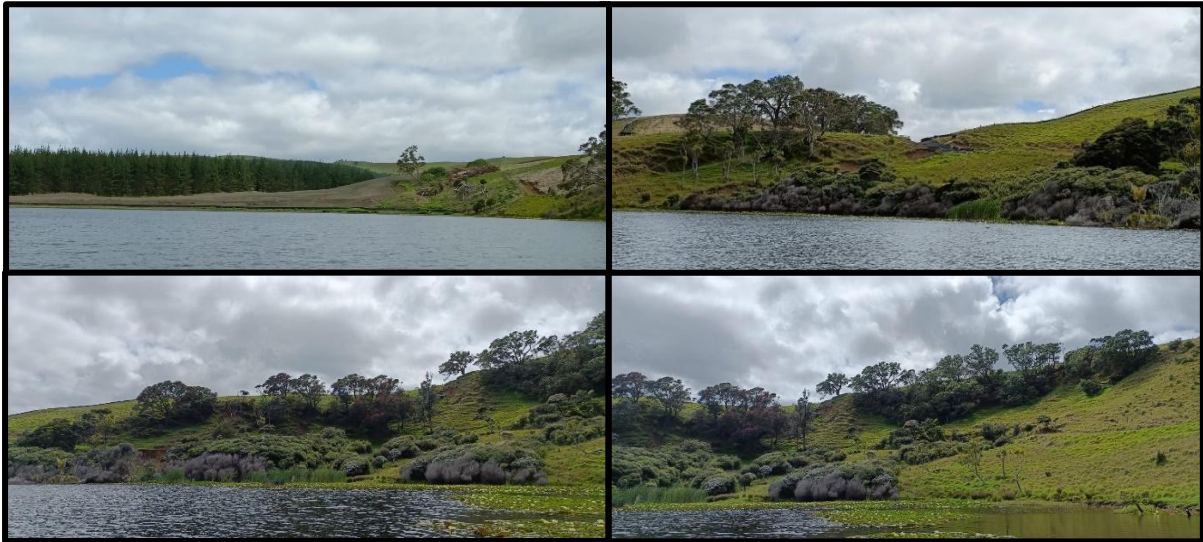
**Photo plate 21:** Representative photos of common erosional features observed on site including landslips and grazing related erosion.

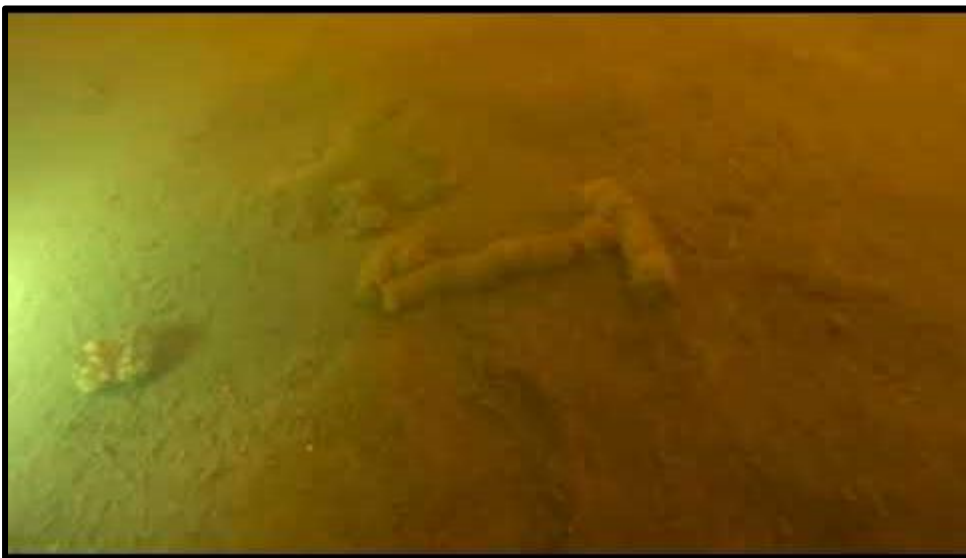
Lake Ōkaihou supports a large population of Canadian geese (*Branta canadensis*) with more than 100 sighted during the survey. The large biomass is evident by the amount of faeces seen across the lakebed (Video 48).

**Video 48:** Bird faeces & benthic feeding pits on the lakebed.

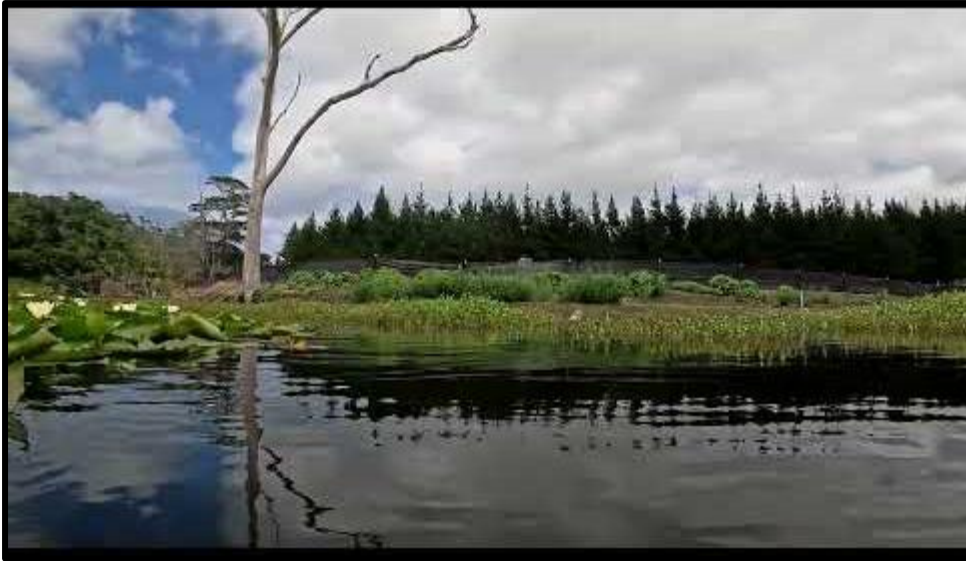
Floating species created a wide band along 75 - 80% of the lake margin. The western arm was almost entirely covered with exotic waterlilies (*Nymphaea cultivars*) (Video 50) and the southern end of the lake had a 20 - 30 m wide band of waterlilies (*Nymphaea cultivars*) and alligator weed (*Alternanthera philoxeroides*) (Video 50). The rest of the lake had sections of alligator weed (*Alternanthera philoxeroides*), water primrose (*Ludwigia peploides*) and waterlilies (*Nymphaea cultivars*) ranging from 2 - 5 m wide. The dense floating vegetation has shaded out large sections of the lake and rendered them unable to support macrophyte growth.

**Video 50:** The western arm of the lake choked with exotic lilies.

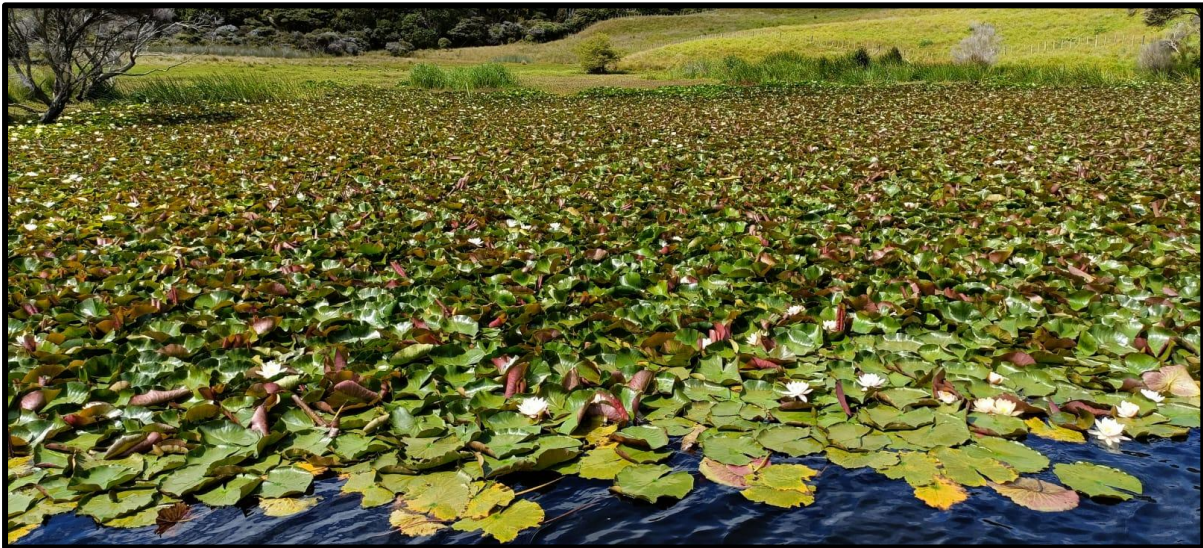
**Photo plate 22:** Southern bay choked with waterlilies.

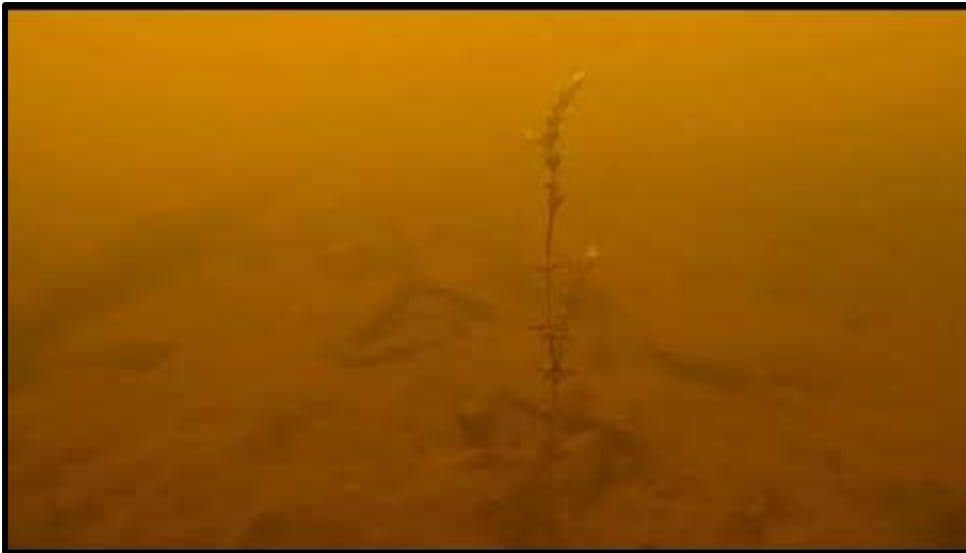
Hornwort was sparsely distributed throughout the lake and primarily occurred as small clumps and single stems with covers of 1 - 5 % (Video 51). The overall plant condition is good with minimal signs of prolonged stress and almost no epiphytic coating.

**Video 51:** Representative hornwort growth indication low cover, short single stems & small clumps.

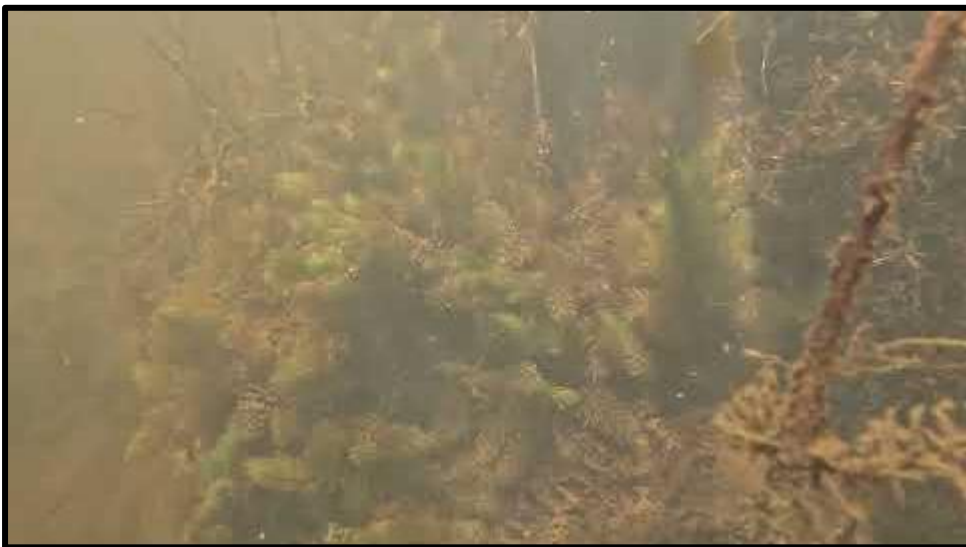
Dense beds of hornwort were found in discrete locations along the western bay near transect C (Video 52) and the southern bay near transect B (Video 53). In both cases hornwort formed a 10 m wide band along the upper littoral margin with almost 100% cover between 0.3 - 1.8 m deep. The maximum depth at which hornwort was detected was 2.9 m and the tallest stand reached 140 cm, the average height was 36 cm.

**Video 52:** Dense hornwort growth in the upper littoral zone along the western bank.

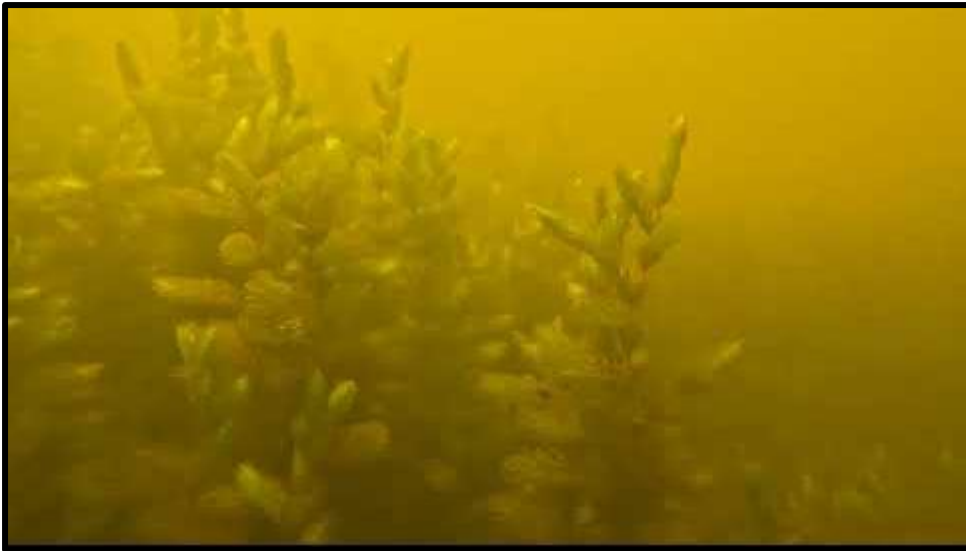
**Video 53:** Tall dense hornwort growth along the southern bay.

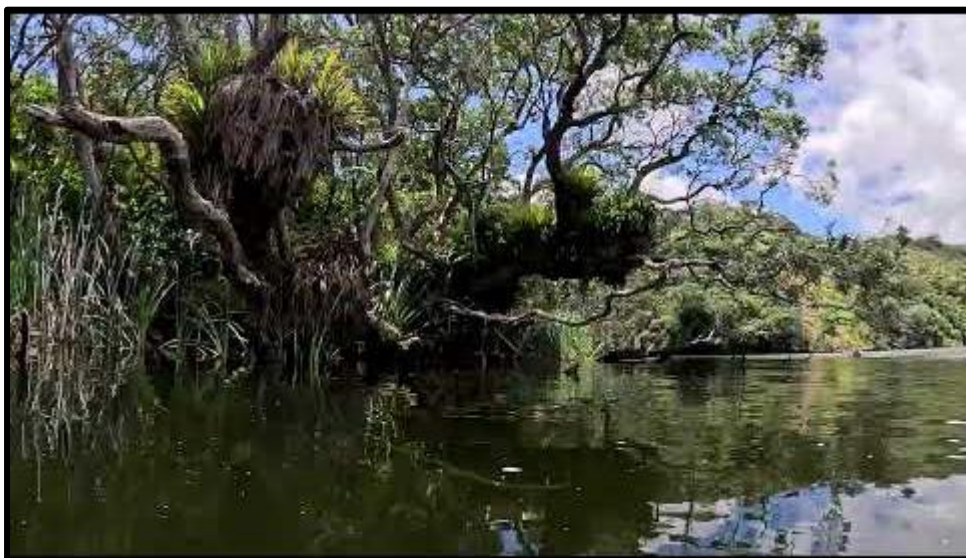
The riparian zone surrounding Lake Kawaupaku is variable in width and quality, emergent vegetation formed a fragmented fringe along ~75 % of the lake edge with an average width of 0.5 - 3 m (Video 54). The northern and western banks feature a narrow strip of riparian vegetation, mostly consisting of raupō reedland and small patches of native sedges. The terrestrial vegetation extends from the surrounding slopes into the riparian margin and consists of native scrub and tall canopy species that often overhang into the lake (Video 54).

**Video 54:** Representative riparian margin with native scrub, overhanging trees and an emergent reed line.

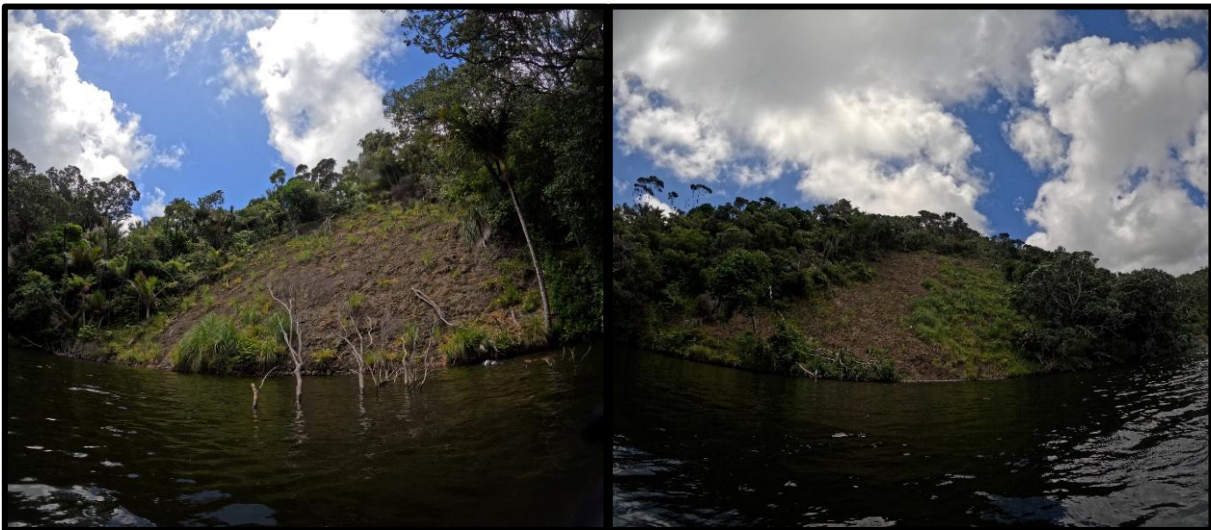
Large areas of bare soil, collapsed banks and land slips were commonly seen across the steep slopes (Photo plate 24). The larger slips are a result of Cyclone Gabrielle (February 2023) however, there is evidence of historical erosional issues pre Cyclone Gabrielle. These erosional issues have created sizable deposits of sediment and organic matter along the littoral margin.

**Photo plate 24:** Cyclone induced land slips.

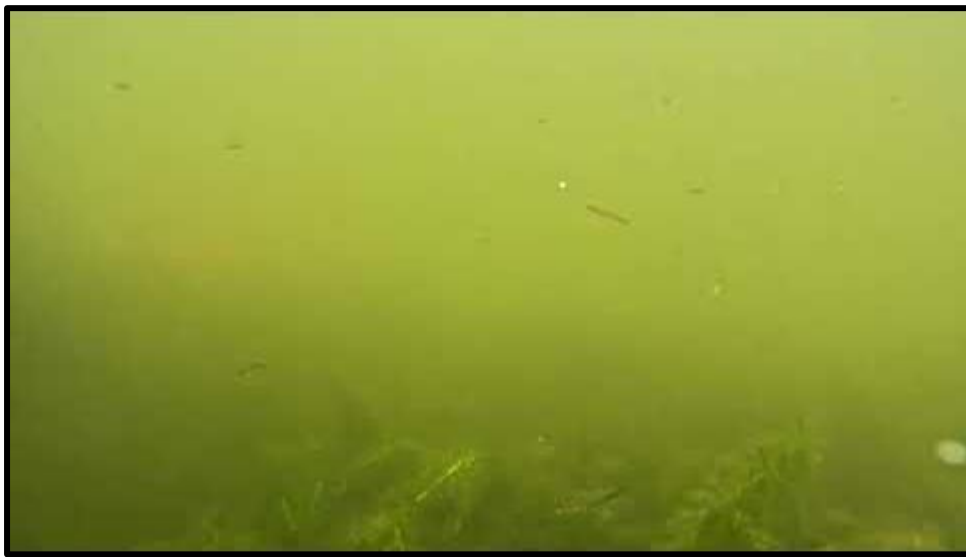
Native common bullies (*Gobiomorphus cotidianus*) are abundant in the lake (Video 55) and shortfin eels (*Anguilla australis*) have been detected (New Zealand Freshwater Fish Database). Invasive coarse fish, rudd (*Scardinius erythrophthalmus*) and tench (*Tinca tinca*) are known to occur in high numbers however none were sighted during the 2024 assessment (New Zealand Freshwater Fish Database, Auckland Council unpublished data, 2022). Extensive benthic feeding pits on the lakebed as well as widespread grazing damage on the apical portion of the *Egeria* stems are indicative of a high coarse fish population.

**Video 55:** School of bullies in the shallow littoral zone.

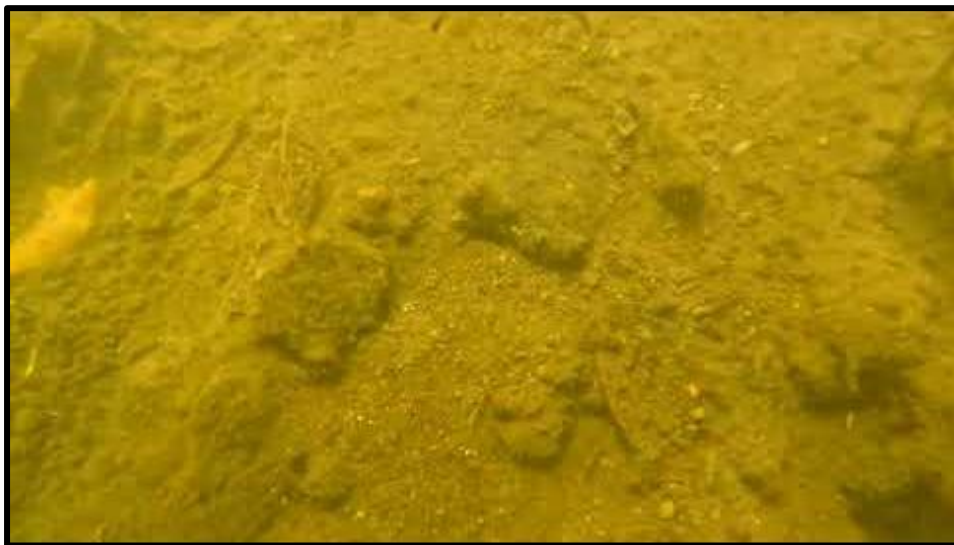
Cyclone induced landslides have altered the lakebed at the base of the large slips. Topsoil and sediment have buried submerged macrophytes and limited *Egeria* regrowth (Video 56). The substrate at the base of the slips consists of rock, sand and stone as well as large pieces of organic debris. Entire manuka, kanuka and pohutokawa trees were seen on the lakebed. The slips have also created a continuation of the surface slope so that the adjacent hill drops at a constant gradient toward the maximum lake depth, there is no shallow littoral plateau in these areas (Video 56).

**Video 56:** Substrate alterations & macrophyte burial/exclusion caused by land slips.

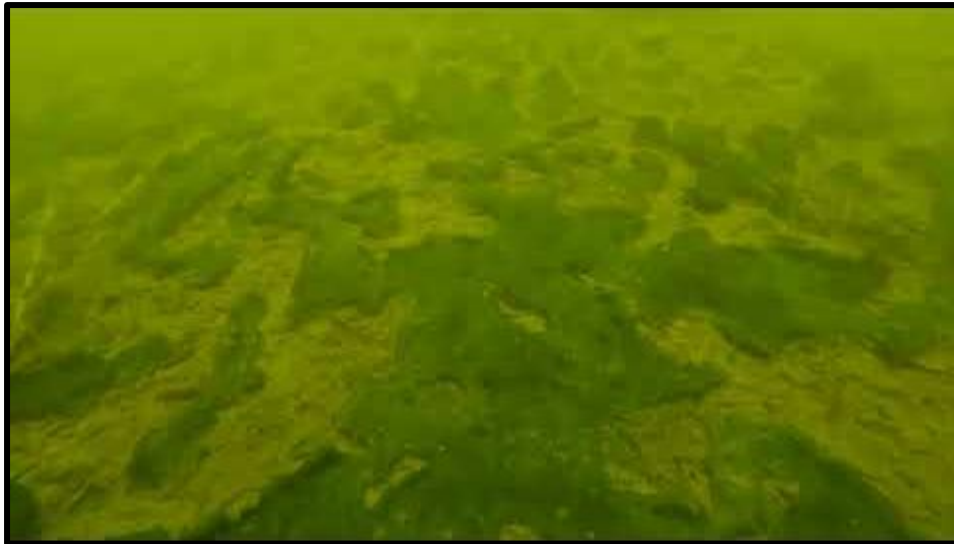
The substrate throughout the rest of the lake was soft with thick layers of organic floc and decomposing detritus. The substrate below the *Egeria* beds showed signs of persistent anoxia and had large amounts of decomposing plant material. Benthic algal mats were common (~75% cover) along the outer edge of the deeper *Egeria* beds (Video 57). The shallower sections of the lake had limited benthic algal growth however, epiphyton was seen coating macrophytes between 0.2 – 0.5 m deep.

**Video 57:** Benthic algal mats along the outer edge of the deep *Egeria* beds.

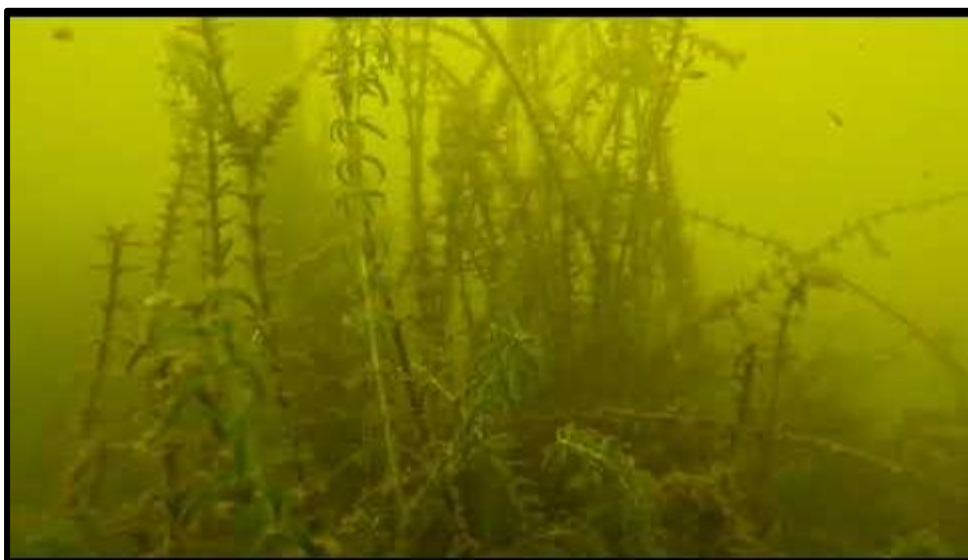
The general growth pattern consisted of dense short beds in the shallows (0.2 – 1.5 m) followed by dense taller beds between 1.5 – 2.5 m deep, the beds gradually became less dense toward the maximum vegetated depth of 4.1 m (Video 58). The reduction in density was offset by an increase in plant height with the tallest stems reaching almost 4 m high. This growth pattern is driven by the ambient light conditions and fluctuating water level.

**Video 58:** Representative transect from the lower macrophyte extent to surface.

The lower macrophyte extent is primarily limited by photic depth and possibly anoxia. Short dense beds form in the shallows where light availability is optimum, less dense but taller stands form along the mid-section of the photic zone where light availability allows for both tall mature plants and new shoots to grow. The deeper contours have prolonged periods of insufficient light over summer where algal blooms reduce the photic depth further, these conditions favour taller plants and limit the establishment of new growth.

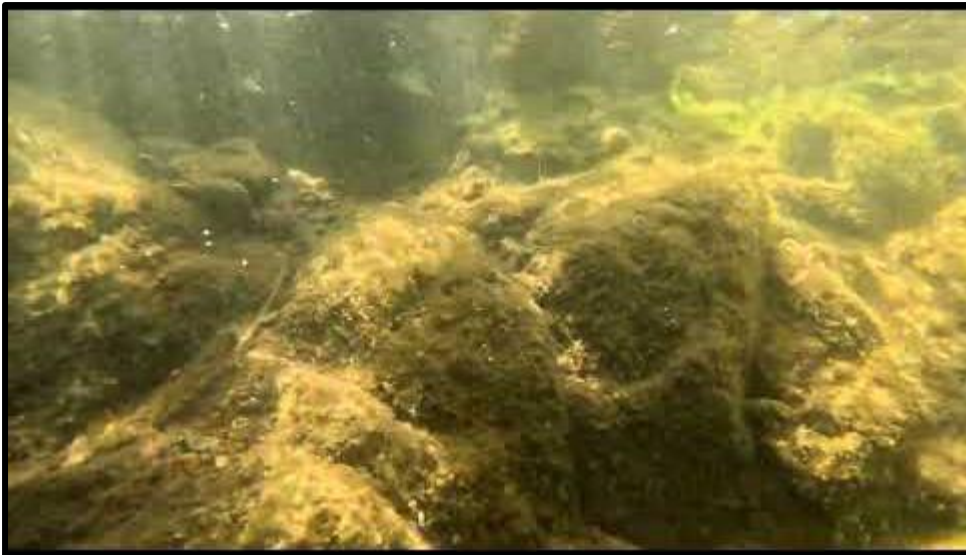
**Video 59:** Transect below a land slip indicating the impacts to the upper macrophyte extent.

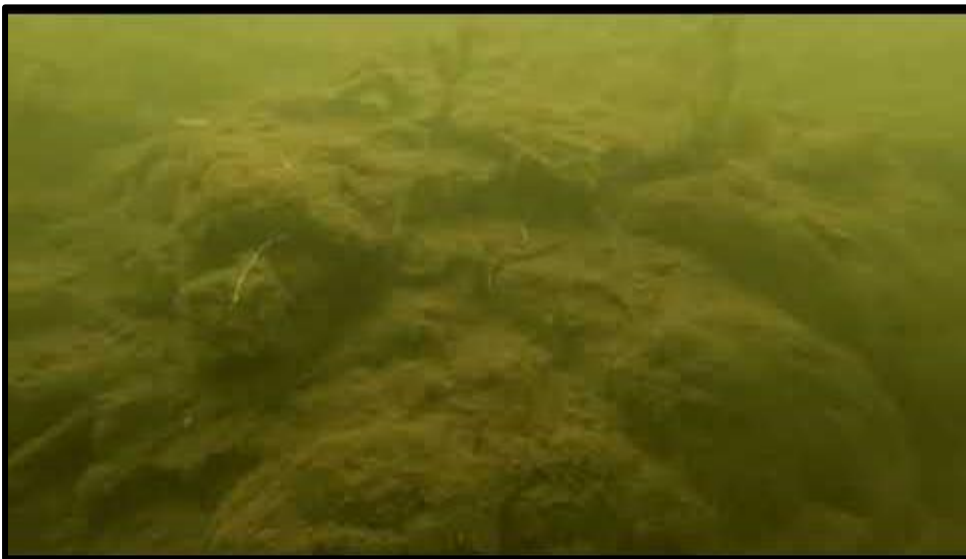
Egeria regrowth was seen at the base of minor slips and along the outer edges of the major slips (Video 60), it is likely that the bare areas will eventually be colonised as the lakebed stabilises.

**Video 60:** Transect from the base of the slope to surface along the outer edge of a slip.

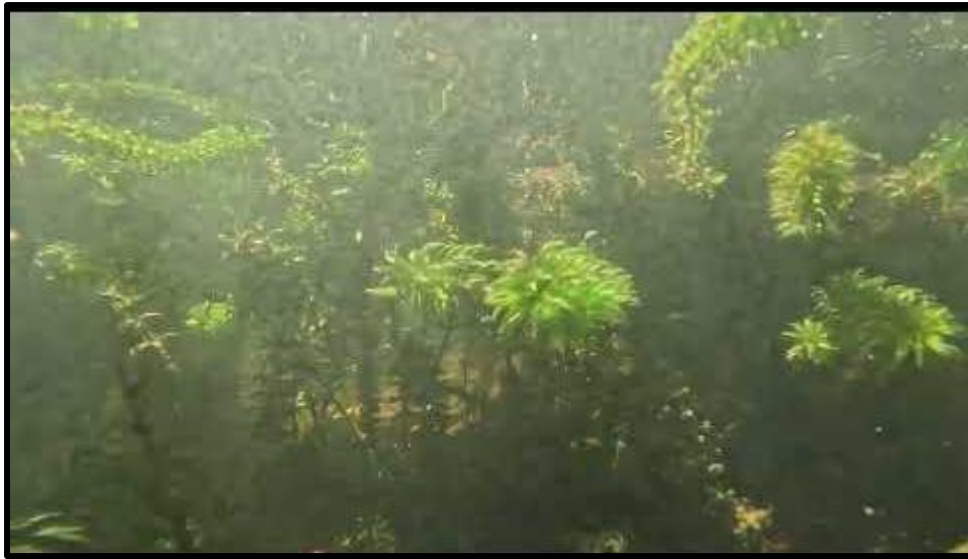
The Egeria beds are resilient to minor sediment inputs and organic matter deposition. Large deposits of woody debris, not associated with landslides, were commonly seen throughout the littoral margin and is a result of the steep loped sub-catchment. This deposition did not appear to limit the upper extent of the Egeria and dense beds had established amongst the debris (Video 61).

**Video 61:** *Egeria* amongst the woody debris & organic material along the lake edge.

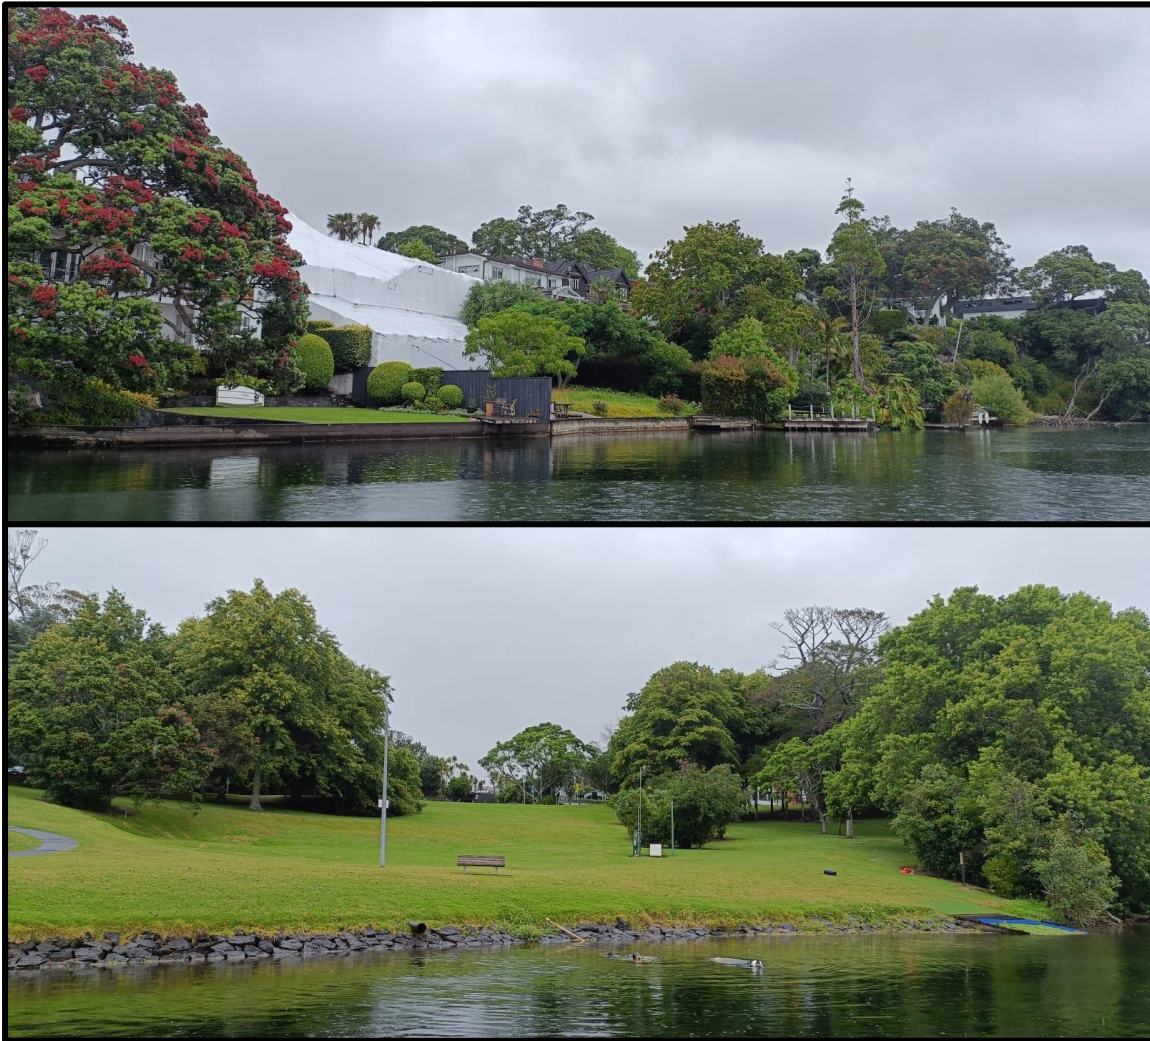
The riparian zone around Lake Pupuke is fragmented due to the surrounding urban development. Much of the shoreline is bordered by residential properties, public parks, and roads, leaving limited room for contiguous sections of native vegetation (Photo plate 26). Exotic garden species and manicured lawns cover the majority of the riparian margin around the lake (Photo plate 26).

**Photo plate 26:** Modified riparian margins – *Top:* Residential properties with maintained gardens extending to the lake edge; *Bottom:* Public park with recreational amenities (bench & boat ramp) and manicured lawn extending to the lake edge.

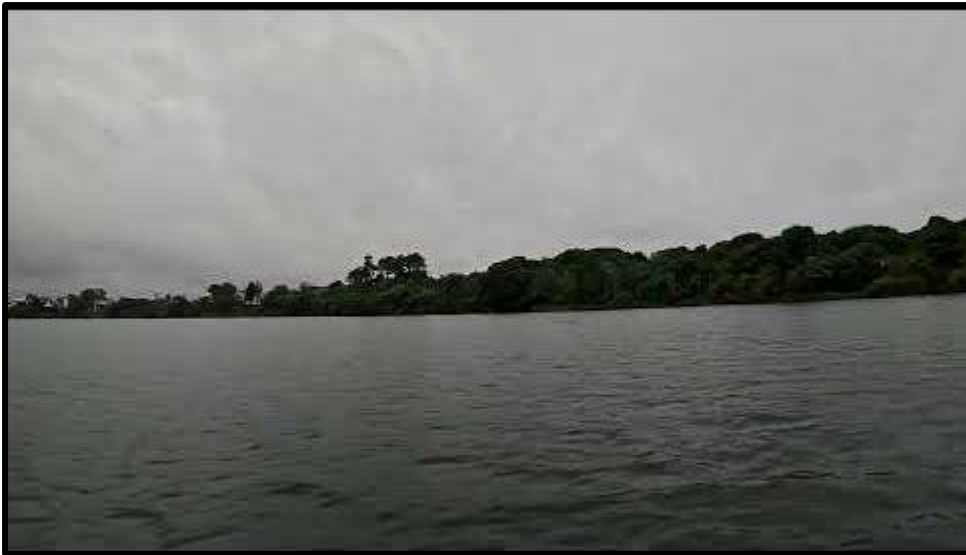
There are some sections, particularly around Killarney Park and Sylvan Park, where large strips of intact riparian vegetation can still be seen, these areas provide a buffer zone between the urban environment and the lake (Video 62). Pockets of emergent reeds were seen in parts of the lake, and some have been integrated into the landscaping elements of the surrounding houses. The reeds don't form significant beds and often extend for only short distances.

**Video 62:** Intact riparian margin with mature vegetation along the southern lake edge.

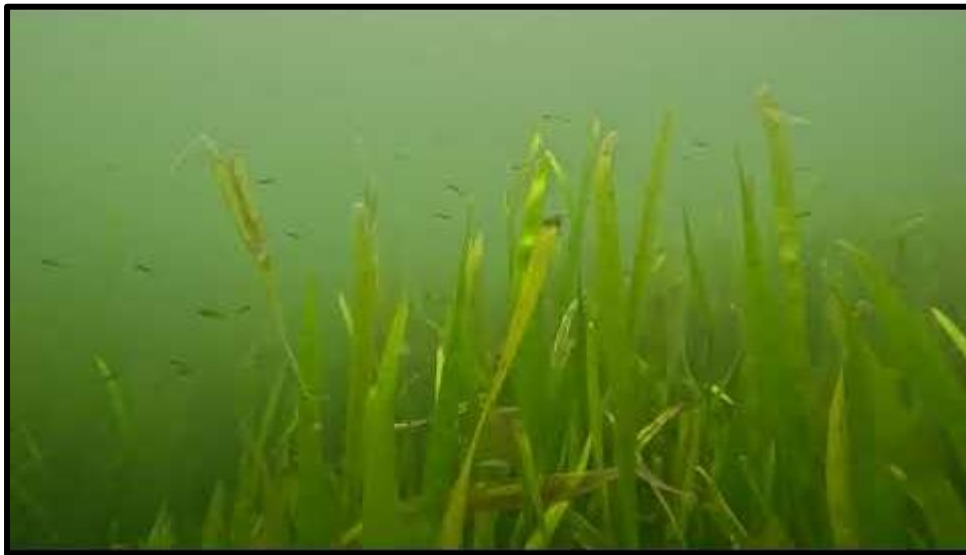
Fish species in Lake Pupuke include native shortfin eels (*Anguilla australis*) and common bullies (*Gobiomorphus cotidianus*), as well as introduced recreational fishing species like rainbow trout (*Oncorhynchus mykiss*) (New Zealand Freshwater Fish Database). Common bullies are the most abundant fish species in the lake and were seen at all survey depths (0 – 10 m) (Video 63). The lake also supports a variety of

**Video 63:** Common bullies amongst the shallow eel grass beds.

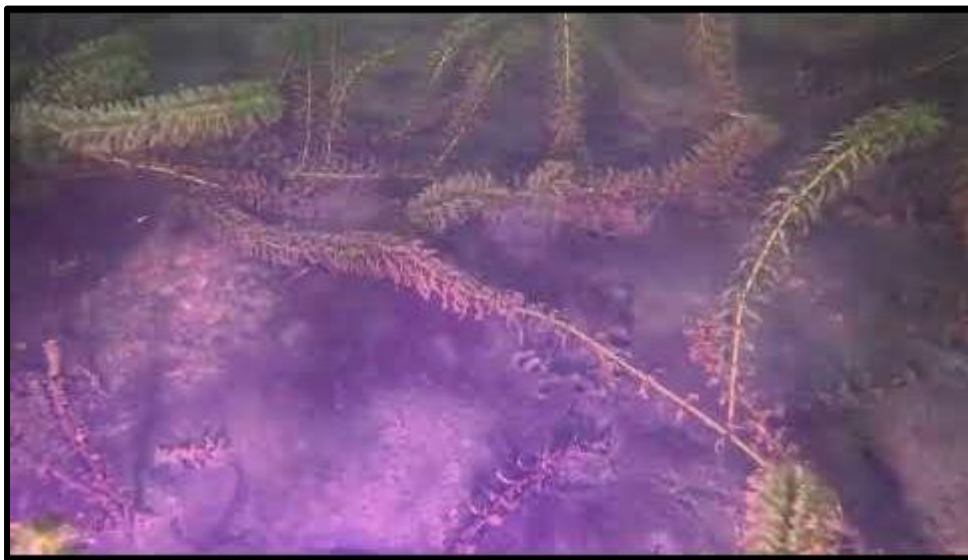
The areas under the *Egeria* and *Vallisneria* beds exhibited signs of persistent anoxia, the substrate was black with a > 1m thick layer of organic floc and had benthic algae. Benthic algal mats with more than 75% cover were common past the maximum macrophyte depth extent and along the outer edge of the deep water charophytes (Video 64).

**Video 64:** Benthic algal mats along the lower macrophyte extent.

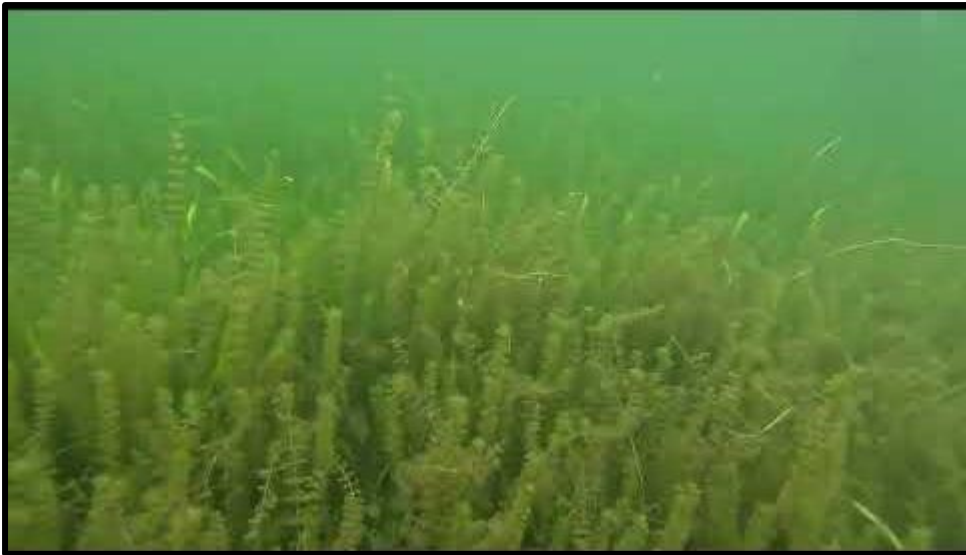
The vegetation assemblage typically consists of a 2 - 5 m wide band of *Myriophyllum triphyllum* with a short *Vallisneria australis* understory in the shallows (0.5 – 1 m) (Video 65), a 15 - 20 m wide band of taller *Vallisneria australis* with small clumps and isolated stems of *Egeria densa* extends from 1 – 2.5 m deep, *Egeria densa* then forms a dense wide (20 – 50 m) band of tall growth from 2.5 – 7 m deep (Video 66). In some areas the *Egeria densa* band extends up to 100 m wide. The outer edge of the maximum vegetated extent (6.5 – 7.7 m) is dominated by *Chara australis* with isolated stems and small clumps of *Egeria densa* (Video 67).

**Video 65:** Band of *Myriophyllum triphyllum* with a short *Vallisneria australis* understory in the shallows.

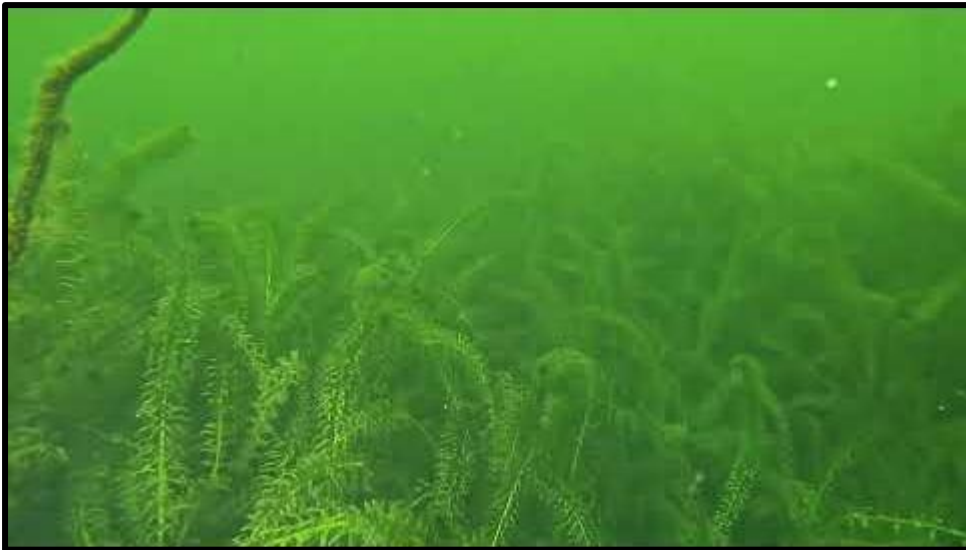
**Video 66:** Extensive *Egeria densa* beds.

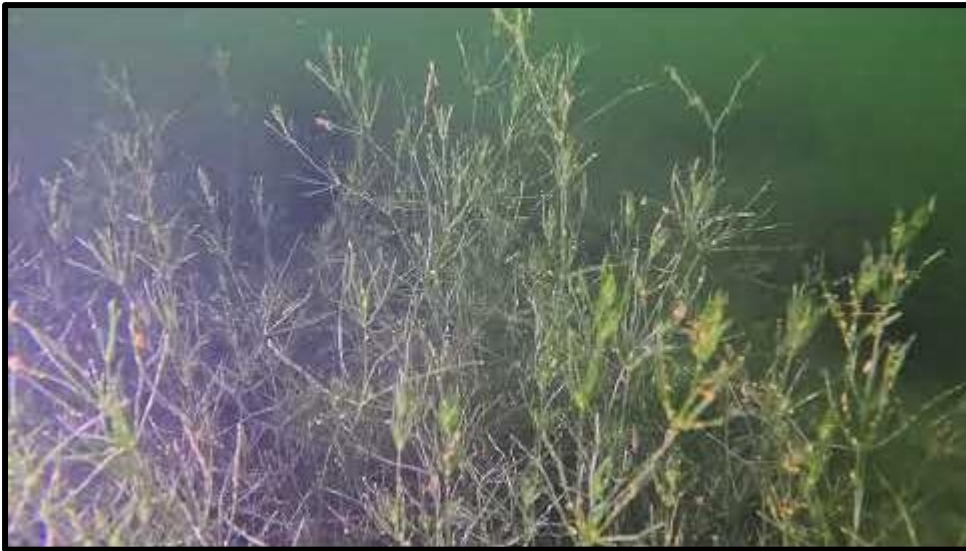
**Video 67:** Deep water *Chara australis* beds with low covers of *Egeria densa*.

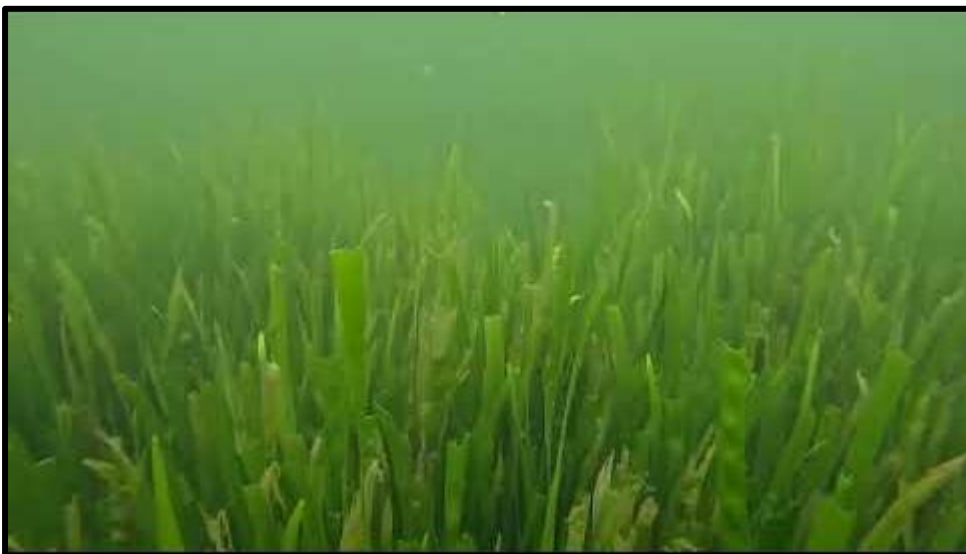
**Video 68:** *Vallisneria australis* with apical damage from grazing swans.

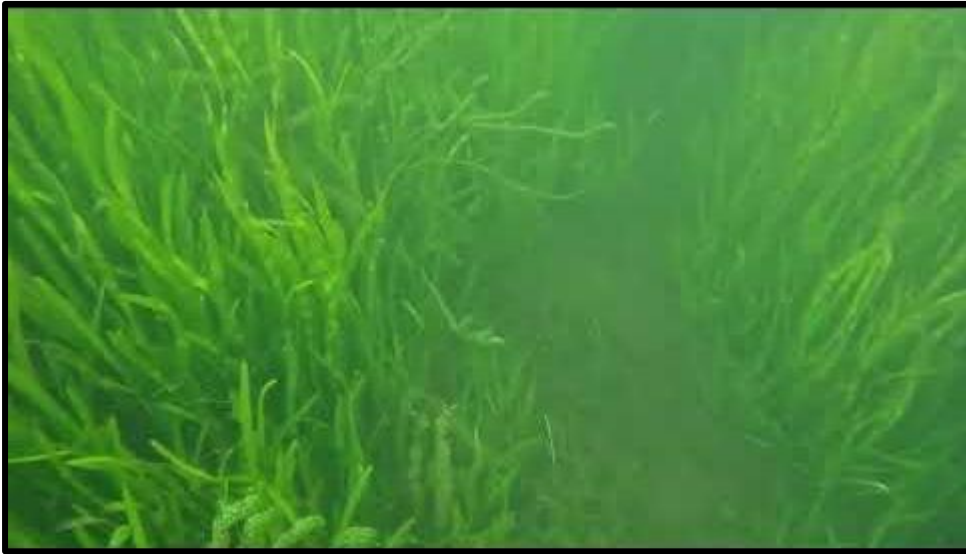
The invasive species (*Vallisneria australis* & *Egeria densa*) are the dominant macrophyte and form a 50 – 75 m wide band along 80% of the lake perimeter. Several *Lagarosiphon major* clumps were seen along the Sylvan Park boat ramp area and a single stem of *Potamogeton crispus* was observed on Transect E. These species have been sighted before and have been reducing in extent over time however, *Lagarosiphon major* was commonly seen amongst the *Vallisneria australis* near the Sylvan Park boat ramp (Video 69).

**Video 69:** *Lagarosiphon major* amongst the *Vallisneria australis* near the Sylvan Park boat ramp.

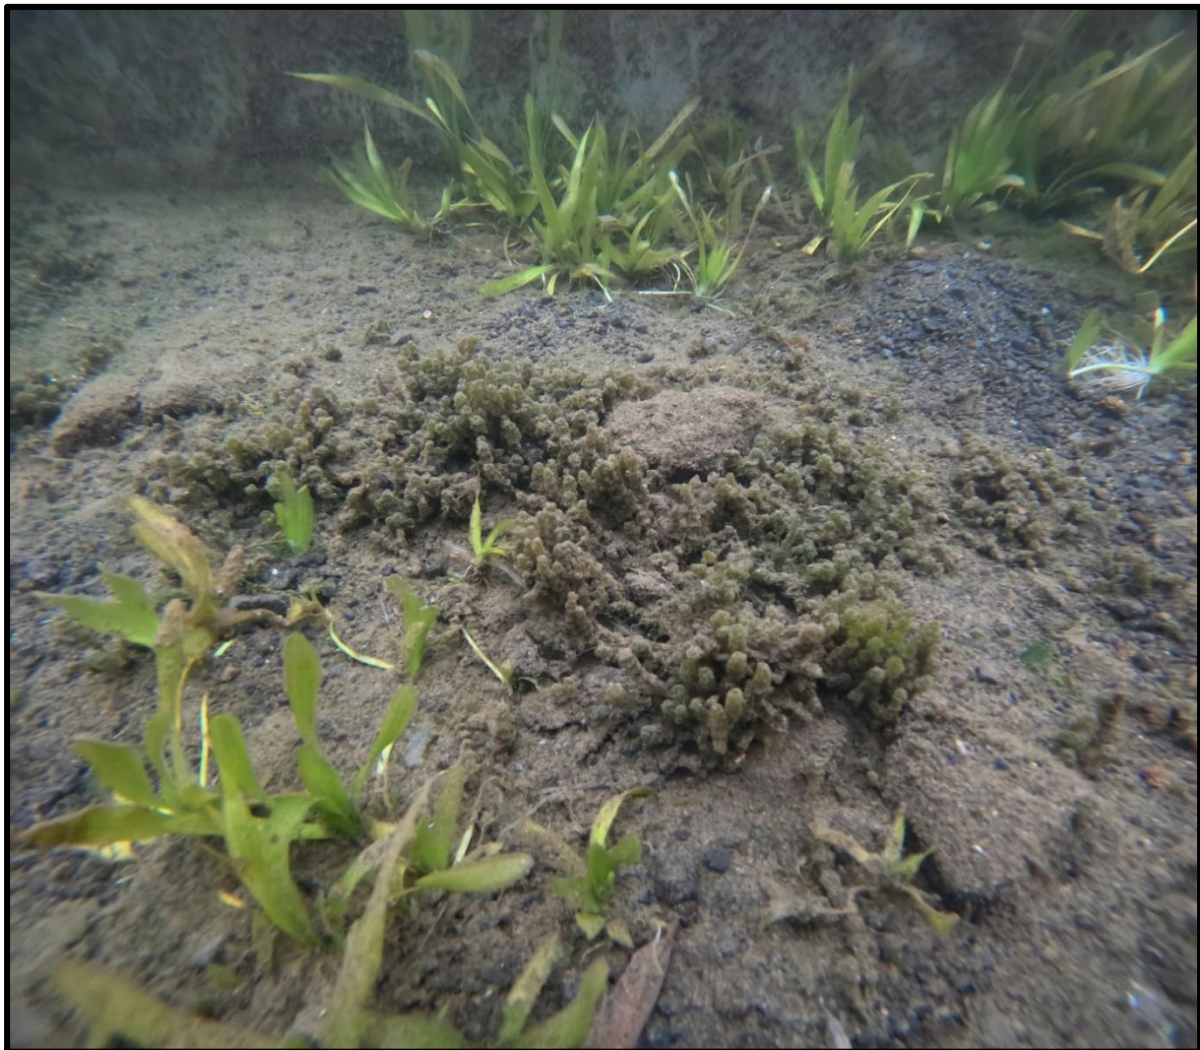
plate 27), and *Nitella sp. aff. Cristata* was found amongst the *Chara australis* bed but never exceeded 15% cover.

**Photo plate 27:** Discrete clump of *Nitella hyalina* near the wetted edge around Sylvan Park.

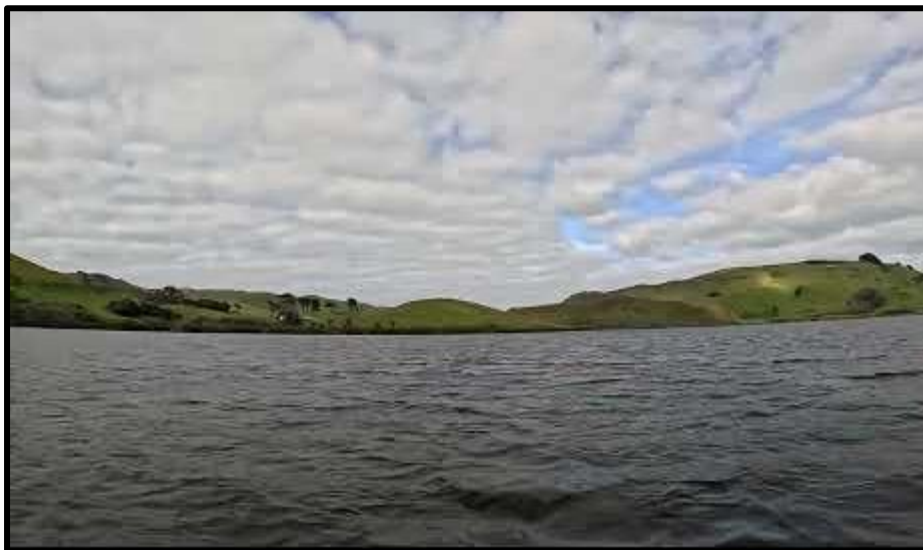
The areas directly adjacent to the lake are flat, however the wider catchment and sub-catchment consist of steep sloped pasture, with large areas of active erosion and bare earth (Video 70). The steep nature of the sub-catchment contributes to the high volume of nutrient laden sheet flow that enters the lake. The riparian buffers vary in quality and offer limited contaminant attenuation along large sections of the lake edge.

**Video 70:** Steep sloped sub-catchment with pasture dominant land cover.

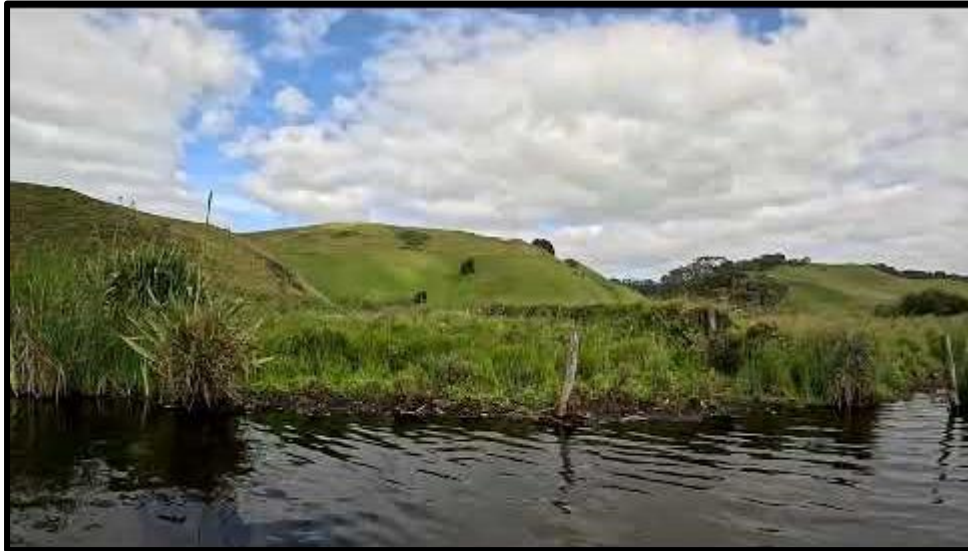
over 100 metres in some areas. Vegetation within the riparian areas comprises a mix of exotic and native grasses, alongside mānuka and kānuka scrub (Video 71 & Video 72). The sparse terrestrial vegetation in these margins provides limited protection against nutrient and sediment runoff from the surrounding land use and some areas have signs of stock access and bank erosion (Video 71).

**Video 71:** Poor condition riparian margin with exotic grass extending into a band of emergent reeds. Bank erosion & signs of previous stock access can be seen along the lake edge.

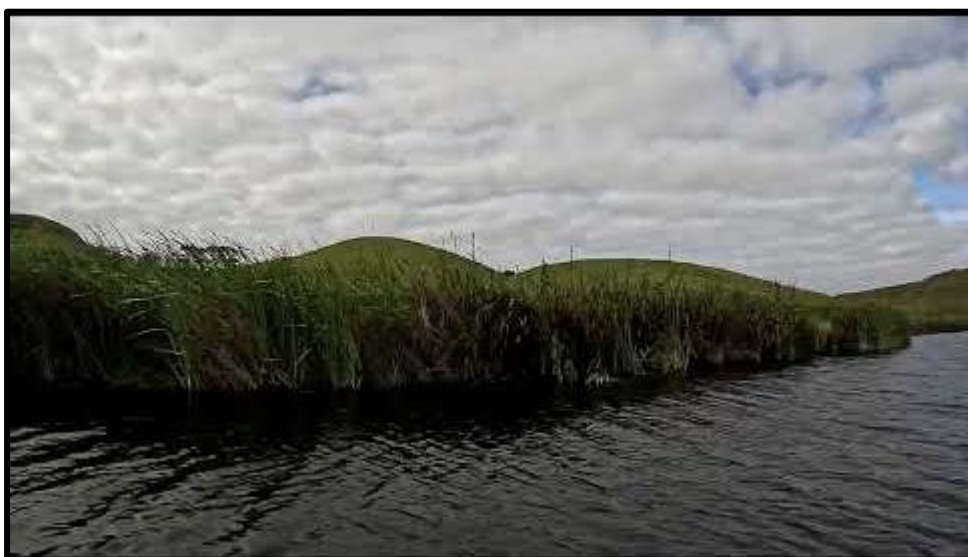
Large sections of the lake perimeter (75 – 80%) are bordered by a wide 10 – 15 m band of contiguous emerged reeds that extend into the lake to a maximum depth of 1.8 m (Video 72). These reed lines provide good contaminant buffering and habitat for waterfowl.

**Video 72:** Wide band of emergent vegetation creating an intact riparian margin.

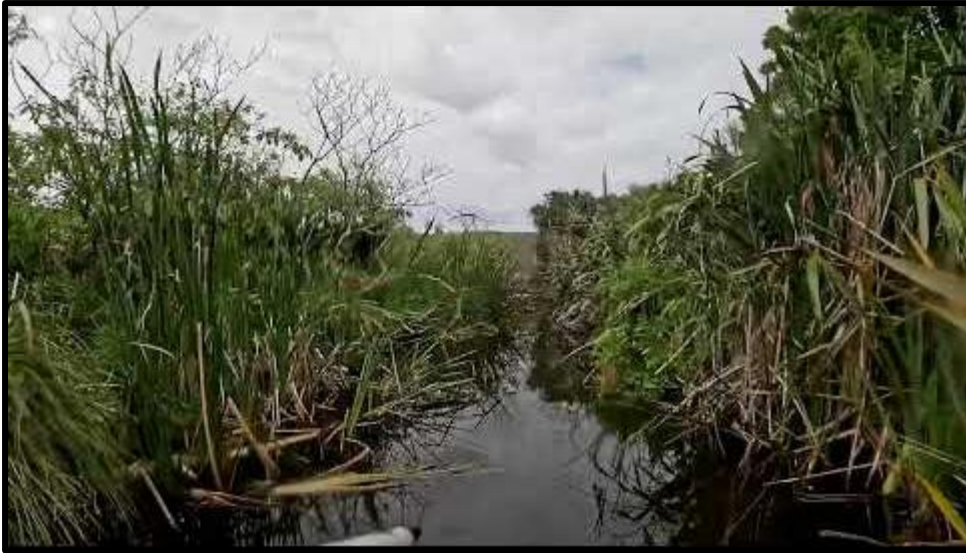
The riparian margins along the outlet stream are intact and have good vegetation assemblages ranging from emergent reeds to mature terrestrial species (Video 73). The outlet stream provides good nesting habitat for wetland birds.

**Video 73:** Riparian margins along the outlet stream.

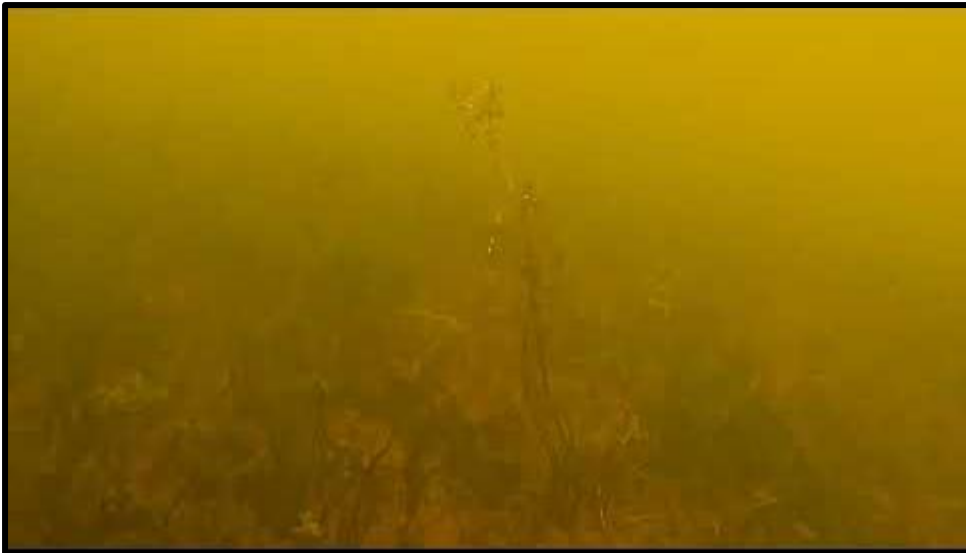
*Myriophyllum triphyllum*, *Chara australis* and *Nitella sp. aff. Cristata* were the dominant species in the shallows (0.2 – 1 m) and frequently reached covers of 75 - 100 % (Video 75 & Video 76).

**Video 75:** Representative shallow macrophyte profile.

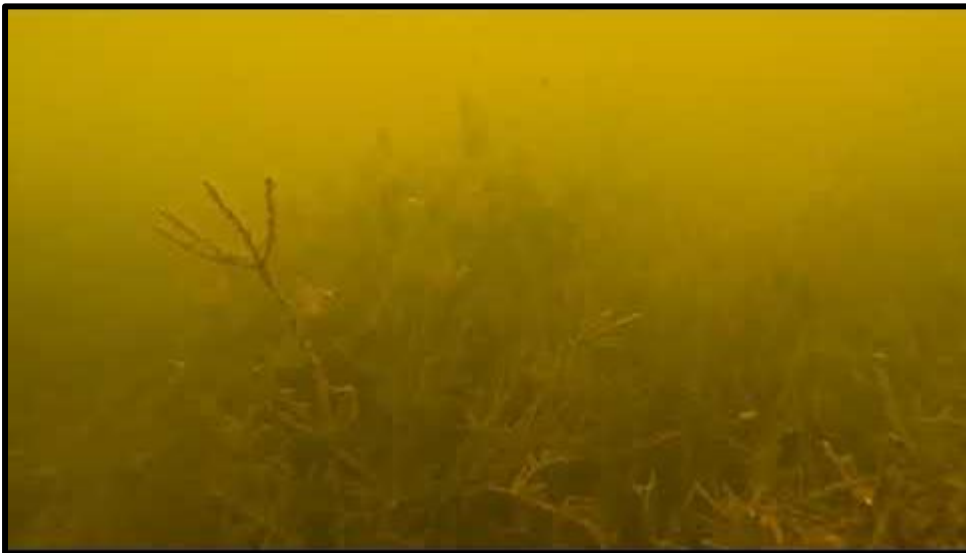
**Video 76:** Dense charophyte bed in the shallow littoral zone.
