**Auckland Lake Assessments**

**2024**

| <b>Document title:</b> | Auckland Lake Assessments 2024 |
| <b>Prepared for:</b> | Auckland Council |

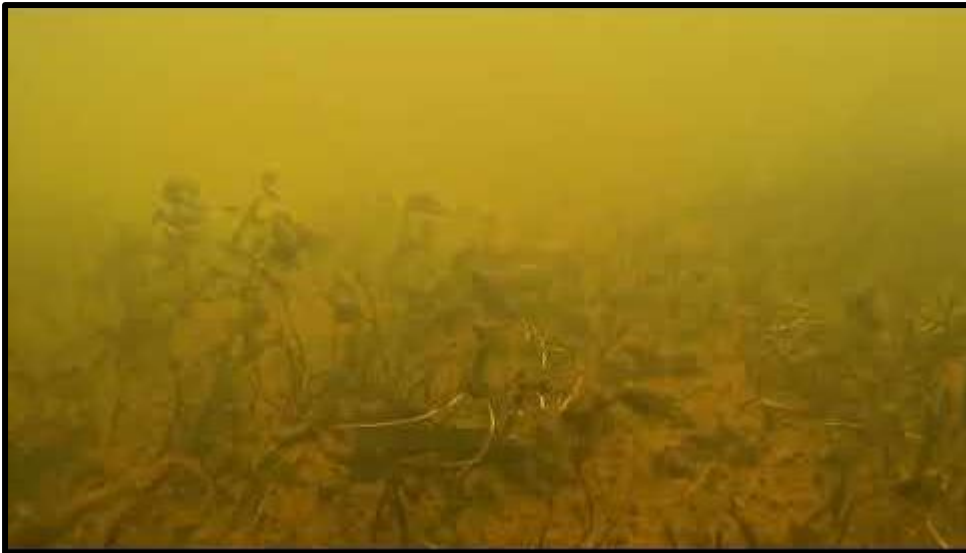
*Elodea canadensis* was present amongst the shallow charophyte meadows however, the achieved cover was lower than observed in the deeper portion of the lake. The apical tips of the *Myriophyllum triphyllum* and *Elodea* along the upper littoral margin had grazing damage from swans (Video 77).

**Video 77:** *Myriophyllum triphyllum* with apical damage cause by grazing swans

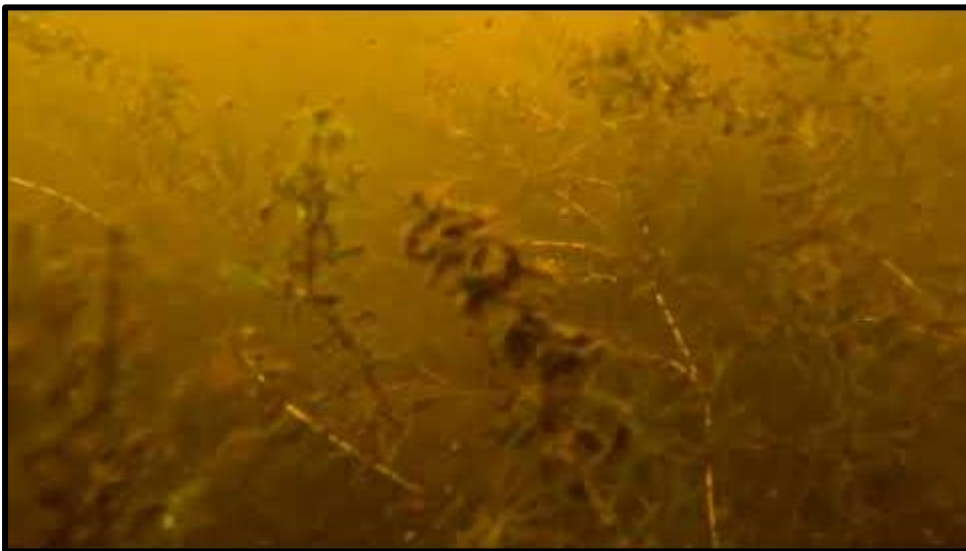
The swans appear to be regulating the growth of tall macrophytes in the shallows and have caused a concentration of *Elodea* in the deeper central part of the lake where it achieved covers of > 85% (Video 78).

**Video 78:** Dense *Elodea* & *Egeria* bed in the deeper central portion of the lake

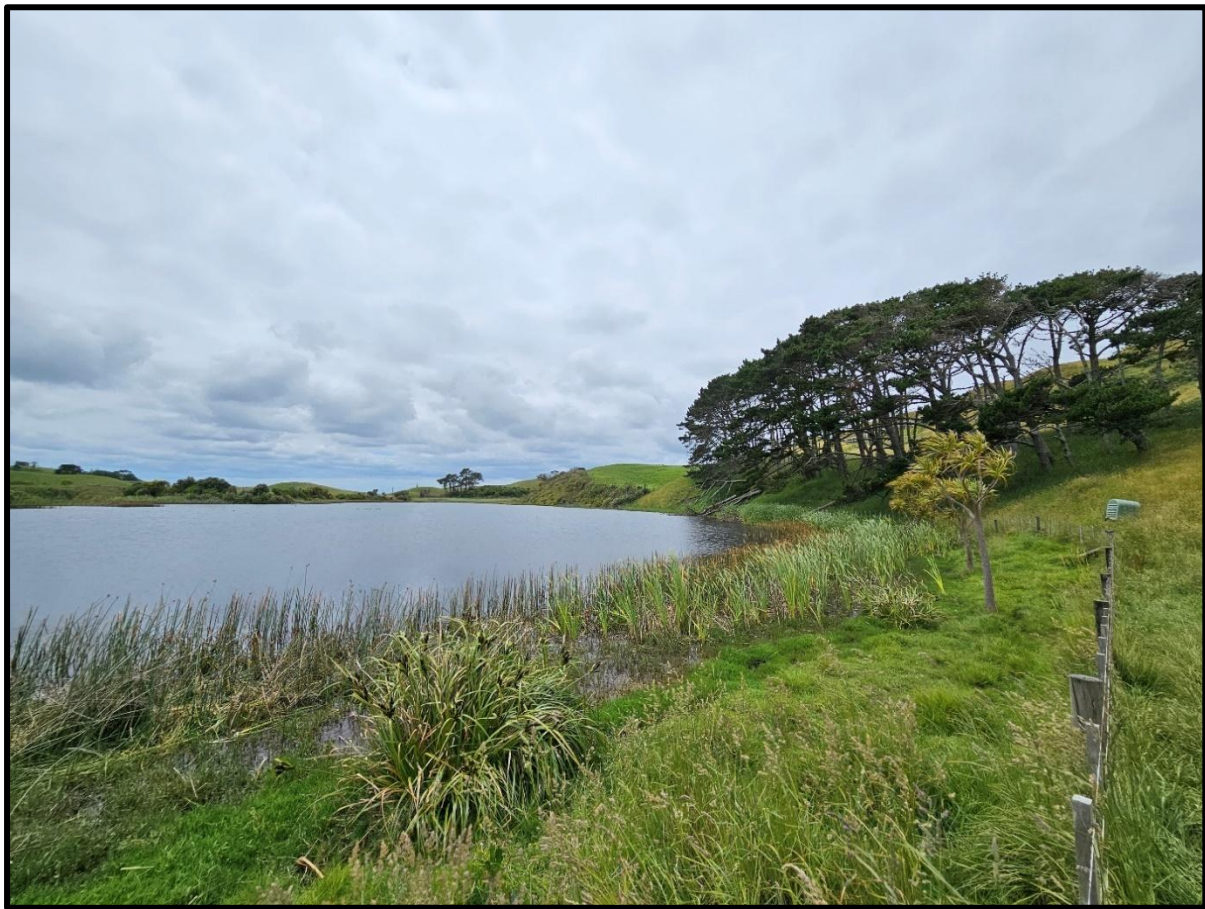
This limited buffer offers little protection from nutrient and sediment runoff originating from the adjacent pasture. In contrast, the southeastern and southern shores of the lake feature a more intact riparian zone, with wider bands of native vegetation, including raupō, harakeke (flax), and manuka (Photo plate 30). These areas, with riparian margins of 10 - 15 m in width, offer better protection against runoff and help stabilise the shoreline.

**Photo plate 30:** Southern shore featuring a more intact riparian margin.

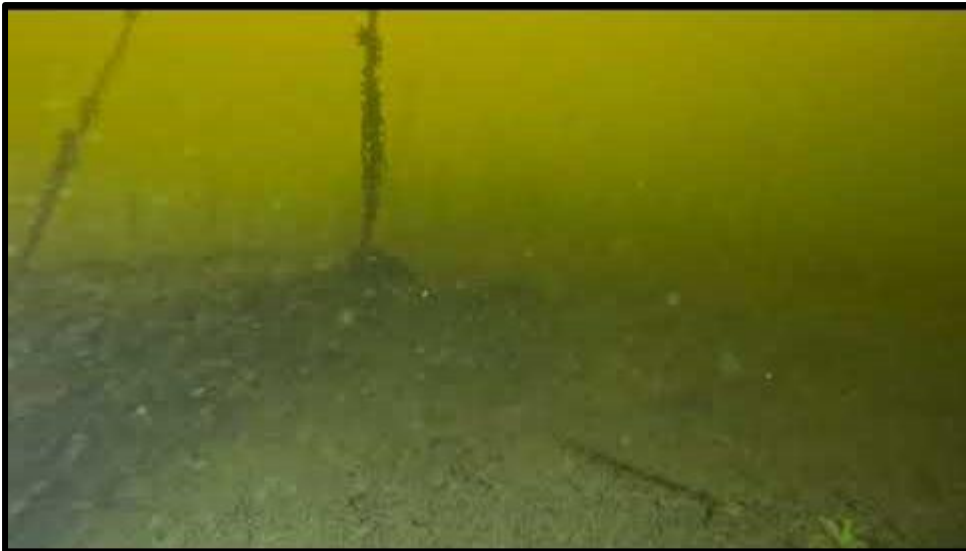
The epilimnion had a lot of suspended matter and visibility was limited to 0.2 – 0.5 m. The visibility increased to 4 m below the thermocline and there was noticeably less suspended matter. This is likely due to the suspended organic matter being contained in the epilimnion that sits on top of the denser cold hypolimnion. Wind induced mixing of this surface layer creates a turbid epilimnion. There was a 1 m thick mid-water sulphide layer between 3 – 4 m deep, which is a result of this organic matter accumulating above the hypolimnion and decomposing (Video 79). The visibility through this layer was near zero and it effectively shielded almost all light from penetrating into the hypolimnion (Video 79).

**Video 79:** Transect through the deep central bowl toward the outer macrophyte extent & into the sulphide layer.

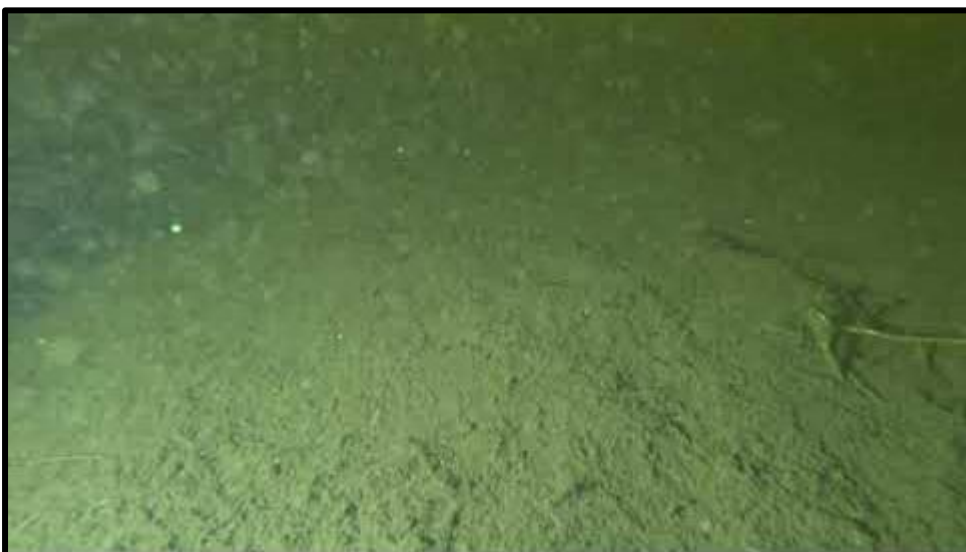
The substrate amongst the emergent reeds and the areas of shoreline that had limited vegetation was sandy with a hard consolidated base. The substrate on the steep sloped southern boundary had a 15 cm layer of organic floc and fine silt on top of a consolidated sandy base. The substrate past the maximum vegetated depth extent was loose and consisted of a thick (>1 m) layer of soft organic floc and silt, no consolidated layer could be found in the deeper sections of the lake (Video 80). There were signs of persistent anoxia and large amounts of decomposing organic matter beneath the dense *Egeria* beds which formed a loose black substrate covered in benthic algal mats.

**Video 80:** Loose unconsolidated substrate in the deep central bowl.

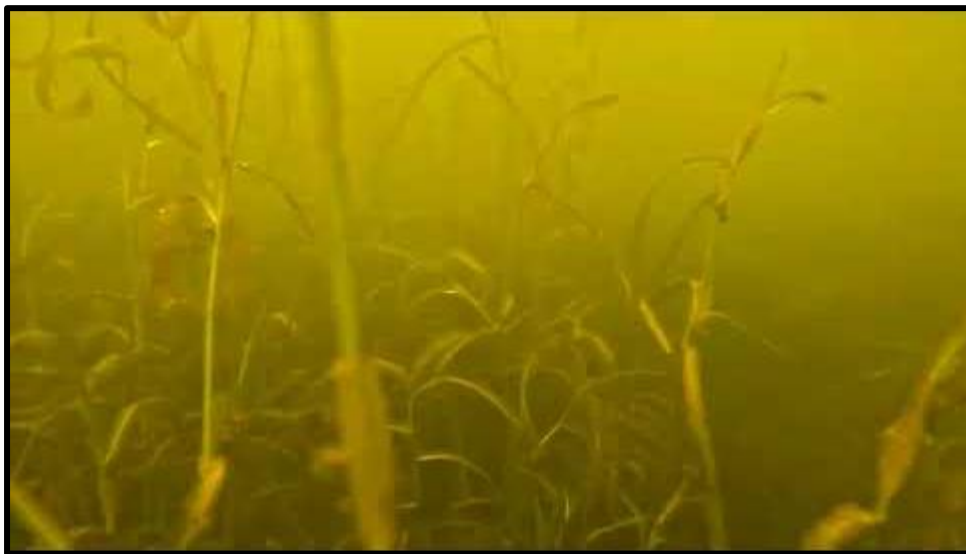
The general vegetation establishment pattern in Lake Whatihua begins with a 1 – 15 m wide band of emergent reeds that extends to 2.7 m deep followed by a think band of *Egeria densa* (~70 m) with *Potamogeton ochreatus* stems dispersed throughout (Video 81). The *Potamogeton ochreatus* forms a 20 – 30 m wide belt along the upper edge of the thermocline before transitioning into another 20 m wide *Egeria densa* dominant area that extends to the maximum vegetated depth of 4.7 m (Video 81). Overall, there is a ~120 m vegetated band that runs along the outer edge of the emergent reed line.

**Video 81:** Transition from dense *Egeria* bed into pondweed belt.

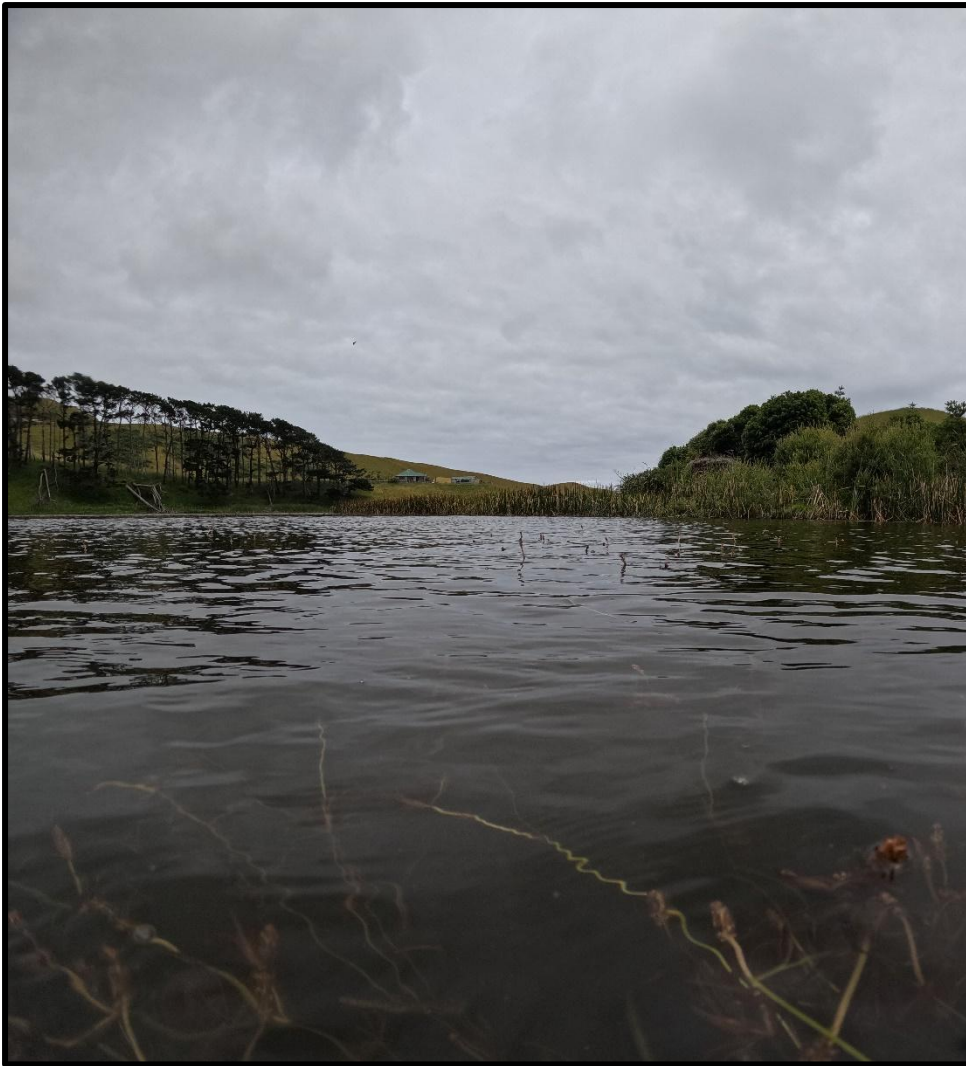
*Potamogeton ochreatus* generally formed the tallest sections of canopy where present in high cover and was surface reaching along the upper littoral margin (Photo plate 31). The pondweed canopy was not dense enough to shade out the *Egeria* and the understory was still dominated by dense *Egeria* growth (Video 82). The maximum height recorded for *Potamogeton ochreatus* was 4 m tall, but the lake-wide average was 1.9 m. The maximum *Egeria densa* height was 3.8 m which is shorter than the tallest stand of *Potamogeton ochreatus* however, the average *Egeria densa* height was taller with most stands reaching 2.4 m.

**Photo plate 31:** Surface reaching *Potamogeton ochreatus* along the northern bank.

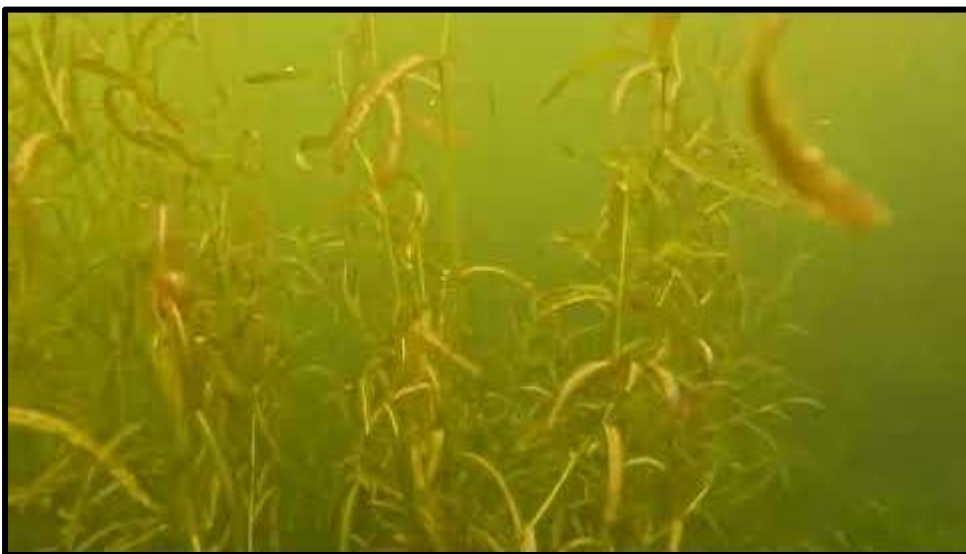
**Video 82:** Canopy of native pondweed with an *Egeria* dominated understory.

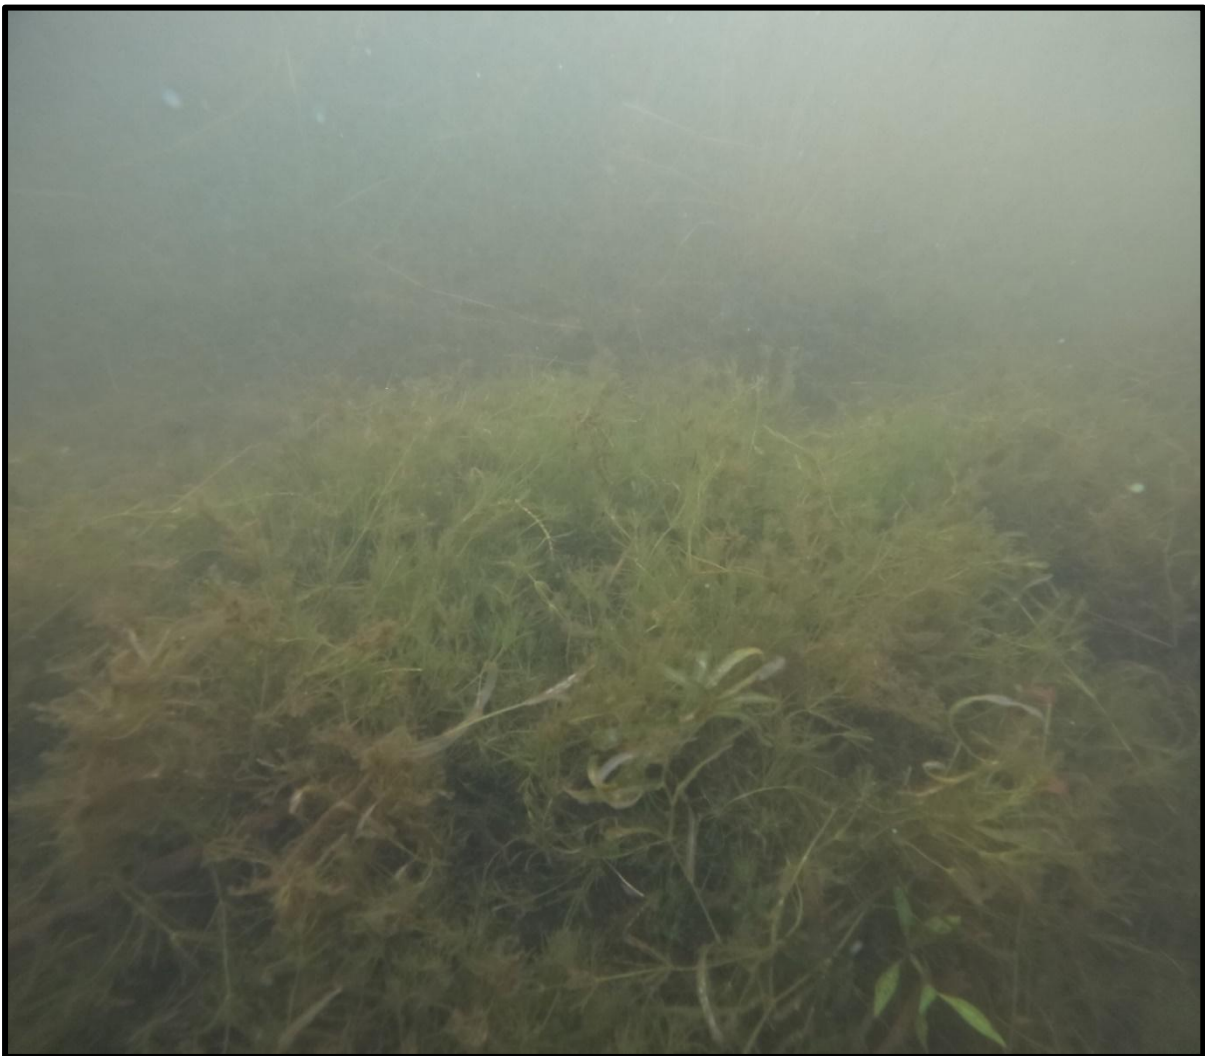
Transect D was the only transect with more than one native species. It had a discrete bed of *Chara globularis* from 0.5 - 0.8 m with a maximum height of 22 cm and the average bed height was 20 cm (Photo plate 32). The bed had a cover of > 90% but the transect wide cover was 1 – 5%. Small clumps of *Nitella hyalina* were seen between 0.5 – 0.6 m with some of the taller stems reaching 18 cm, the average height was 8 – 12 cm, this species never reached covers over 1 – 5 %. *Myriophyllum triphyllum* was also seen along Transect D and was sparsely distributed with a maximum cover of 15% and an average cover of <5% along the transect. Tall stems reached 1.8 m in the deeper sections however most of the growth was between 30 – 50 cm tall.

**Photo plate 32:** Discrete bed of *Chara globularis* along the start of Transect D.

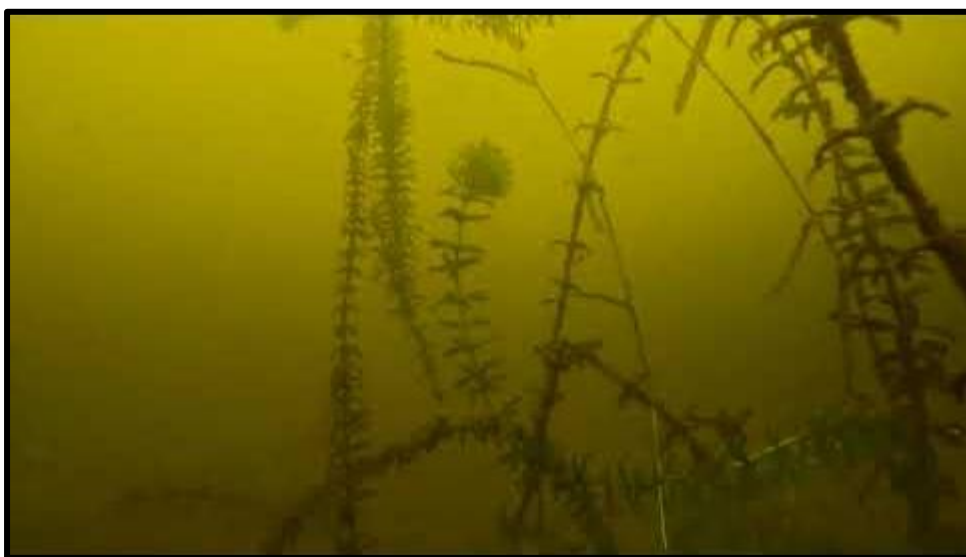
**Video 83:** Pilot site where *Egeria* was cleared using hand removal methods.

The Auckland Council has a pilot project that is investigating the feasibility of *Egeria* control using a combination of hand removal, smothering and herbicide application (M. Jones. pers. comms, 2024). A test plot was cleared in mid-2024 using hand removal with the focus on assessing regrowth, potential native regeneration and rate of colonisation. A brief investigation of the cleared area showed that a noticeable reduction in *Egeria densa* was achieved and limited recolonisation had occurred (Video 83). The effort required to clear the small area could make the widescale application of this method challenging. The rate of colonisation should be quantified as it appears that the *Egeria* is encroaching from the sides of the clearing, single stems of native pondweed and *Egeria* were seen in the centre of the clearing indicating that regrowth is occurring within 4 – 6 months of the initial hand removal. Careful consideration is required when removing large amounts of macrophytes from Lake Whatihua as these species are performing vital nutrient assimilation functions.
