Waitakere Coastal Communities Landslide Risk Assessment

Overall Report - Muriwai

Auckland Council

15 May 2024

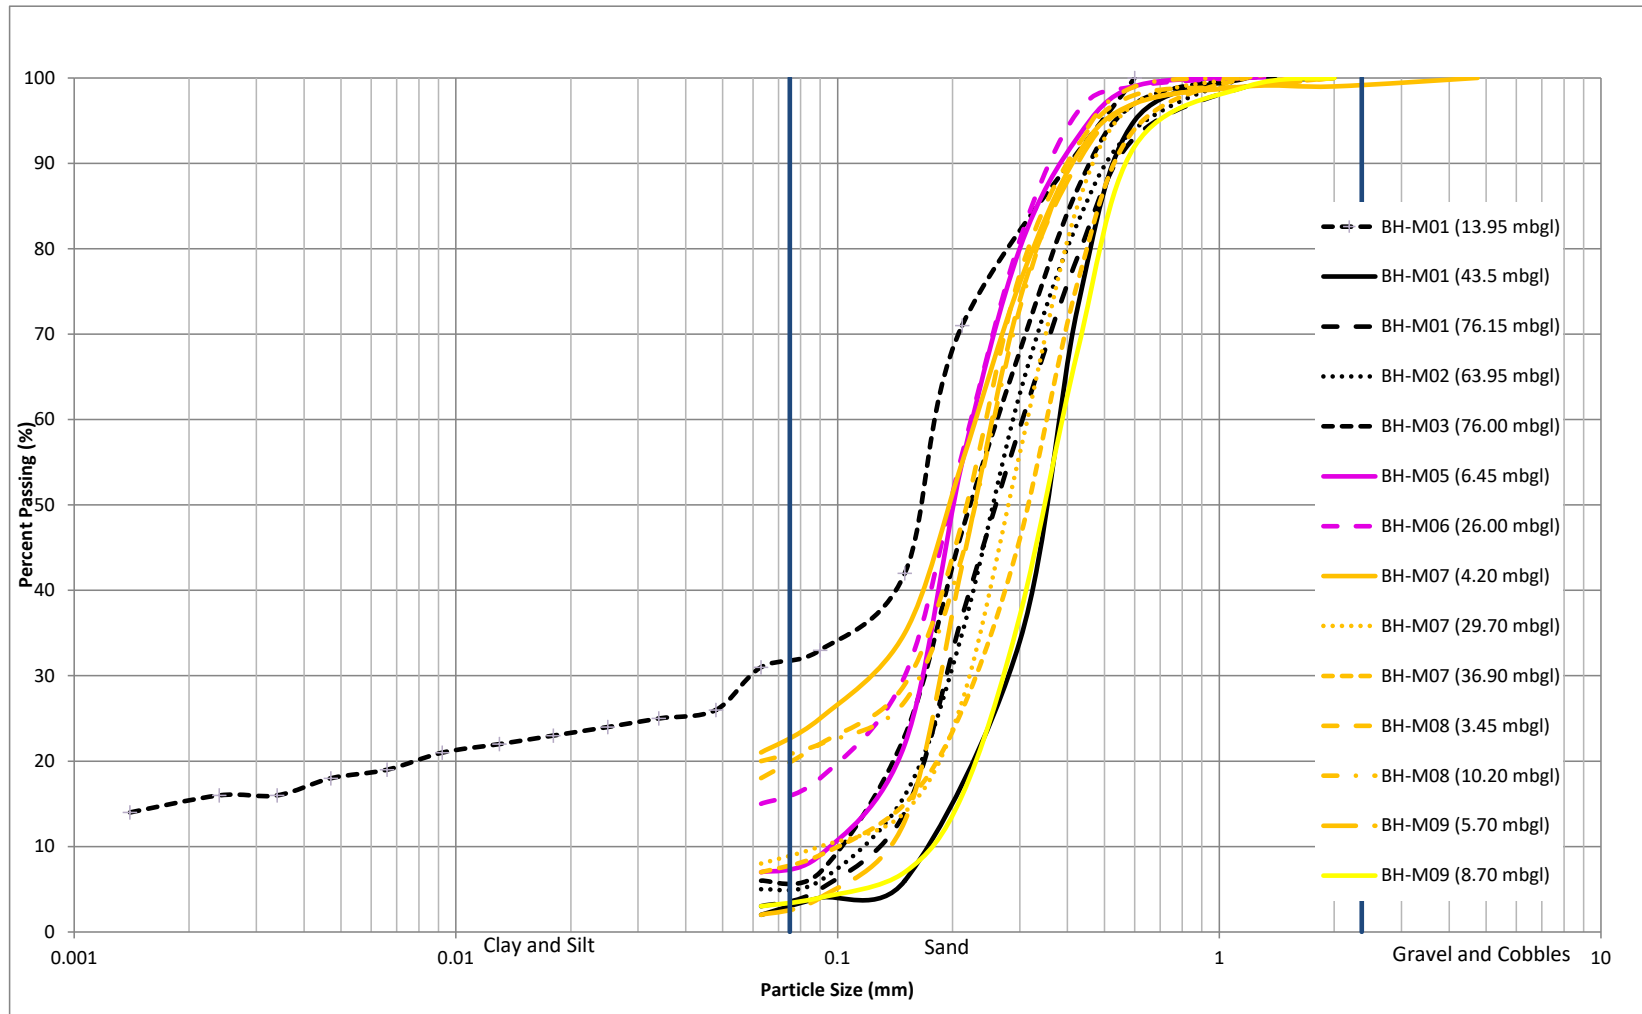
Figure F4 Particle Size Distribution chart

Thirteen samples were taken from BH-M01 to BH-M09 and tested for Particle Size Distribution (PSD - wet sieve). One PSD sample from BH-M01 was tested for PSD - hydrometer (NZS 4402:1986 Test 2.8.4). The results are presented in Figure F4.

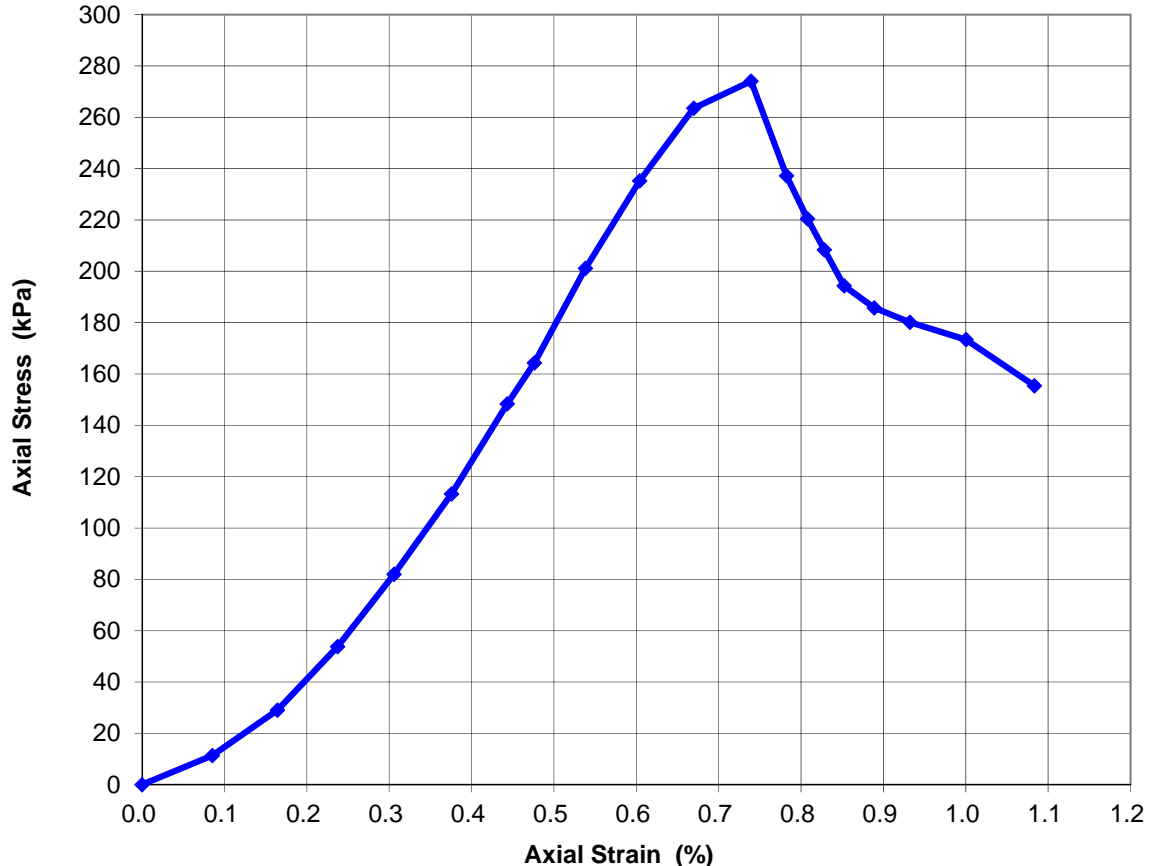
Stress - Strain Curve

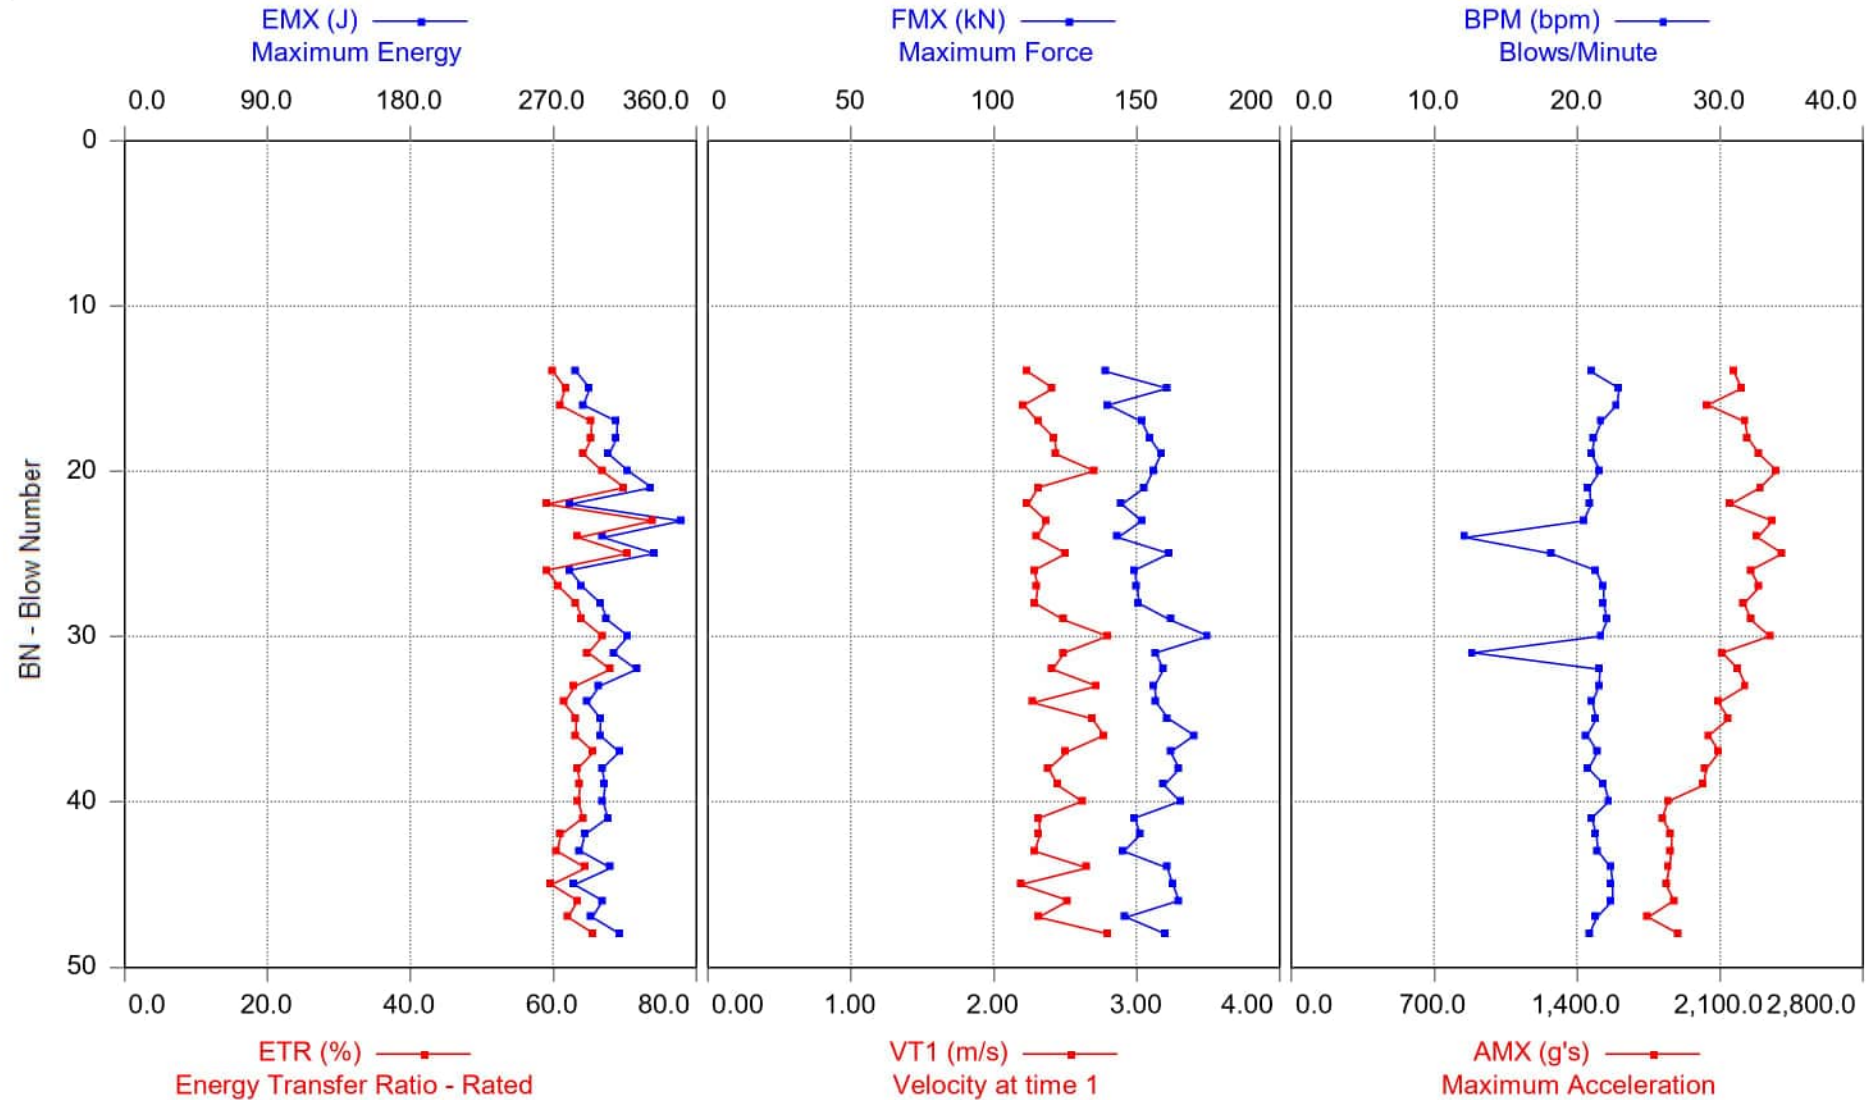
2023-02-09 DCN Drilling - SPT Drop Hammer No.1

Case Method & iCAP® Results

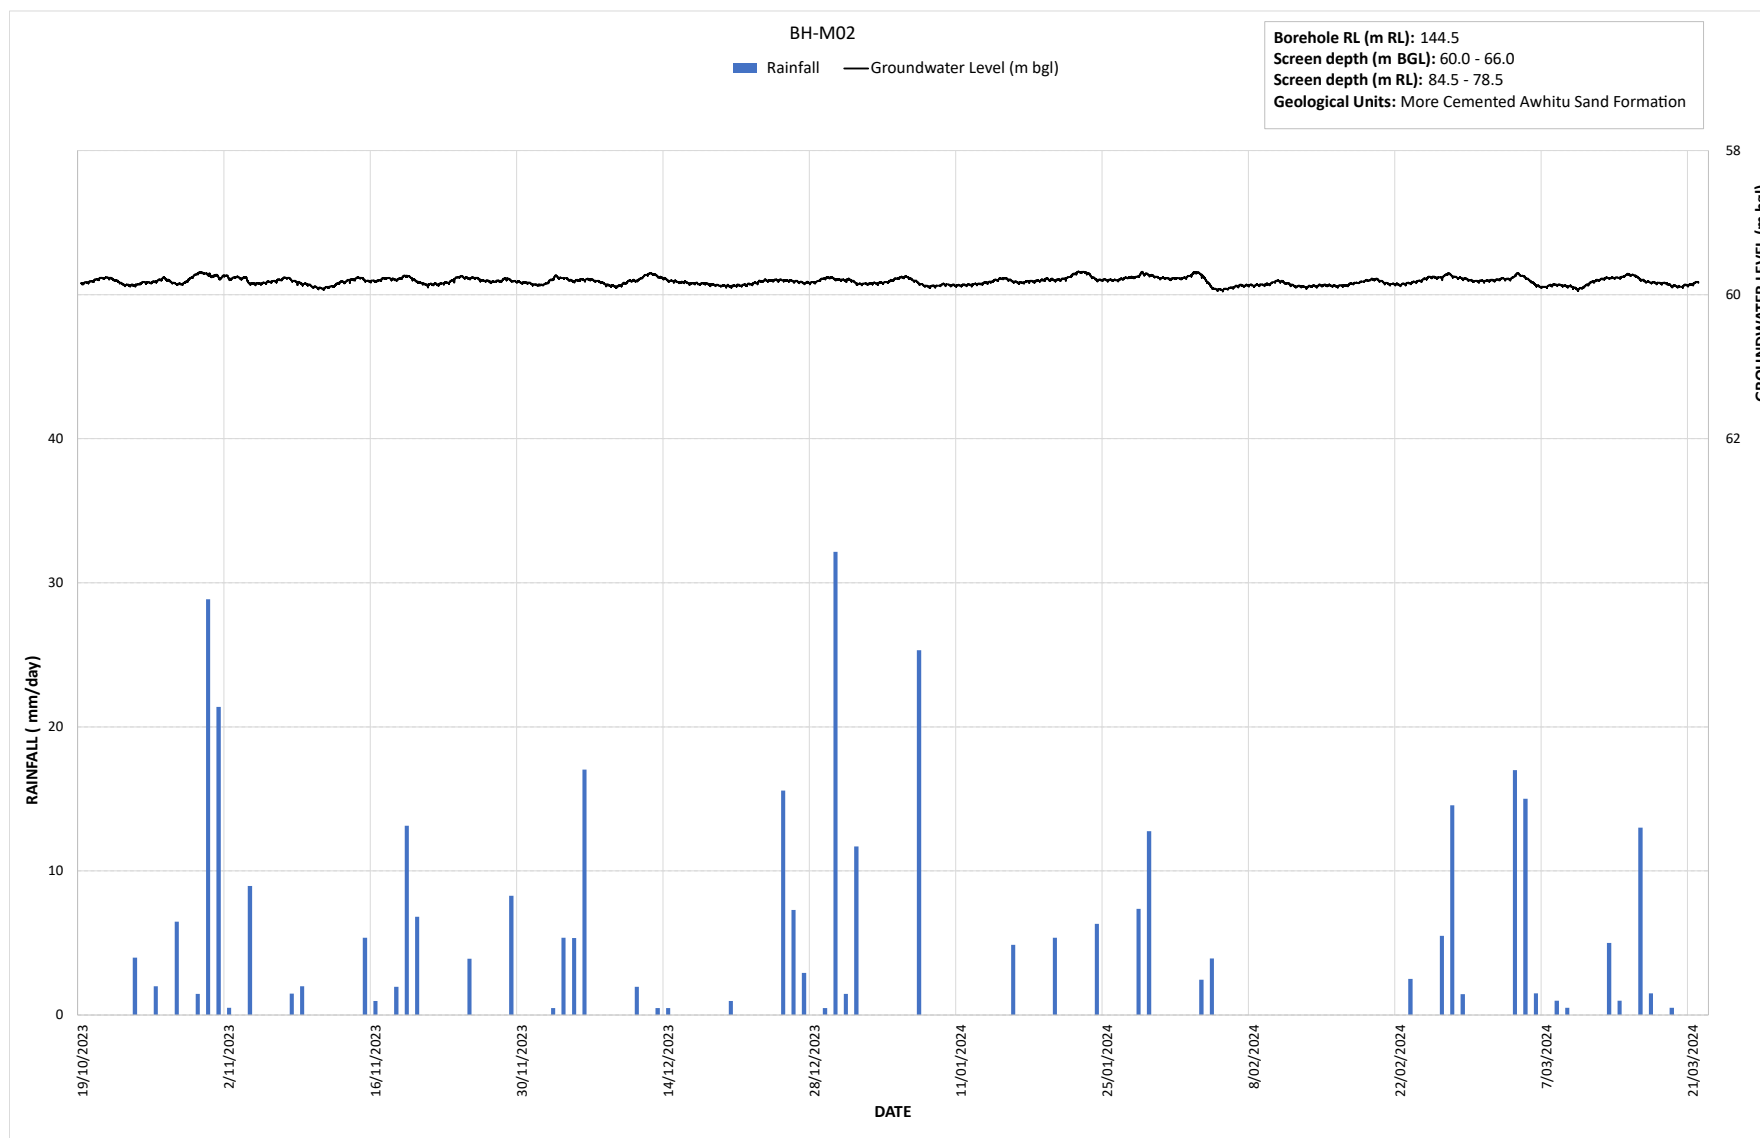
Figure F5-1: Plot of rainfall and telemetered groundwater data from BH-M02. Rainfall data sourced from Auckland Council's Environmental Data Portal

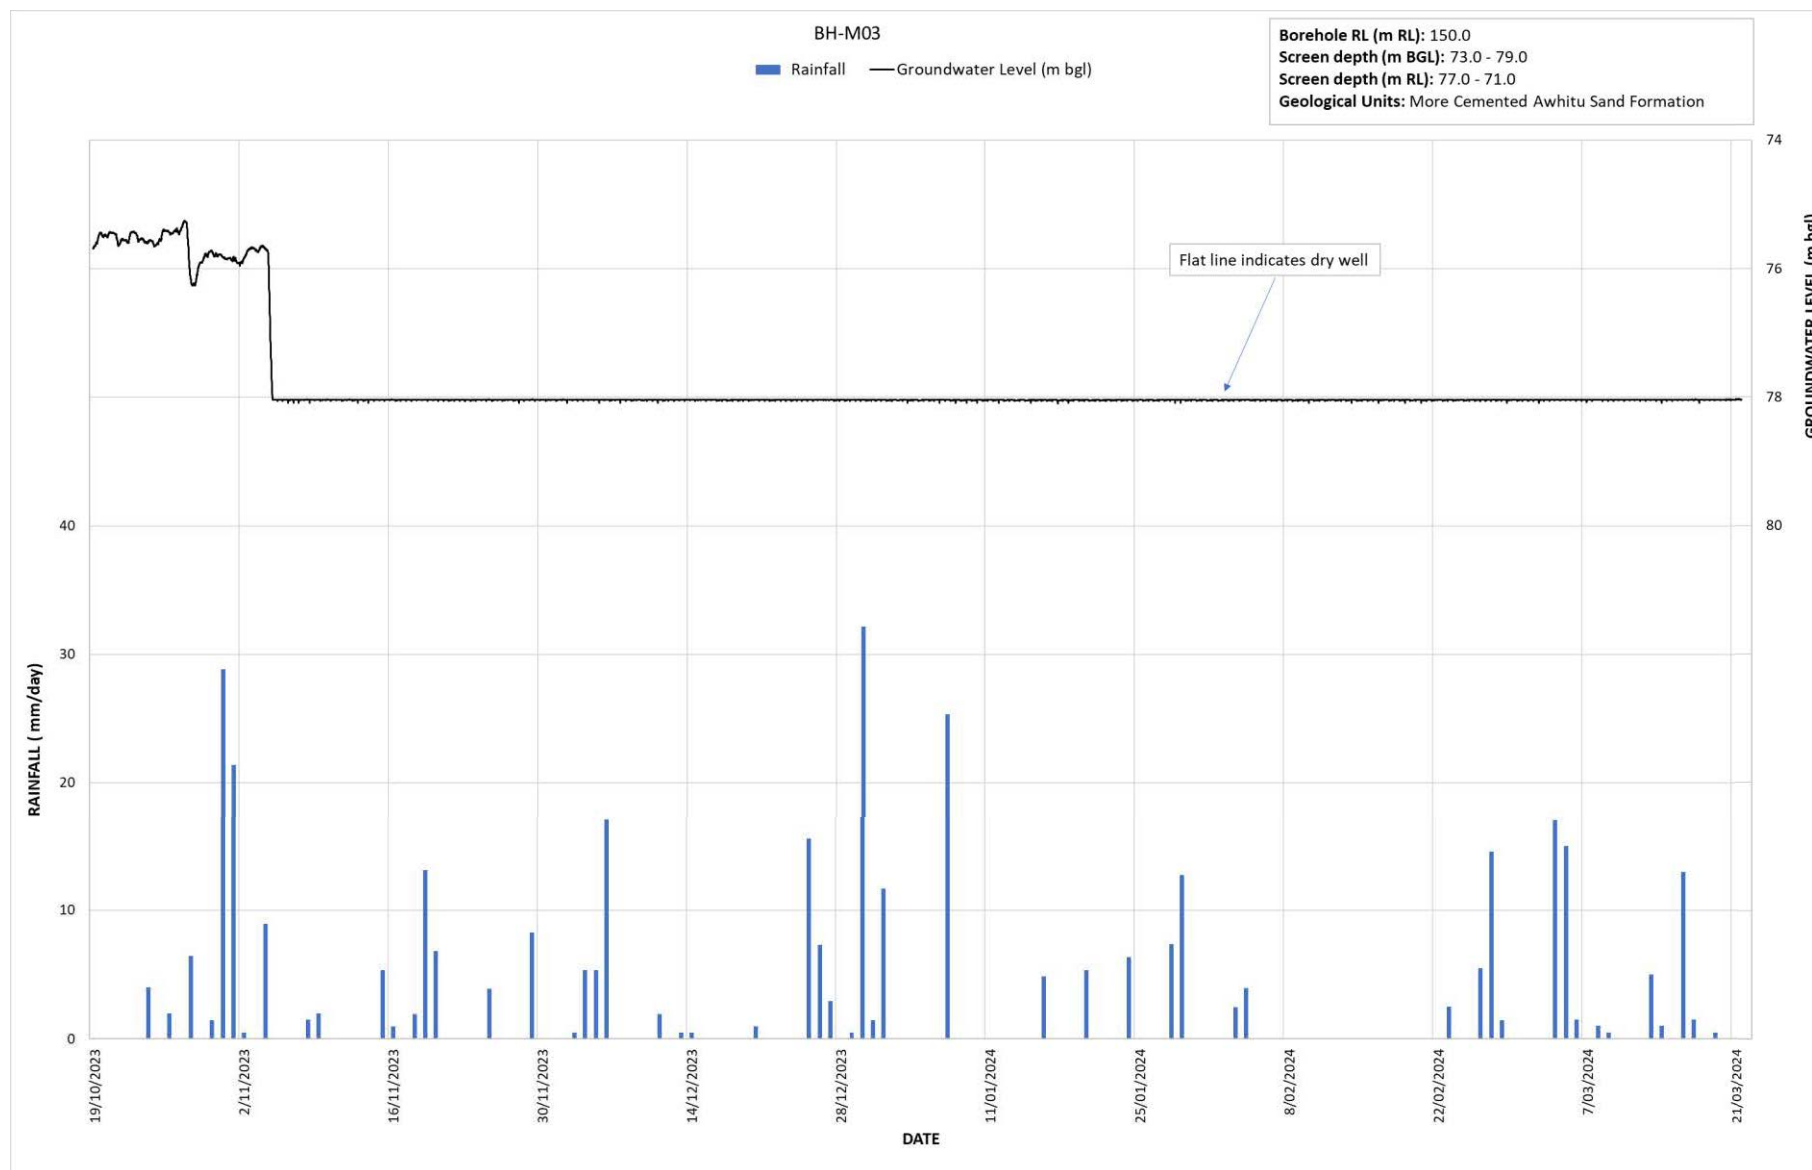
Figure F5-2: Plot of rainfall and telemetered groundwater data from BH-M03. Rainfall data sourced from Auckland Council's Environmental Data Portal

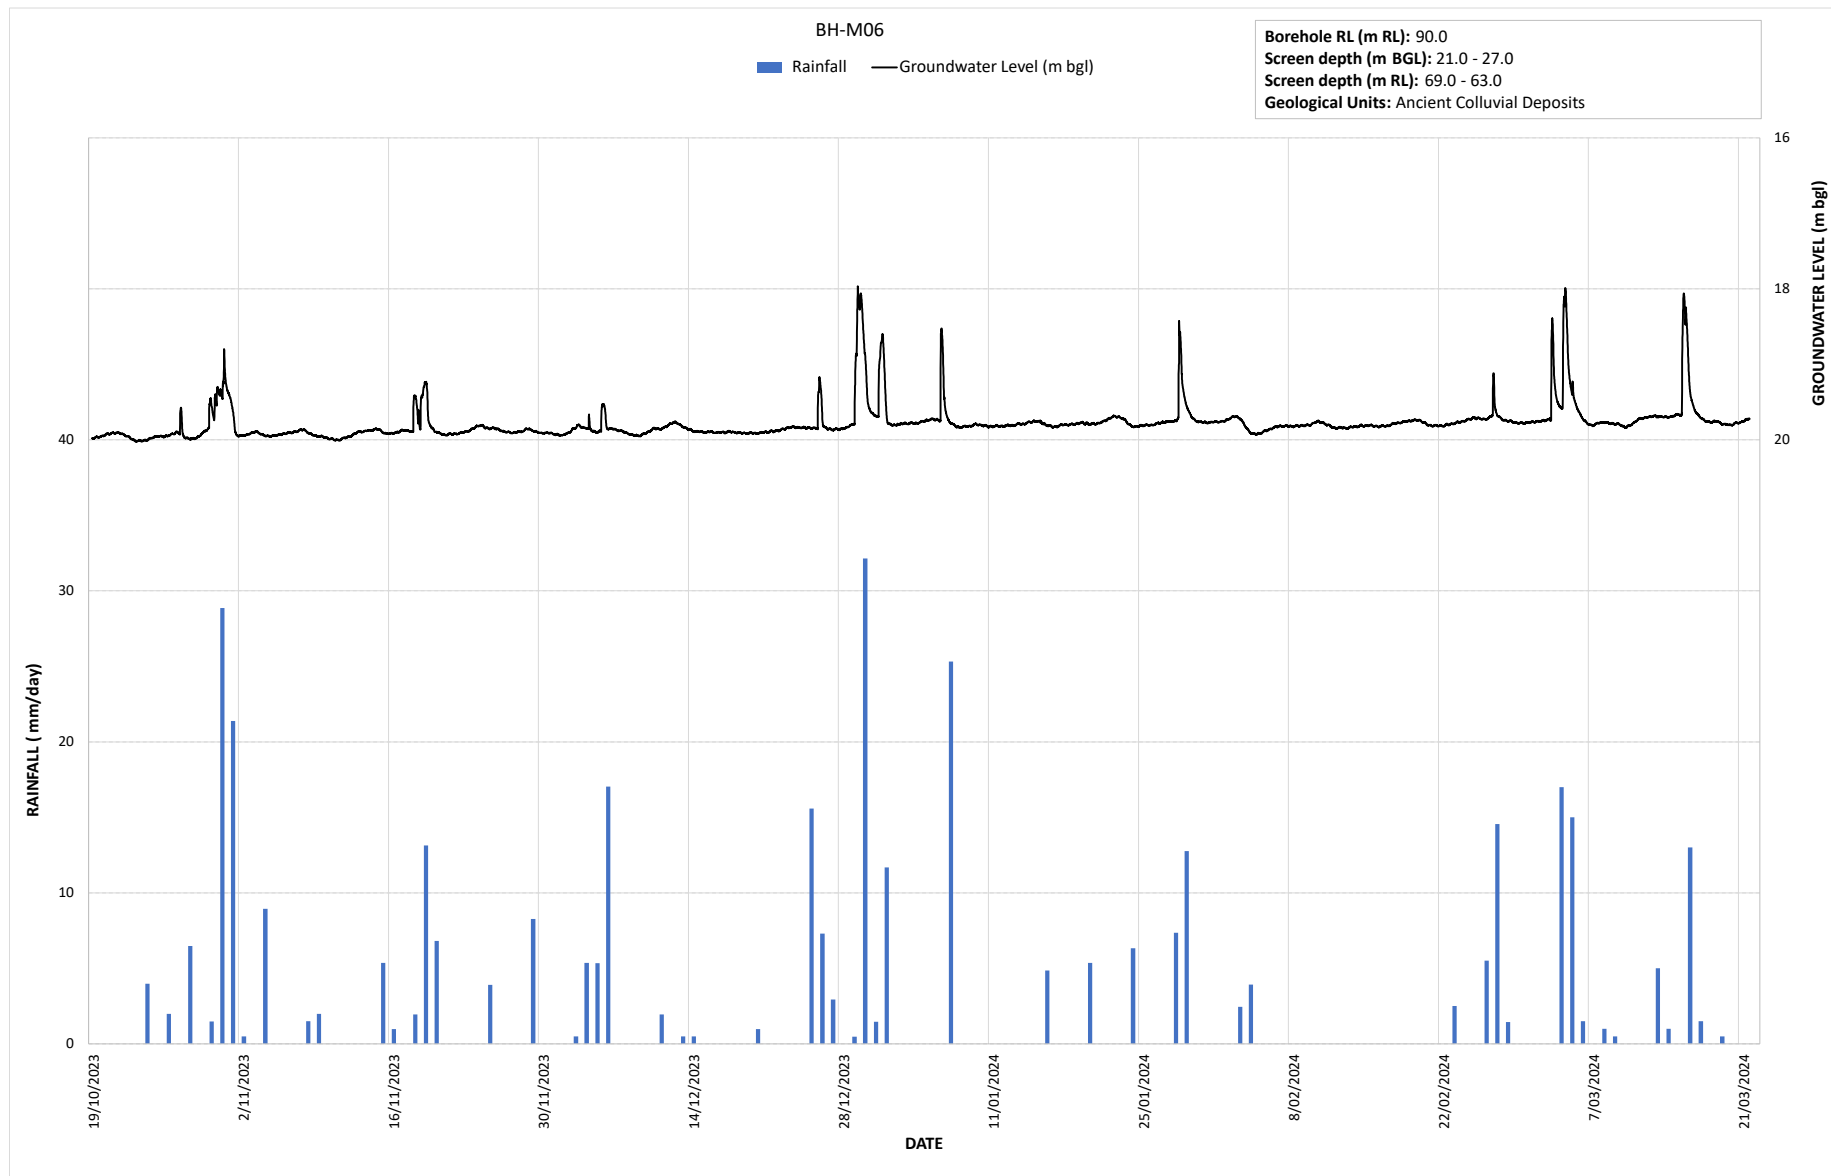
Figure F5-3: Plot of rainfall and telemetered groundwater data from BH-M06. Rainfall data sourced from Auckland Council's Environmental Data Portal

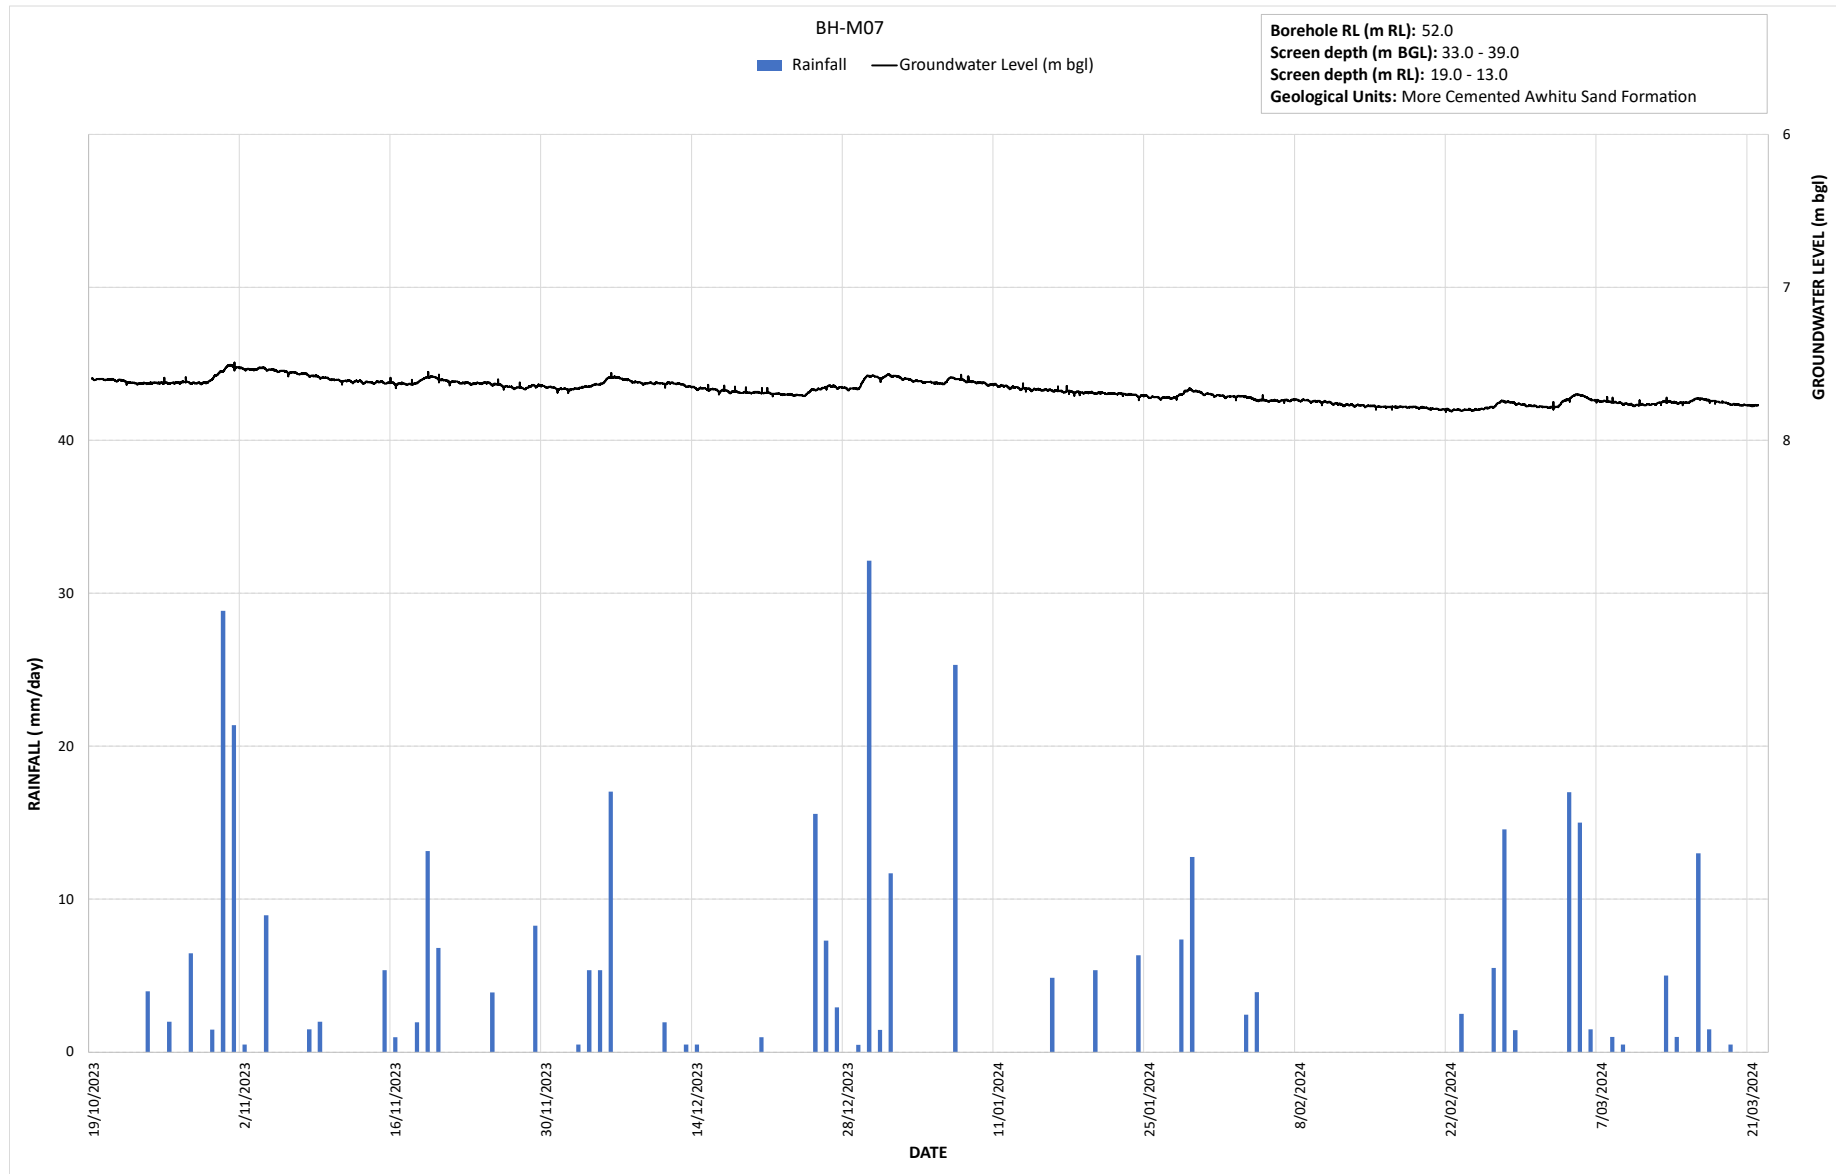
Figure F5-4: Plot of rainfall and telemetered groundwater data from BH-M07. Rainfall data sourced from Auckland Council's Environmental Data Portal
